CK-2520

LOST CREEK km

2019 Inspection

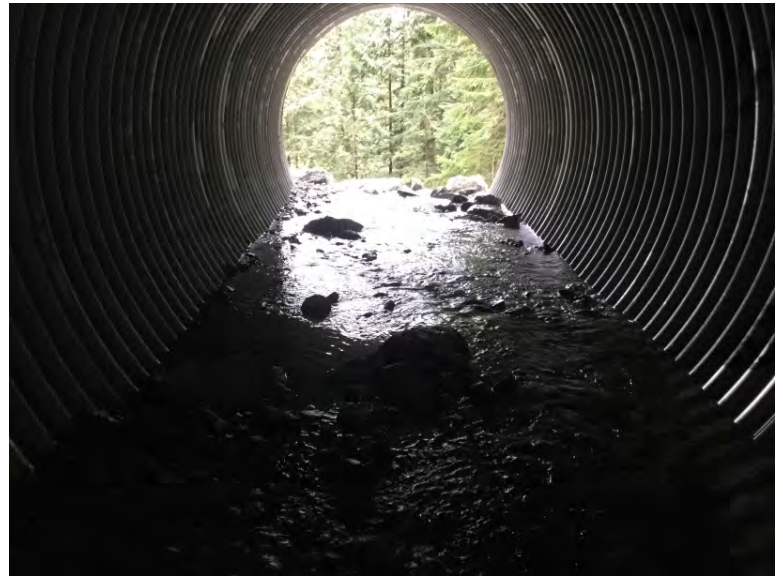
Embedded material

Monitor the embedded material. The current load rating of L100 or 91 tonnes to continue.

| 1 | Embedded material | Routine Inspection |
