CK-2523

SQUEAH 0.4 km

2019 Inspection

| Structure Class | Major Culvert |

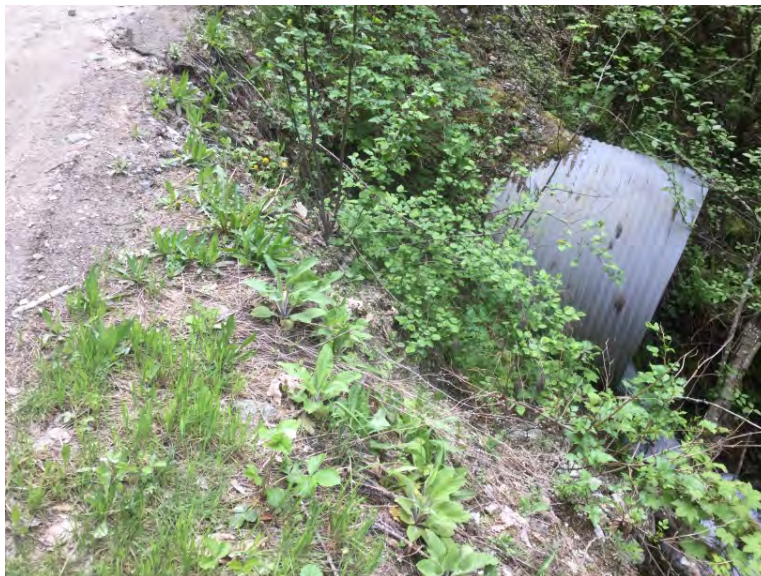
Fill Fair Eroding at downstream right bank

1 Fill erosion noted downstream right bank

Fill erosion at downstream right bank

Monitor the failing fill on the downstream right bank and the minor culvert deformation. The current load rating of BCL-625 or 63 tonnes to continue.

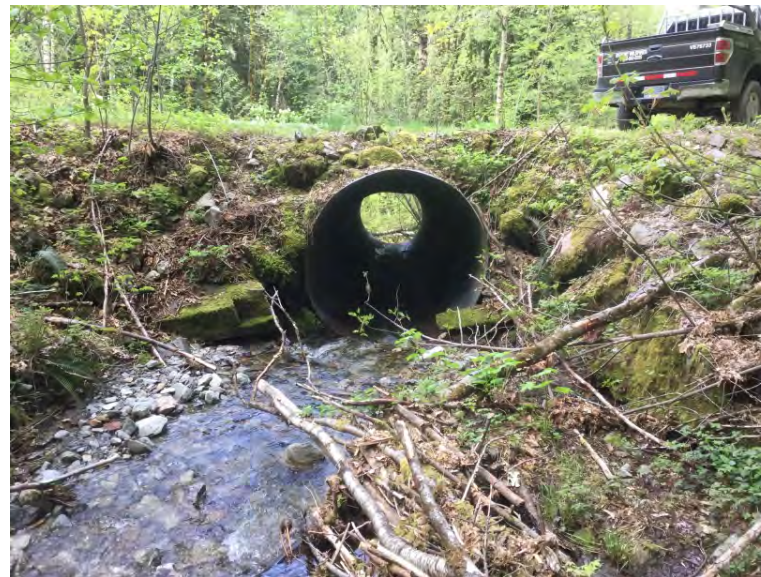
Inlet Good

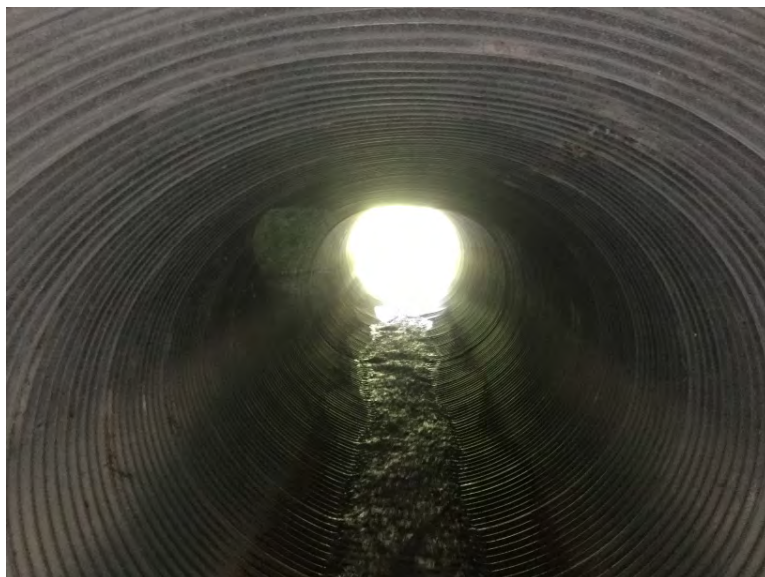
Roof Fair Minor damage noted at midspan

2 Damage noted to roof and floor of culvert

Damage to roof at midspan

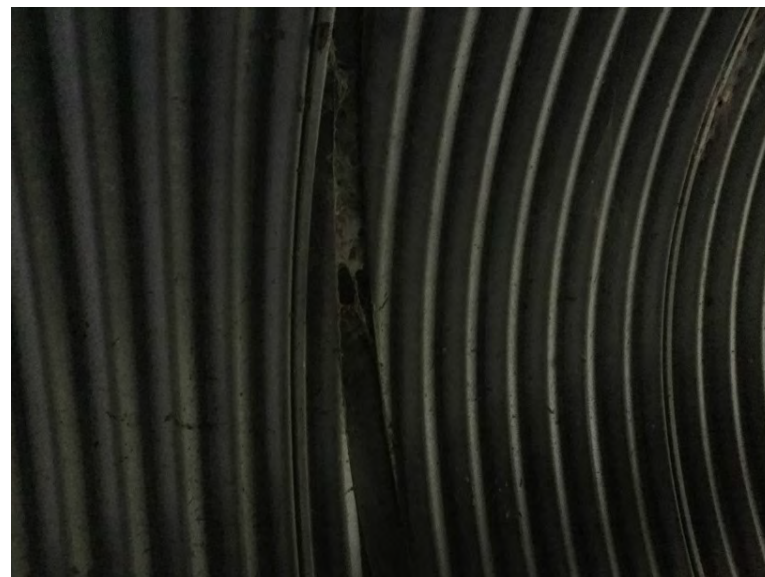
Coupled Connections Fair

Coupler slightly misaligned, tight at roof with 50mm gap on floor

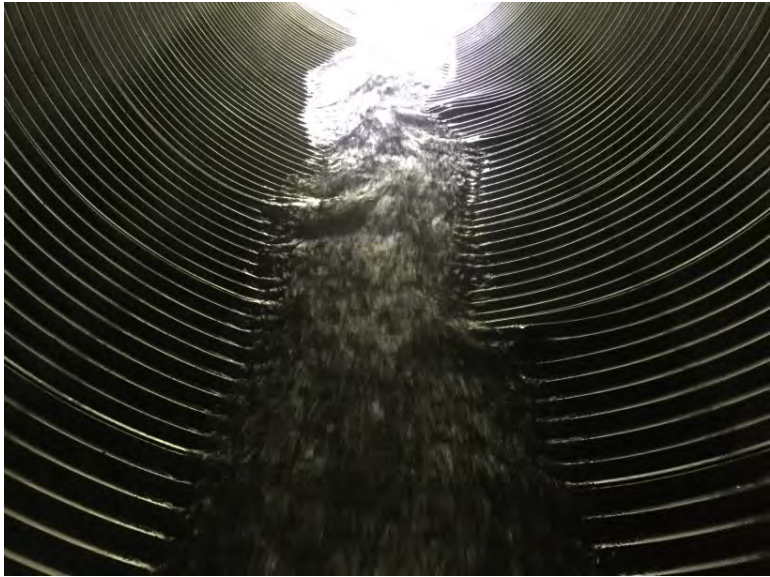
Floor Fair Minor damage noted full length

Minor damage noted on the floor

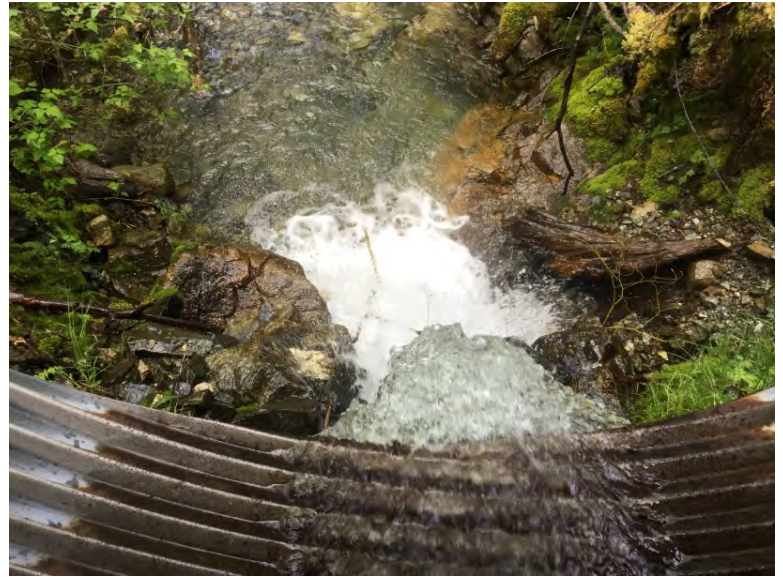
Outlet Fair 2.5m drop into bedrock controlled pool
