# BC Ministry of Forests, Lands, and Natural Resource Operations

## Log Stringer Bridge Inspection Report

| Structure #: | CK-2524 | Site #: | CK-2524 | Road Name: | BIG SILVER | Inspection Date: | 2019/08/20 |

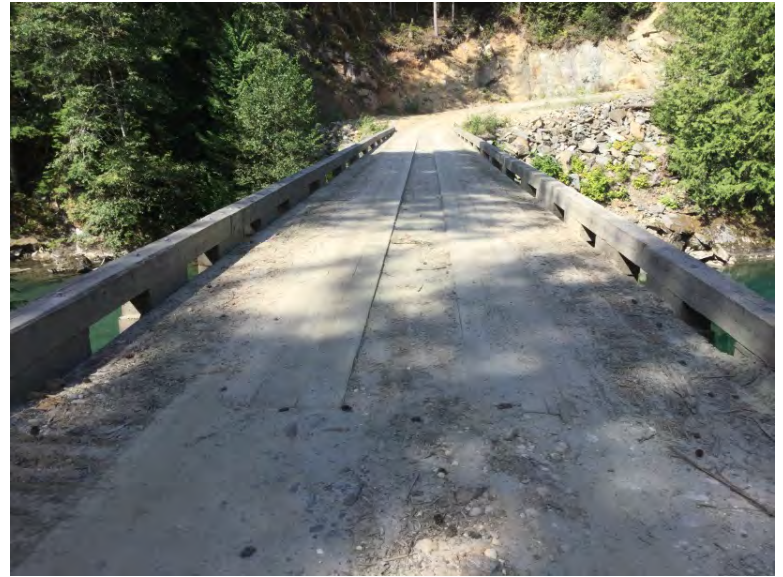
| Overall Deck Condition | Fair | |

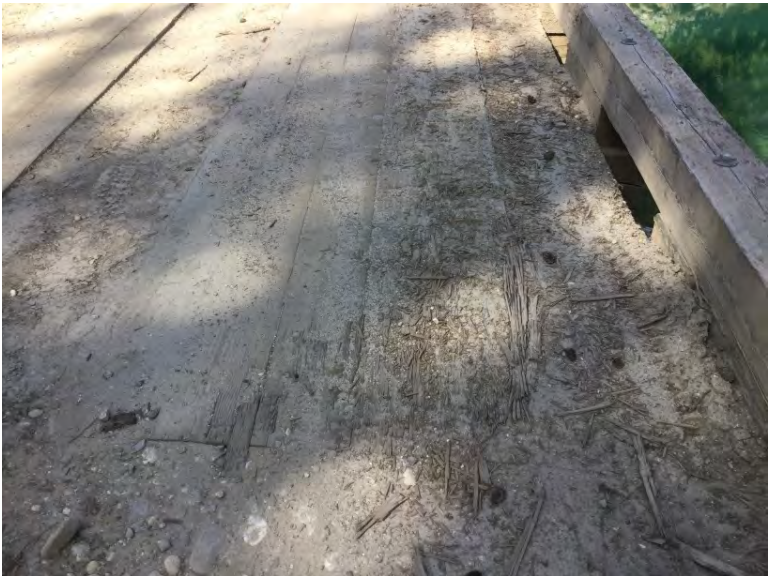
Planks wearing at approaches

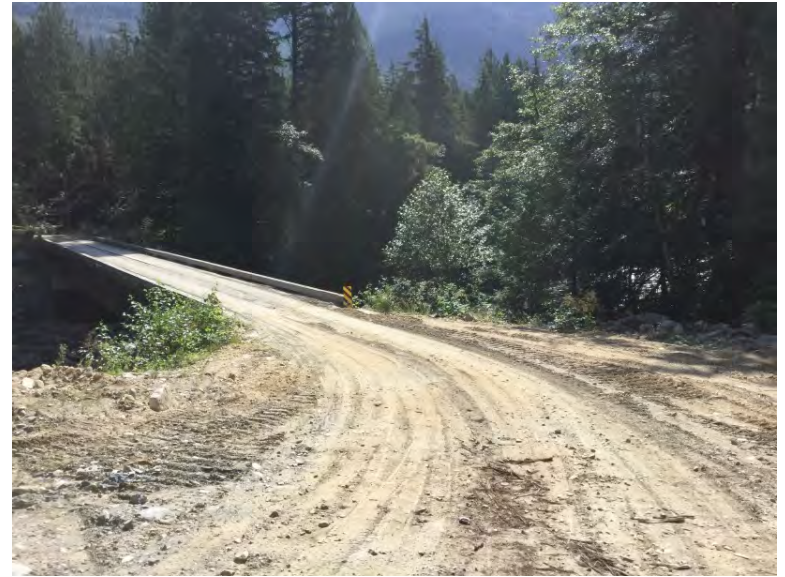
Approach from Right Bank when facing downstream

| Fender Condition | Poor | None at right approach |

| | 2 | Required | Medium | \$2000.00 | replace missing fender logs at right approach | | |

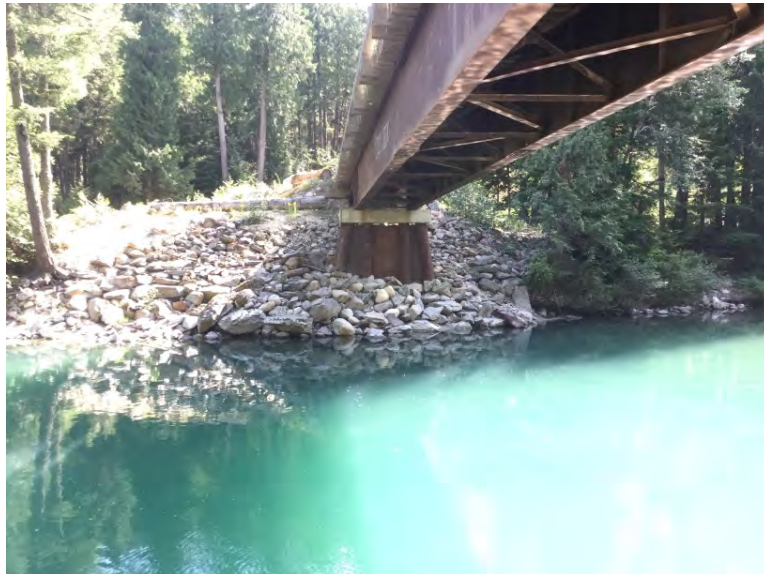
Stream side of pier

| Piles or Posts | Good | 4 round piles, outside ones angled |

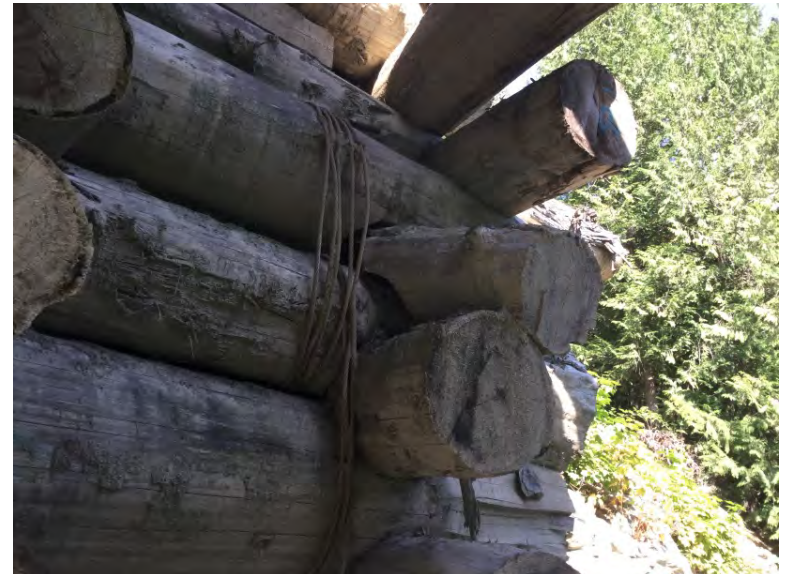
| Tie-backs | Good | 1 single tieback upstream right bank has sheared, no movement in face log |

| <b>GENERAL</b> | <b>Inspector's Comment:</b> | Upstream right bank tieback broke near end - no apparent change/shift in the crib condition from previous years - continue to monitor. Broken tieback is located outside upstream girder bearing location. | | | | | |

Tieback end sheared off upstream right bank

| | 1 | Monitor tieback and face log condition at right bank | | | | | |
| <b>GENERAL</b> | <b>PEng's Comment:</b> | Replace all 4 delineators and replace missing fender logs at the right approach. Continue to monitor the condition of the crib where the broken tieback is located. The current load rating of L100 or 91 tonnes to continue. | | | | | |

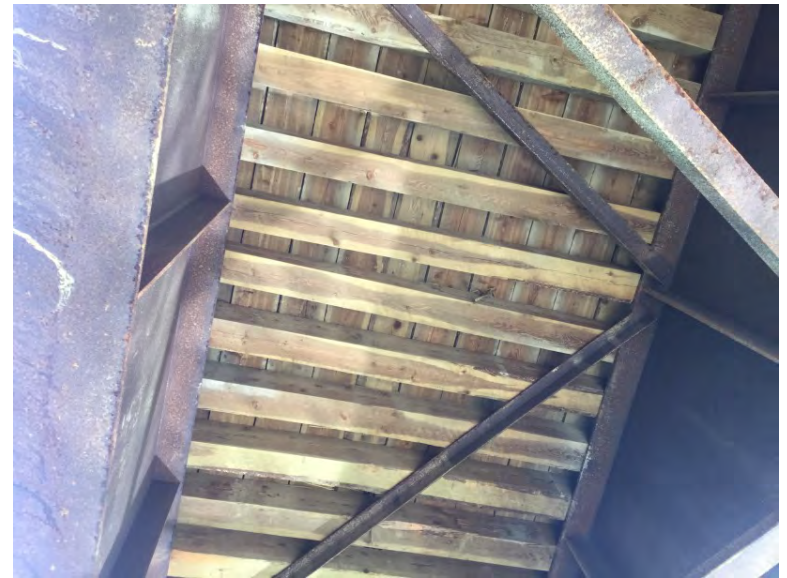
Ties and subdeck condition from underneath

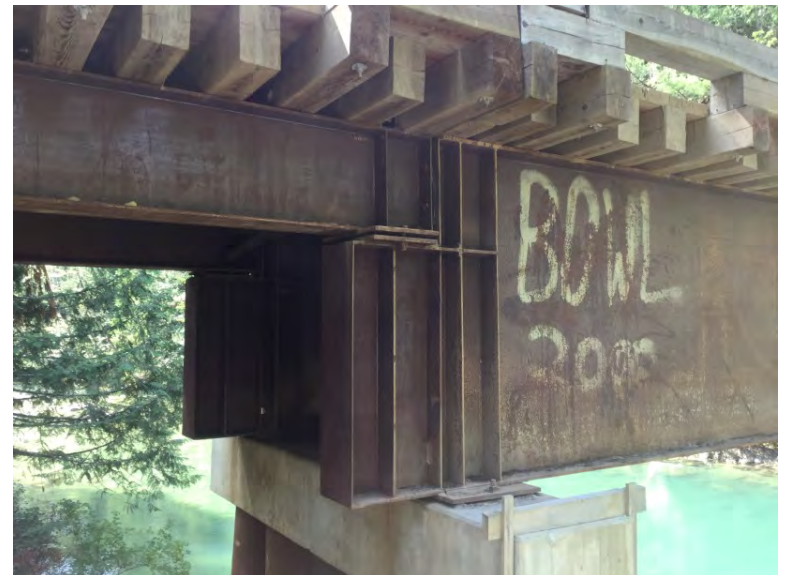
Main span to jump span bearing seat

| <b>Girders</b> | Fair | main span girders reused from previous install and modified for jump span bearing | | | | | |

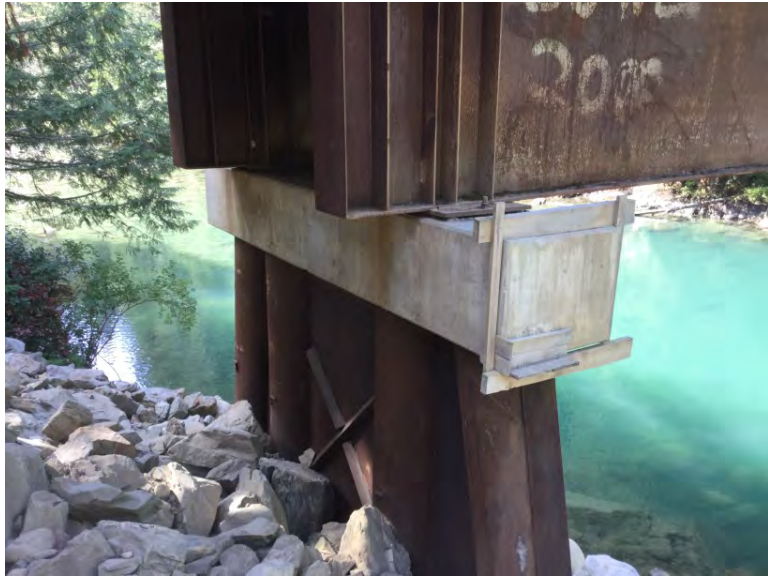
Pier cap

| Caps | Good | concrete cap, form to repair small damage still on cap |
