CK-2528

MOLLY HOGAN POINT 0.1km

2019 Inspection

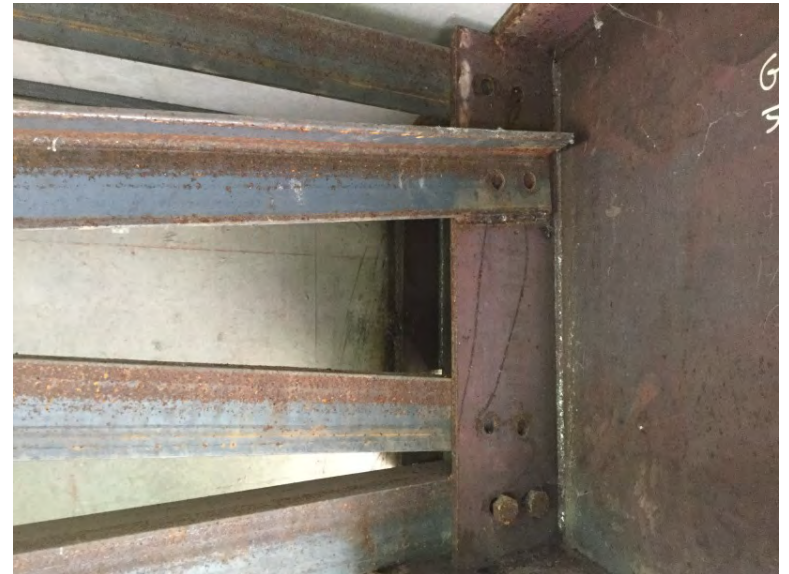
Downstream left bank girder bracing welded

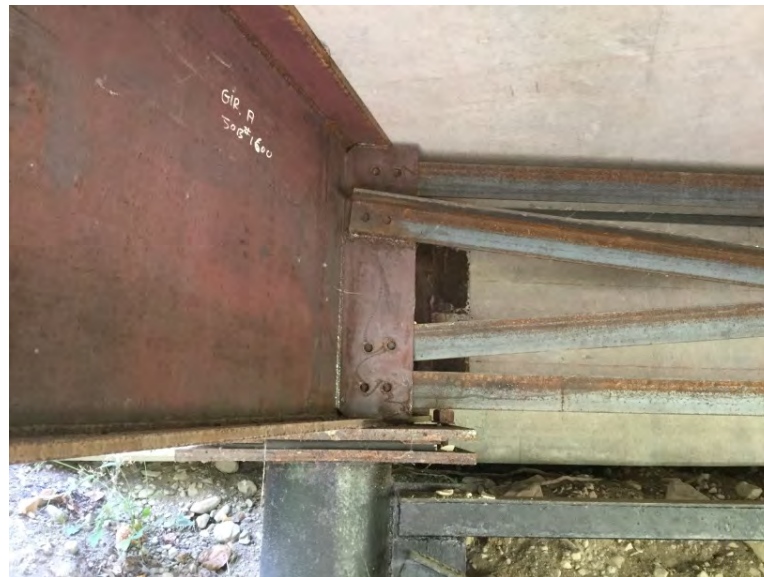
Downstream right bank girder bracing welded
