CK-2531

HARRISON EAST km

2019 Inspection

| Structure Class | Major Culvert |

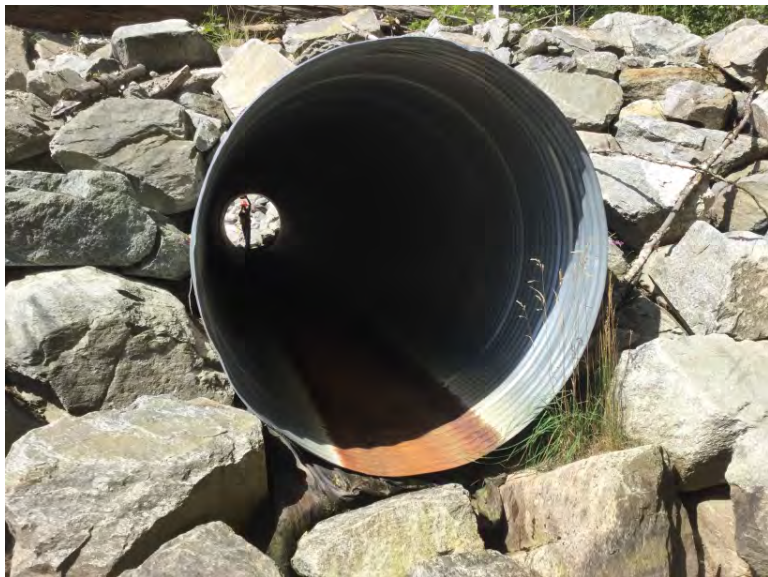
Outlet      Good

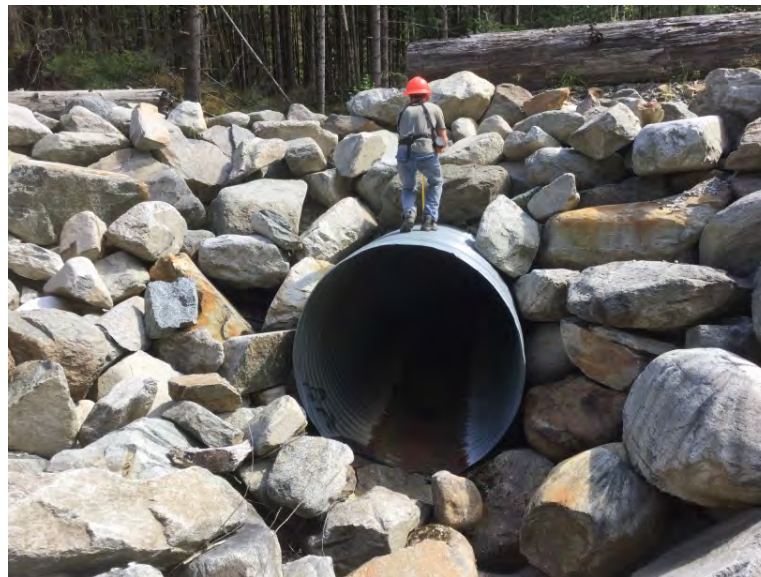
Inlet      Good
