CK-2537

NORRISH 17000 1.8km

2019 Inspection

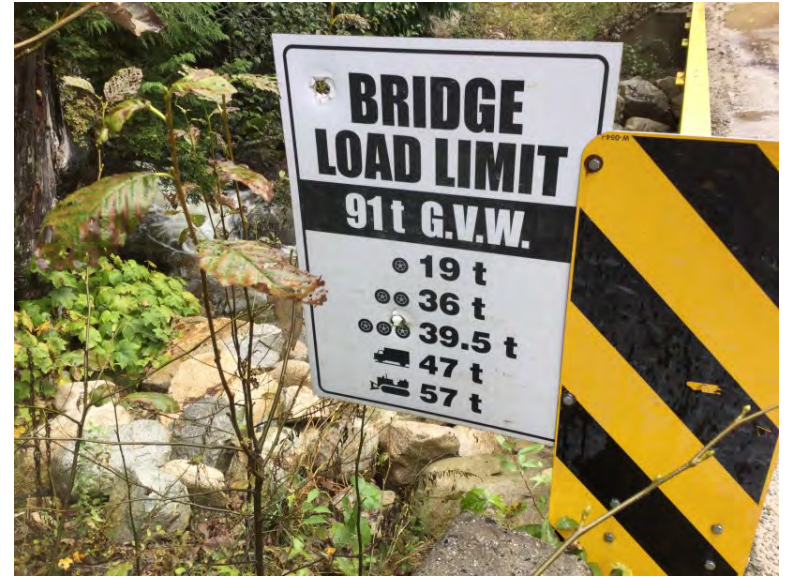
Load Rating Sign

Posted Load Rating 91

See picture

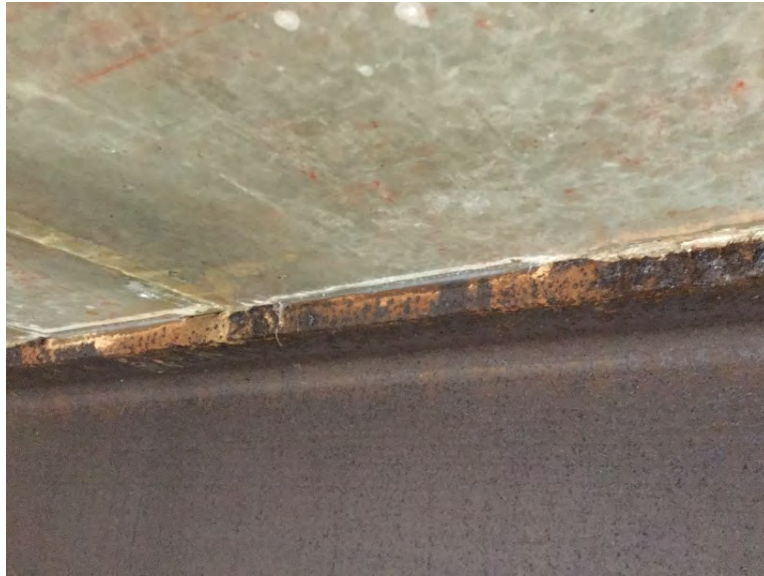
Silicone between deck and girder
