CK-2539

HARRISON EAST km

2019 Inspection

Superstructure Concrete Box Beam

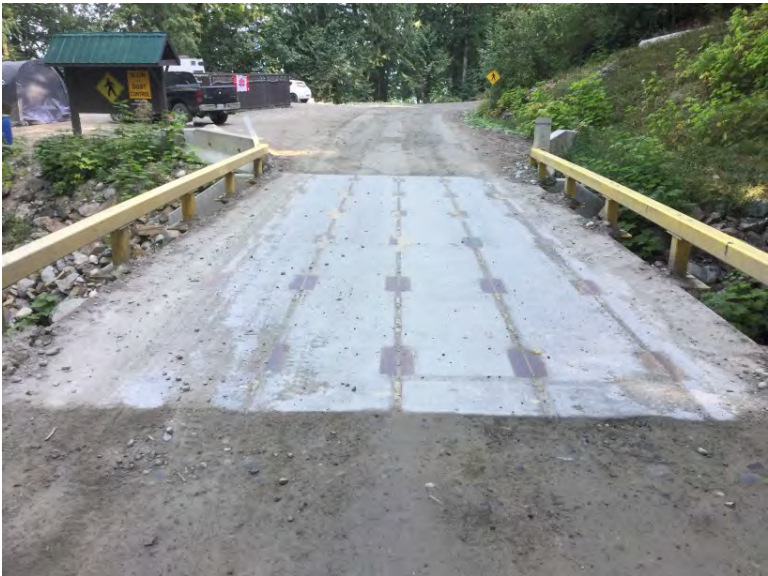
Overall Deck Condition      **Good**

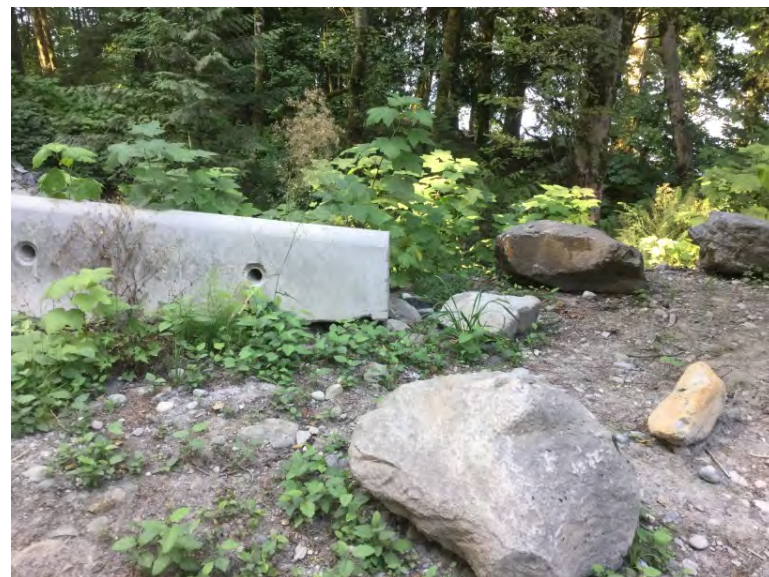
Missing downstream right bank bullnose

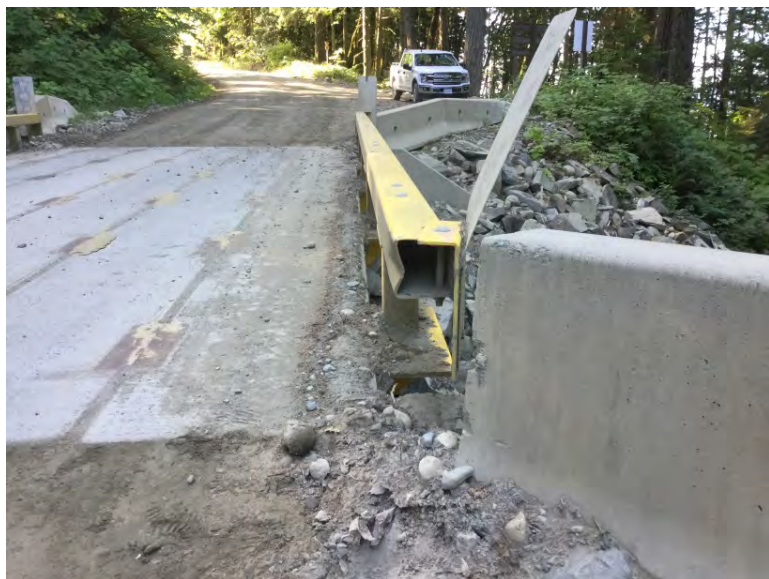
Minor guardrail damage downstream right bank

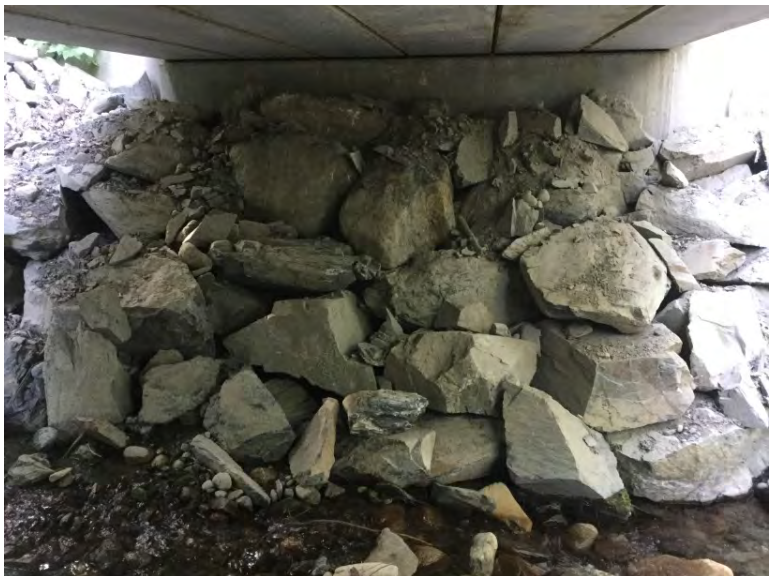
Left Bank Abutment when facing downstream

Caps or Sills Good Concrete cap/wall combo

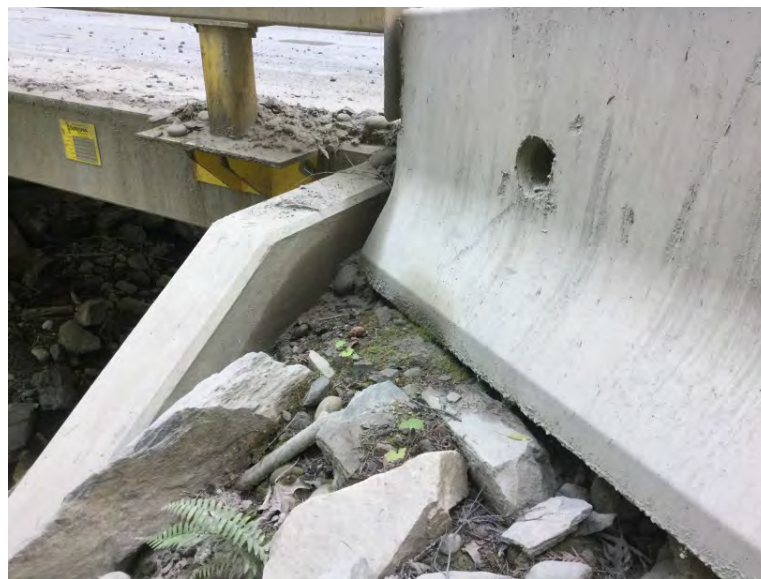
1 Fill erosion downstream left approach Every routine inspection

Minor fill erosion downstream left bank

Remove the downstream concrete no post barriers and replace eroded fill and replace barriers. Rotate the downstream right bank delineator so it faces oncoming traffic. The current load rating of L165 or 150 tonnes to continue.

2 Low Add fill to left approach and reset no post barriers
