CK-2544

UZTLIUS km

2019 Inspection

Structure Class Temporary Bridge

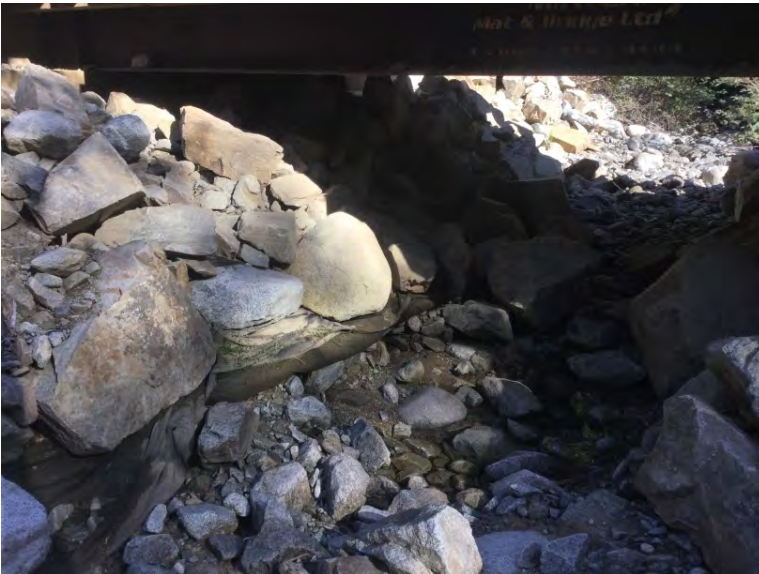
The riprap at both abutments have been compromised.

Riprap Poor

Both abutments have scoured

Right bank riprap scour

Repair scoured riprap at both abutments by removing the the timber deck panels, steel girders and lock block abutments and installing appropriately sized riprap below scour level; then reinstall the above mentioned components. I recommend completing this prior to industrial activity in 2020. At the time of inspection there was complete and adequate bearing and as such the design load rating of L100 or 91 tonnes can continue. However, another inspection should be completed in early 2020 prior to industrial traffic to ensure bearing is still complete before taking equipment over the bridge to complete the repair.

| Item | Priority | Repair Description |
|---|---|---|
| 1 | High | Repair scoured riprap at both abutments prior to activity |
