CK-2546

DEWDNEY 0km

2019 Inspection

| Crossing Name | Coquihalla River | |

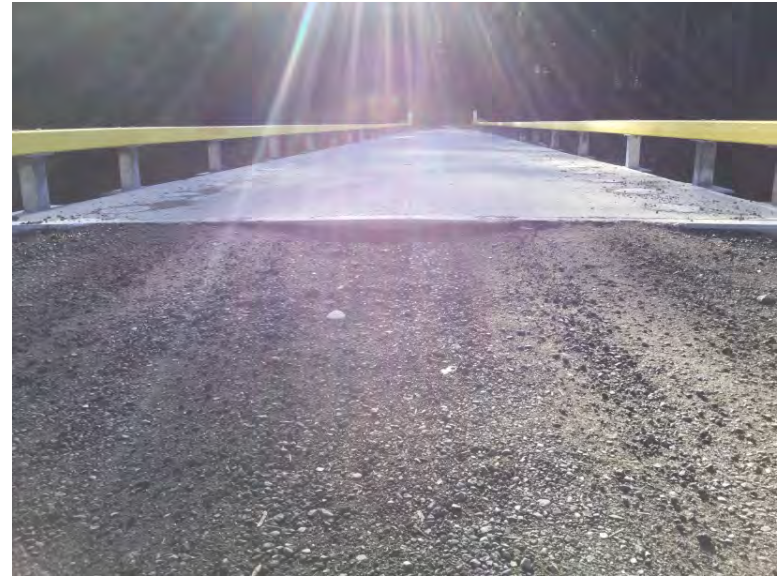
Right approach could use additional surfacing

Add surfacing to both approaches and repair the damage to the top right bank ballast wall consistent with the Concrete Repair Guide for Concrete Bridge Components. The current load rating of L100 or 91 tonnes to continue.

| 1 | Medium | Add surfacing to both approaches |

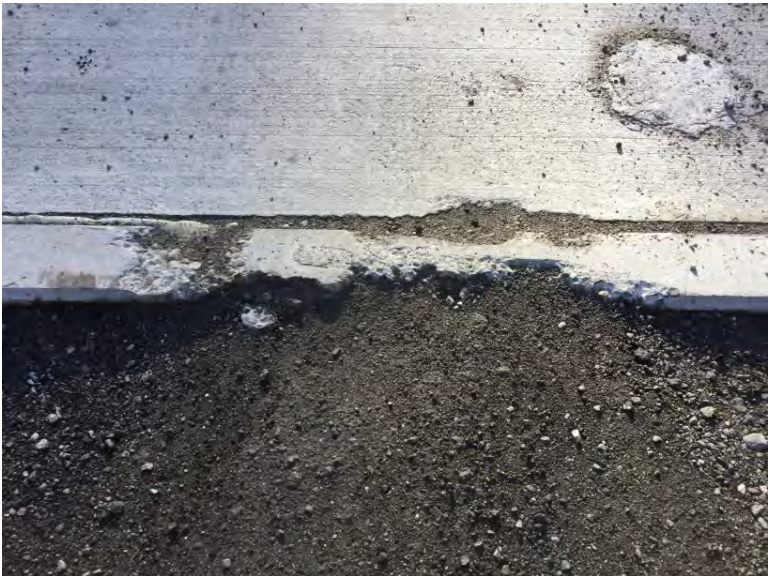
Ballast Wall Fair

Damage noted to top at right bank

Damage to top of ballast wall on right bank

| 2 | Medium | Repair damage to top of ballast wall |

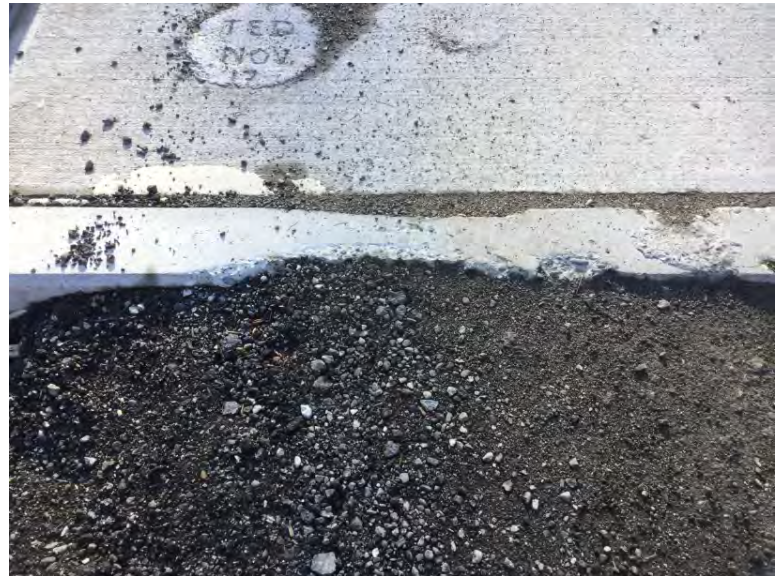
Damage to top of ballast wall right bank

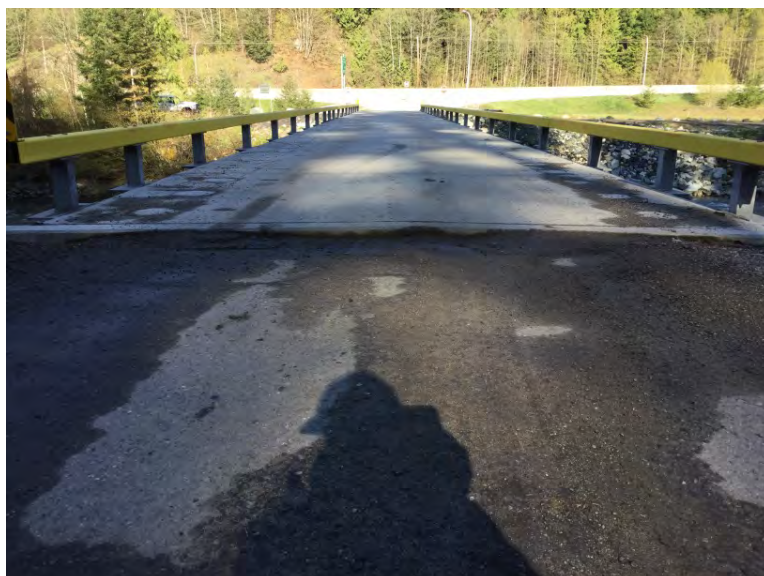
Left approach could use additional surfacing

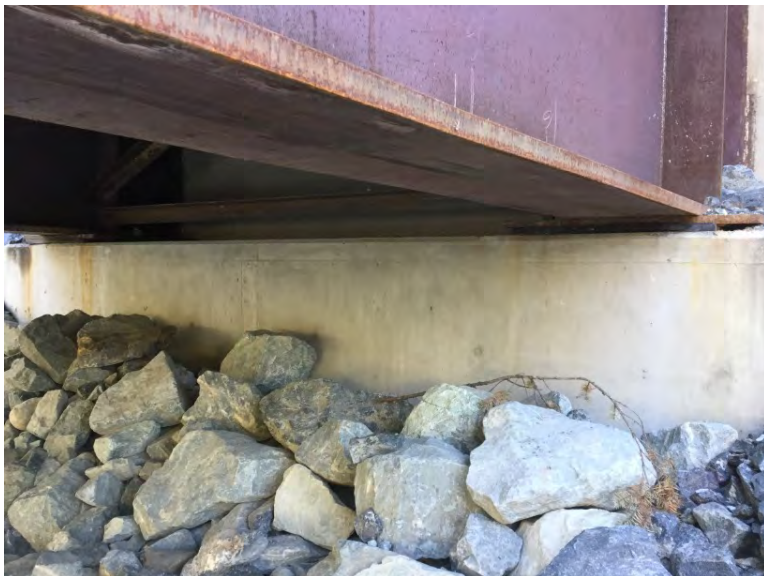
Left bank bearing

Bearings Good

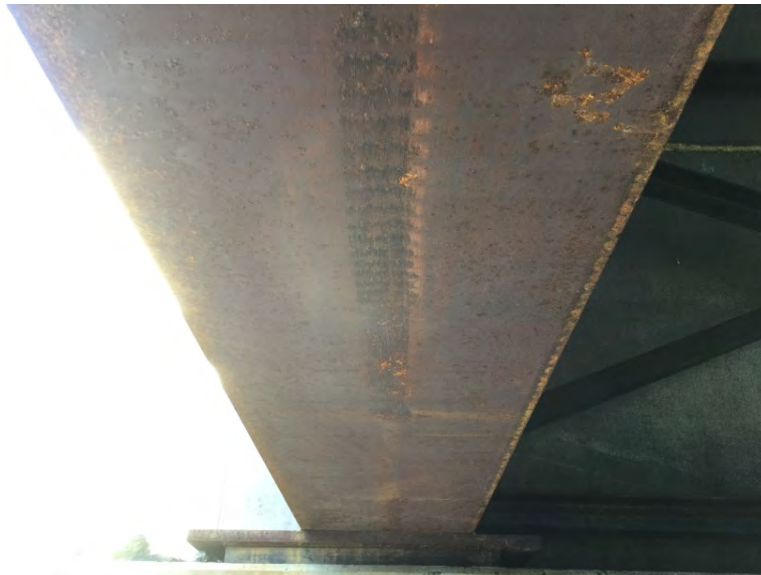
No damage noted to girders where they were drug through river

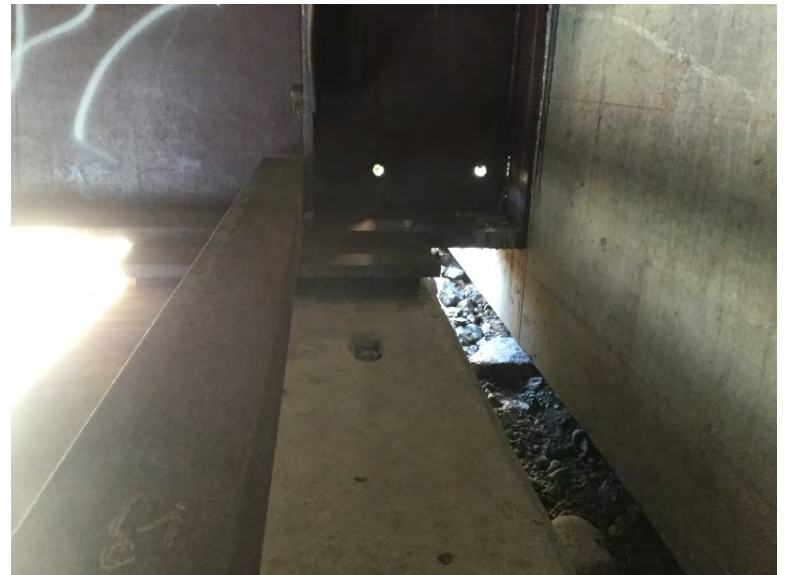
No damage noted to girders where they were drug through river
