CK-2555

GARNET 7600 km

2019 Inspection

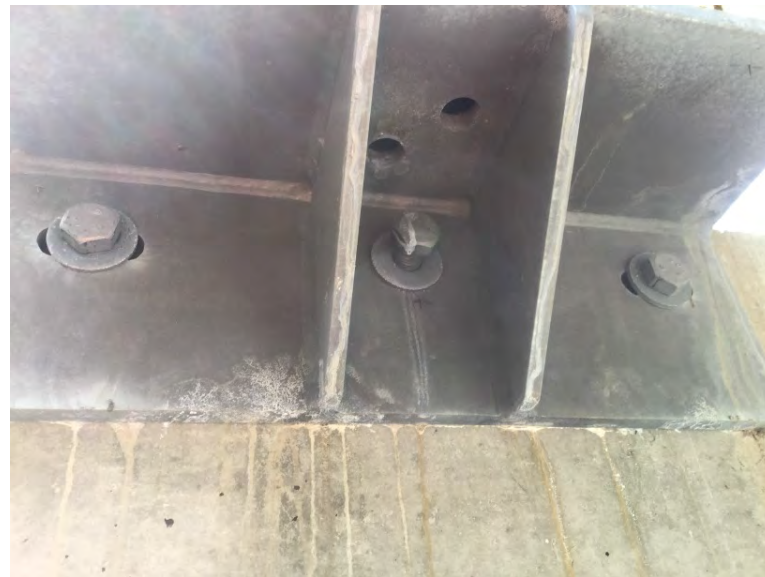
Curb Rail/Blocks/Posts      **Good**      1 riser bolt loose

Hardware      **Good**      1 riser bolt loose

Loose riser bolts

Replace missing hardware and tightening all other hardware. The current load rating of L100 or 91 tonnes to continue.

| Item | Priority | Repair Description |
|---|---|---|
| 1 | Low | Tighten loose rail bolts and replace the missing one |
