CK-2556

GARNET 7600 km

2019 Inspection

| Crossing Name | Garnett Creek |

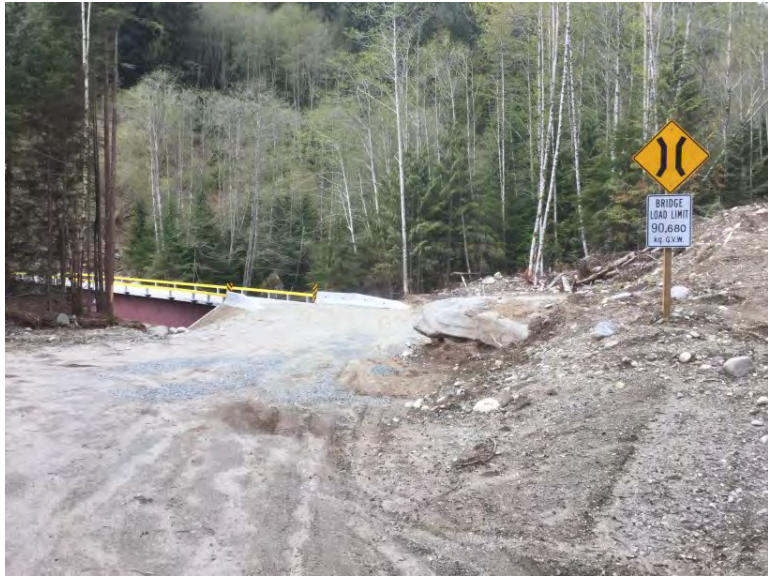
Approach from Left Bank when facing downstream

Alignment Poor

Very tight HC at left approach

Improve the left approach by removing the large boulder and widening the road. The current load rating of L100 or 91 tonnes to continue.

1 Medium Improve horizontal alignment at left approach when active

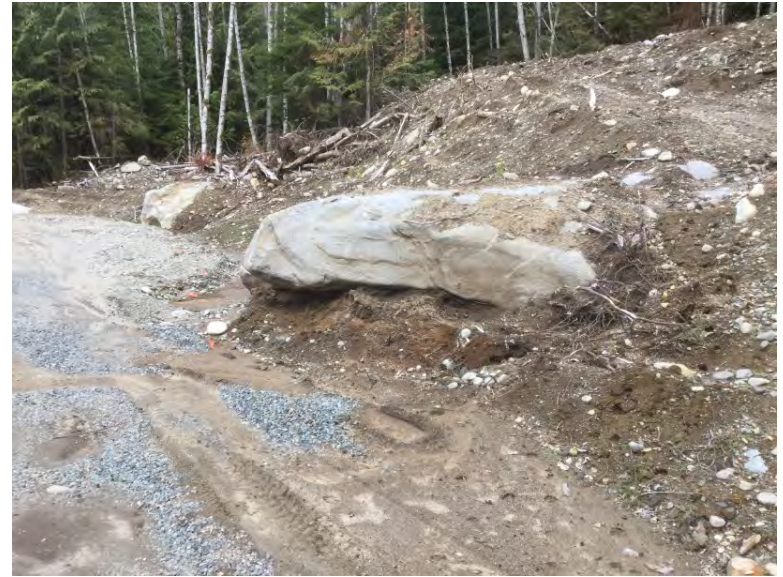
Remove large boulder to improve left approach alignment

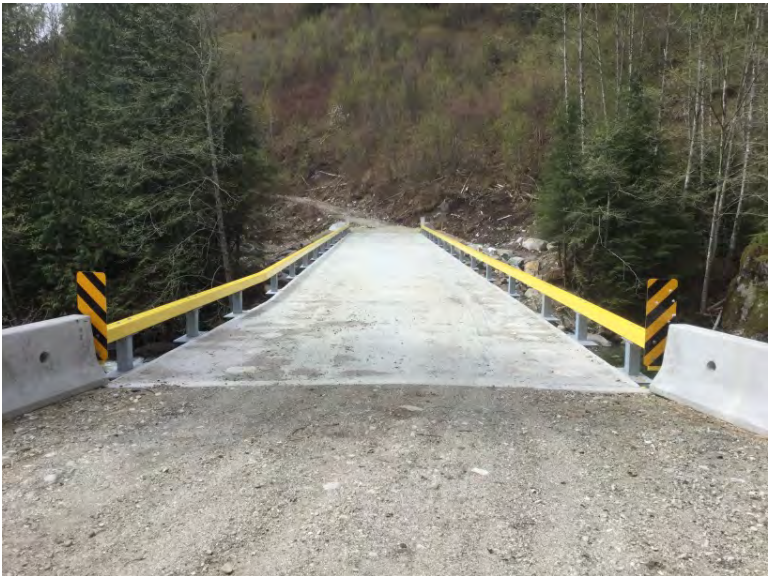
Overall Deck Condition      **Good**

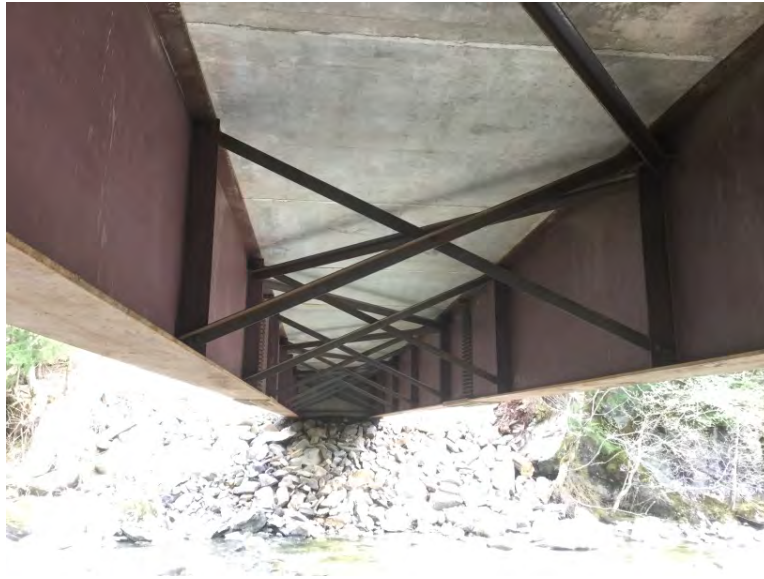
Superstructure

Girders    Excellent

Diaphragms    Excellent    10 bolted bays
