CK-2002  
CK-2002

AMERICAN 4.6km

2020 Inspection

Crossing Name Three Mile Creek

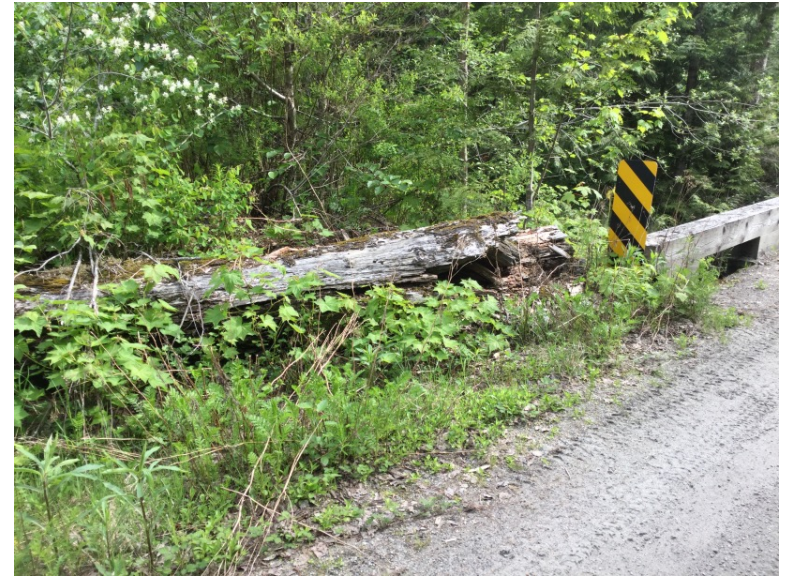
Old rotting logs and missing downstream right approach

Log fender condition

| 2 | Approach. Approach fenders (install). # of units.<br>Priority:Low | Replace all existing log fenders with new ones - 6m length x 600mm diameter |

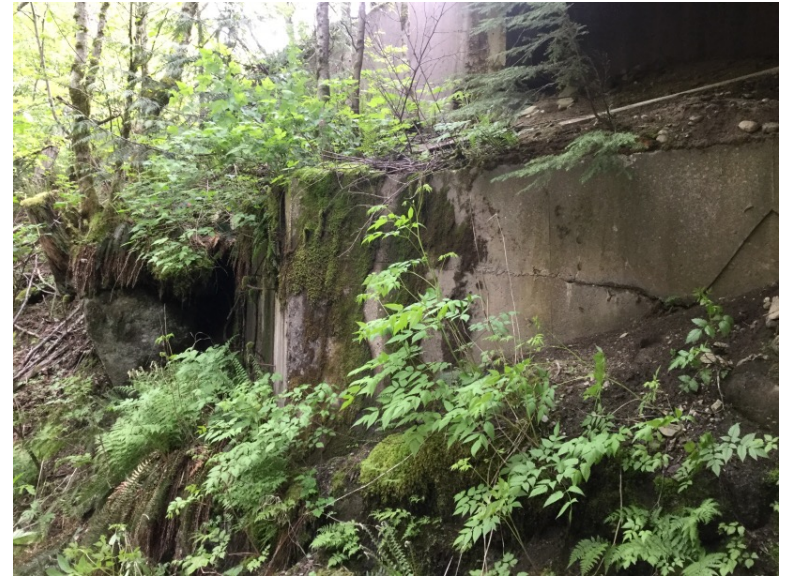
Retaining fill on the right bank only

CIP fill retention system at downstream right bank

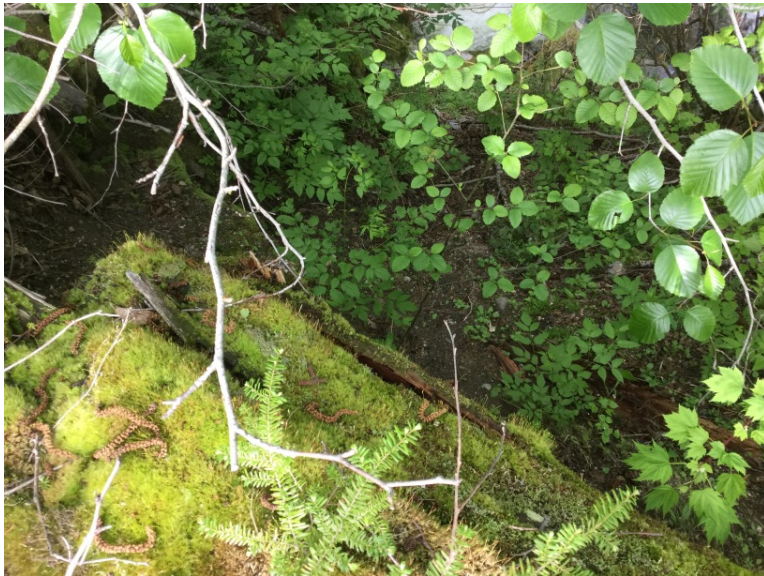
Fair to poor as fill slope at downstream right bank over steepened with fine textured soils

Eroding fill slope at downstream right bank

| Item | Monitor Description | Frequency |
|---|---|---|
| 1 | Fill slope condition at downstream right bank | Routine Inspection |
