CK-2003  
CK-2003A

AMERICAN 7.9km

2020 Inspection

Crossing Name American Creek

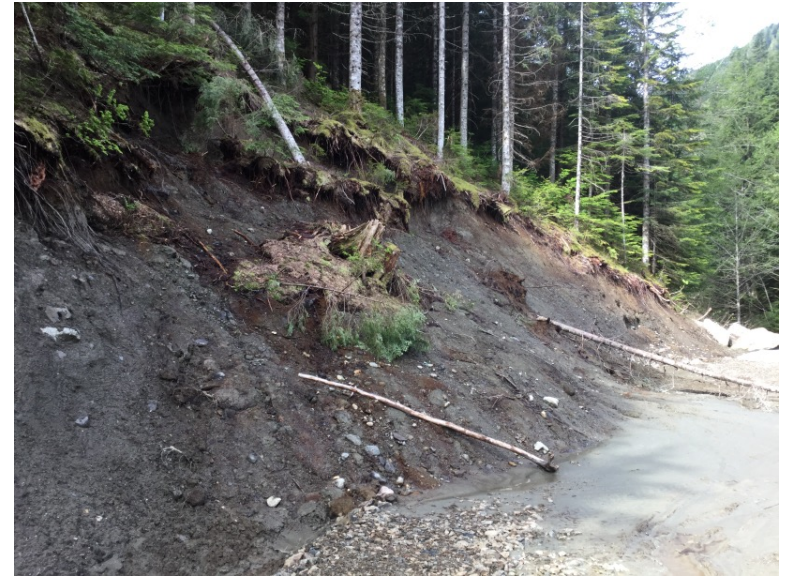
Heavy HC right approach

Cut slope at right approach

Remove material from the cut bank at the town approach. The current load rating of L100 or 91 tonnes to continue.

| 1 | Approach. Surface drainage maintenance (drains, catch basins, flumes, ditches). # of | Remove sloughing material from right approach |
