CK-2007  
CK-2007

ANDERSON 13000 0.1km

2020 Inspection

Crossing Name Anderson River

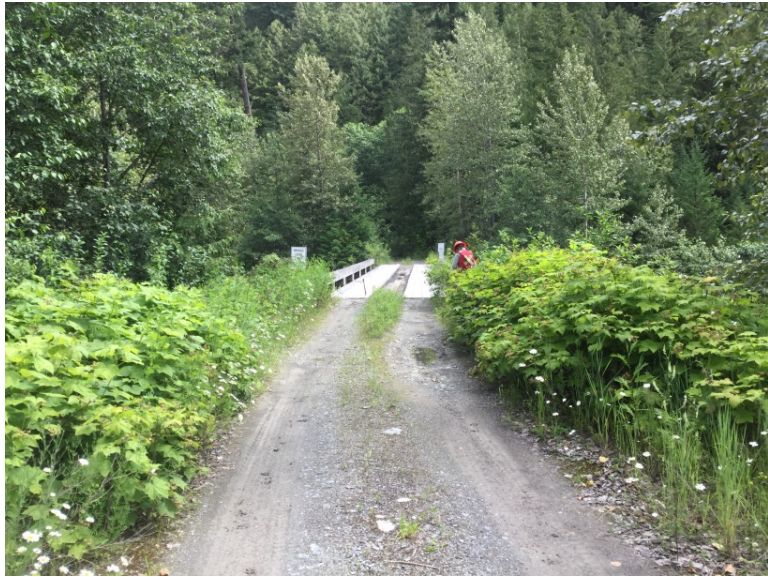
Approach from Left Bank when facing downstream

Rotten and missing at left approach

Replace all 4 log fenders with new ones, 6m length x 600mm diameter. Brush and grade approaches. Post bridge ahead signs. Monitor the condition of the log crib and bearings. The current load rating of L45 or 41 tonnes to continue.

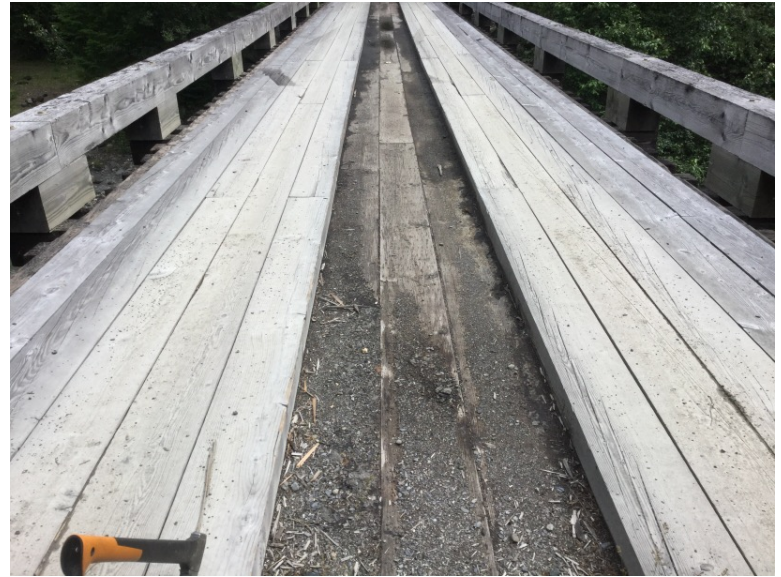
Overall Deck Condition      Good

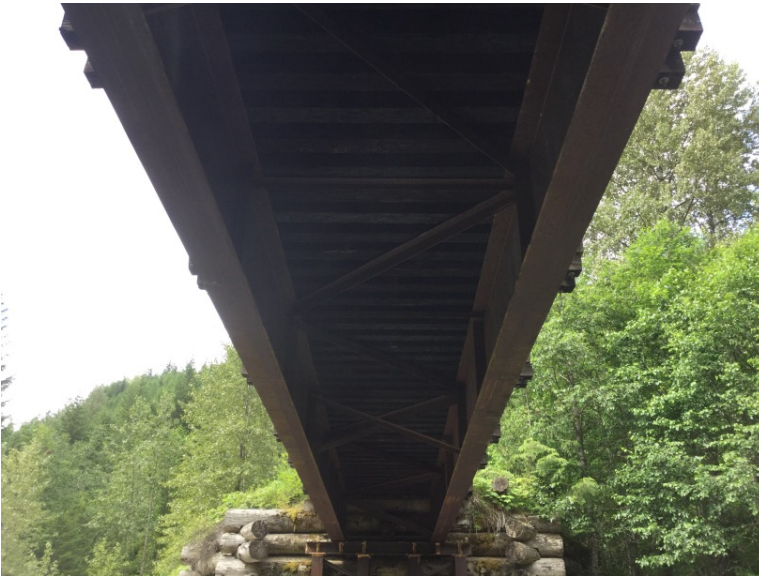
Superstructure

Girders Fair

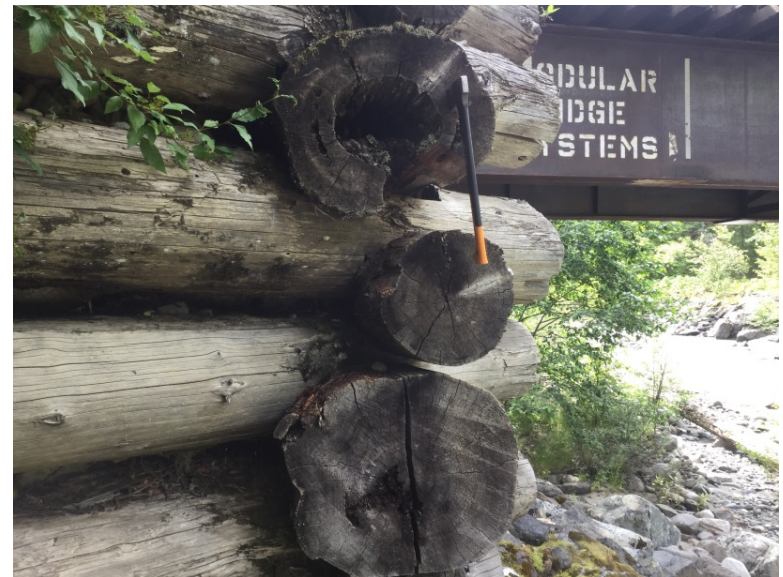
Log cribs only for fill retention. Range of diameters (400mm - 800mm) of face logs with ranging heart rot noted.

Typical face log condition at ends

| Item | Monitor Description | Frequency |
|---|---|---|
| 1 | log crib condition | Routine Inspection |

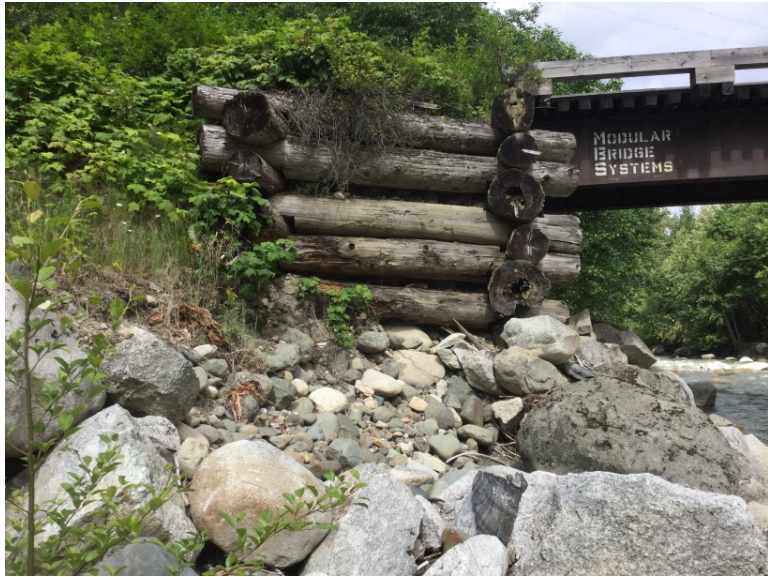
Upstream left abutment scour noted on crib/wingwall, however no signs of movement

Upstream left bank scour

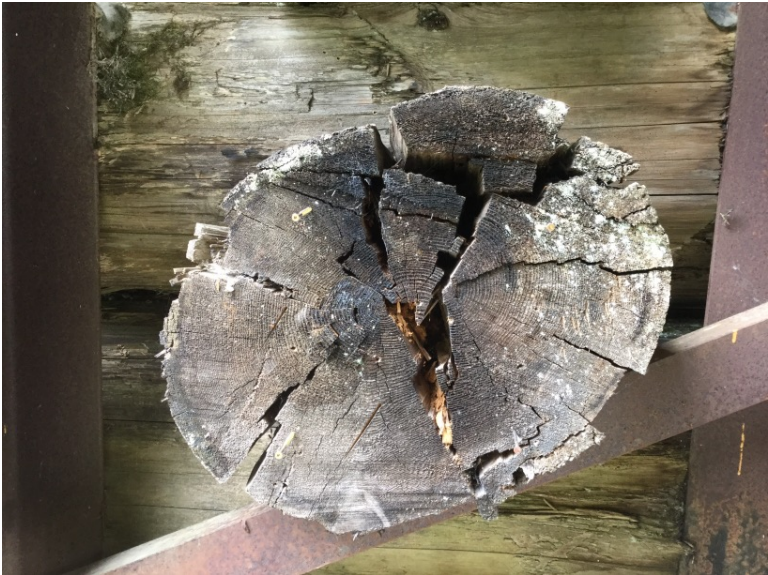
end splitting

Tieback condition at right bank
