CK-2008  
CK-2008B

ANDERSON 13000 0.3km

2020 Inspection

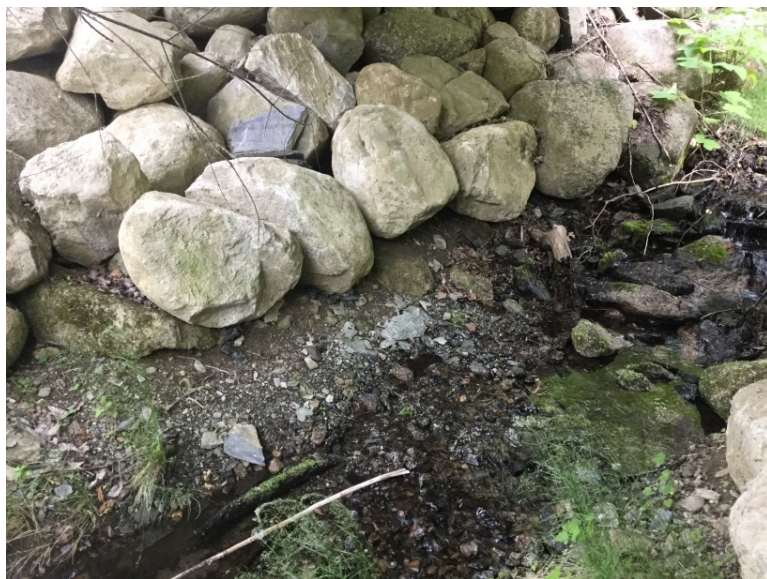
Riprap Fair Functional but round and over steepened

Riprap scour

| Item | Monitor Description | Frequency |
|---|---|---|
| 1 | Riprap condition | Routine Inspection |

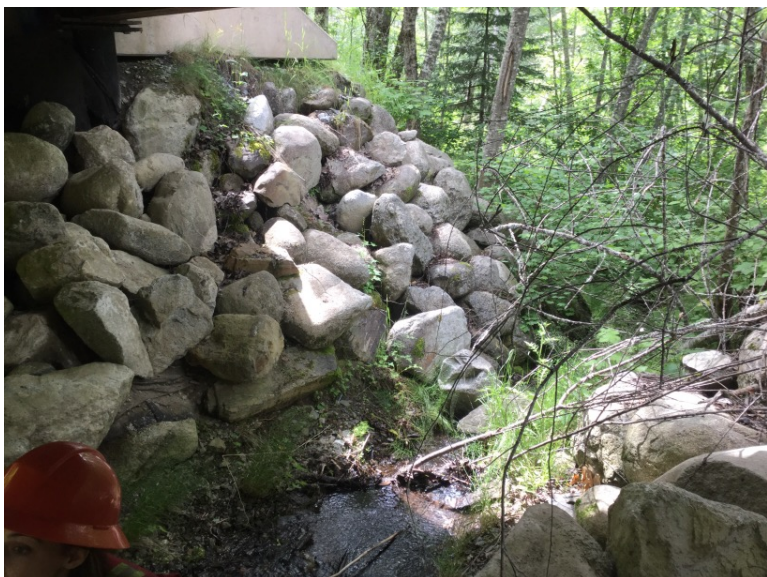
Riprap condition at downstream left bank
