CK-2010A

BLUE MOUNTAIN 300 2.5km

2020 Inspection

Major Culvert

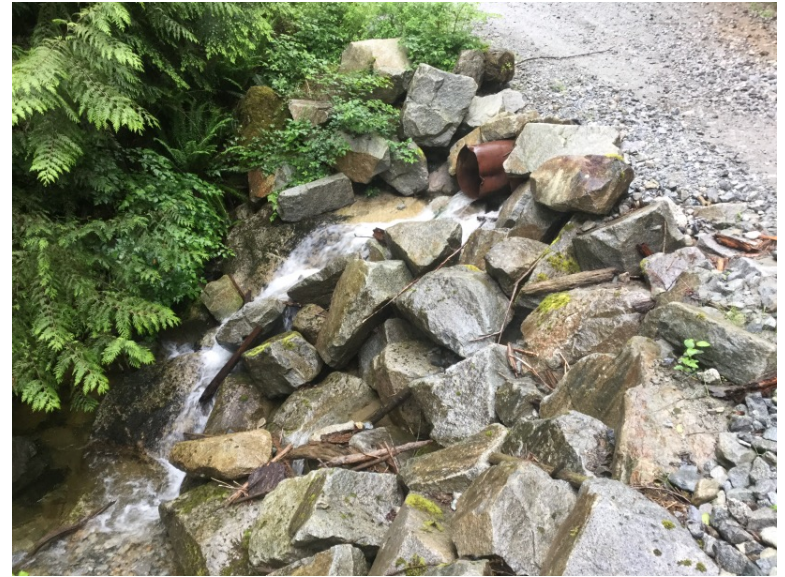
Outlet      **air**

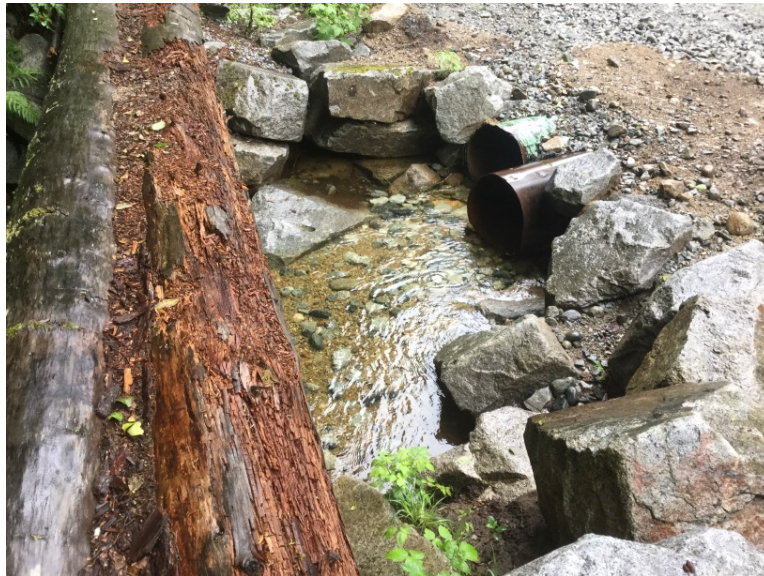
Inlet      **air**
