CK-2011  
CK-2011

BLUE MOUNTAIN 300 0.1km

2020 Inspection

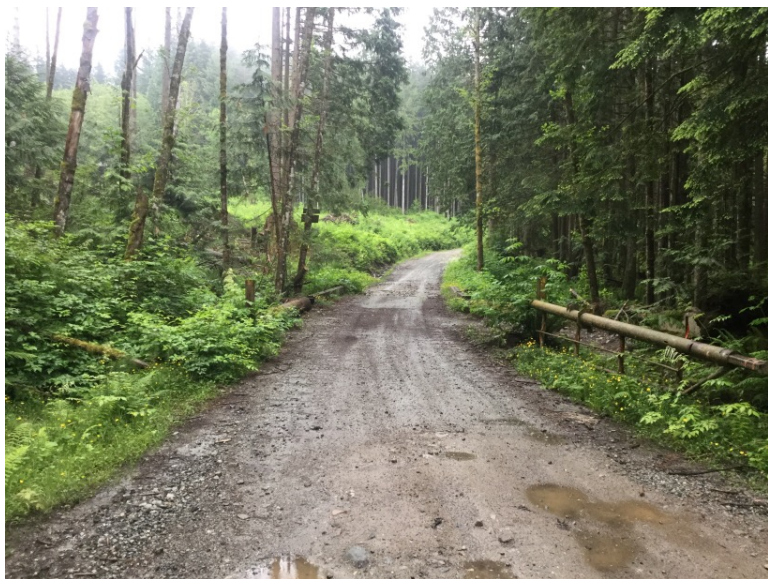
Approach from Right Bank when facing downstream

Bridge Ahead Signs  
Missing ☐ 0 ☐ 1 ☒ 2

Delineator Missing  
Left ☐ 0 ☐ 1 ☒ 2

Delineator Missing  
Right ☐ 0 ☐ 1 ☒ 2

| Repair Item | Repair Description |
|---|---|
| 2 Approach. Add Warning Signs. # of signs. Priority:High | Post rating signs and bridge approach signs at both approaches |
| 3 Approach. Area/sight line brushing. m <sup>2</sup> . Priority:Low | Brush approaches |

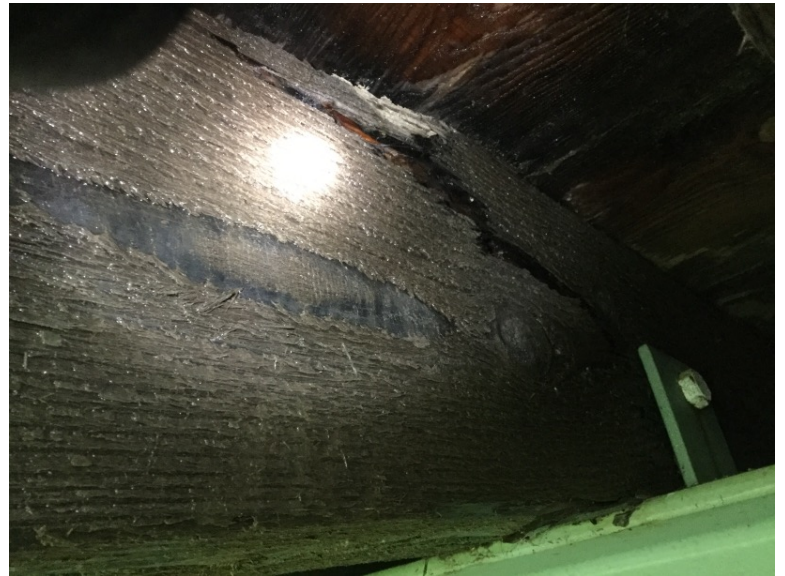
The 2 cross ties that have sheared at the downstream girder connection point, approximately 3m from the town bearing location, still have not been replaced. Until these ties are replaced there should NOT be any industrial activity over this bridge. Replace the missing delineators, post bridge ahead signs, remove sediment from deck and brush approaches. The current load rating of 10 tonnes to continue, post load rating signs.

Ties Poor 2 cracked ties at downstream left bank

Curb Rail/Blocks/Posts Poor sagging at center span due to failed cross ties

Overall Deck Condition Poor Due to 2 cracked ties

2 cracked ties just outside downstream girder

| Repair Item | Repair Description |
|---|---|
| 1 Structure. Major redecking (crossties or laminated deck). m. Priority:High | Replace 2 cracked ties |

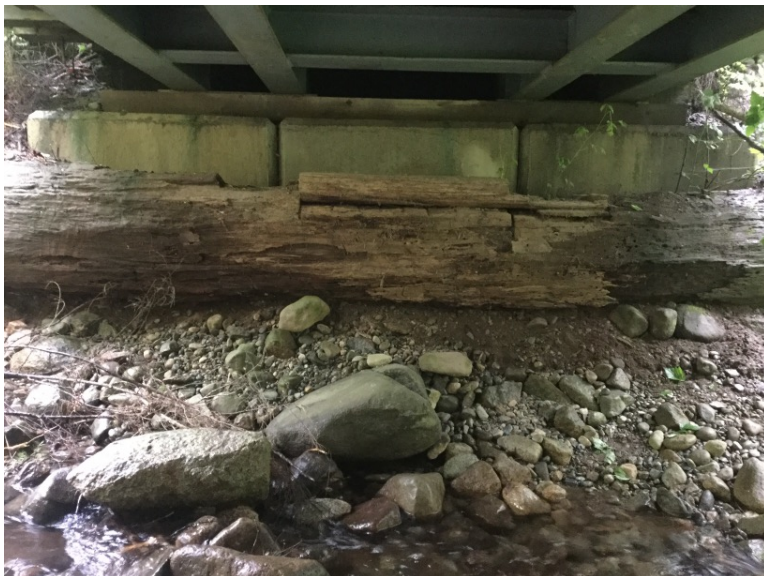
Riprap Poor None in front of either abutment

Left Bank Abutment when facing downstream

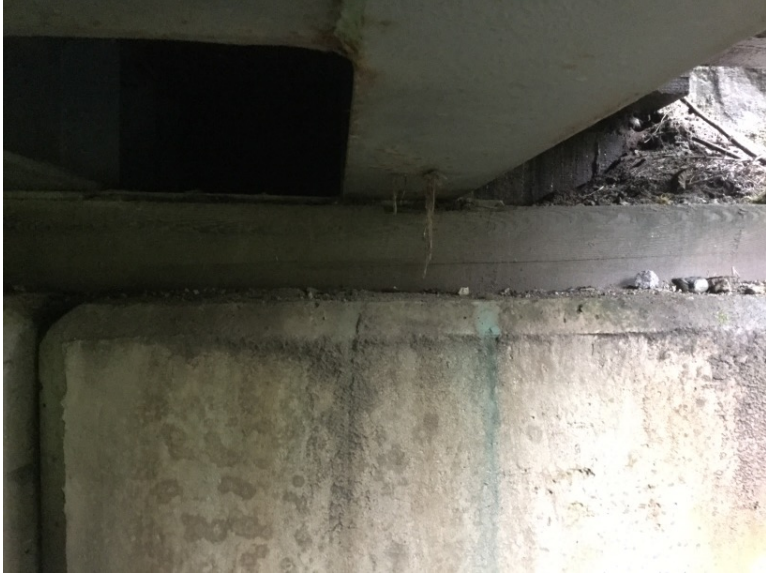
Caps or Sills Fair Upstream right bank has hairline crack

Upstream right bank sill condition
