CK-2014  
CK-2014B

CANTELON 8.2km

2020 Inspection

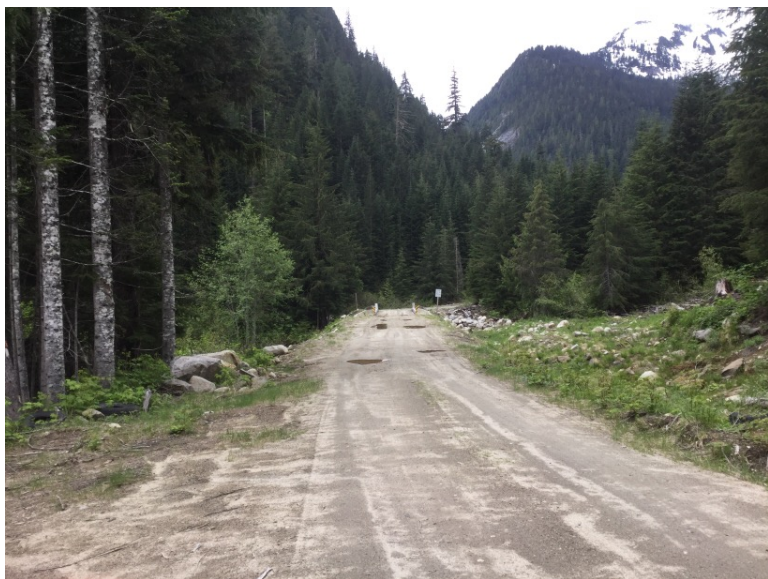
Approach from Left Bank when facing downstream

Road Surface Poor Large pothole at left bank

| Repair Item | Repair Description |
|---|---|
| 1 Approach. Approach surfacing grading. m. Priority:Medium | Grade approaches |

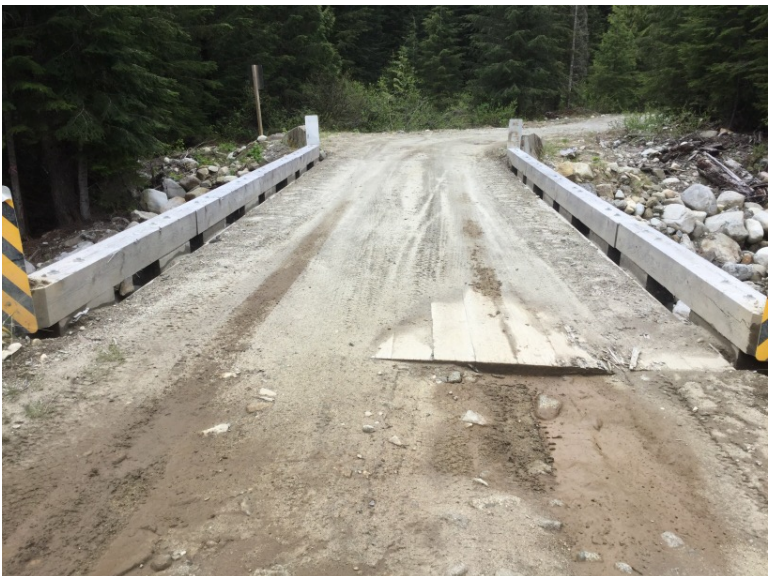
Running Surface      Fair      Large pothole at left bank and sediment on deck

Overall Deck Condition      Fair

| Repair Item | Repair Description |
|---|---|
| 2 Structure. Clean Deck. # of delineators. Priority:Medium | Clean sediment off deck |

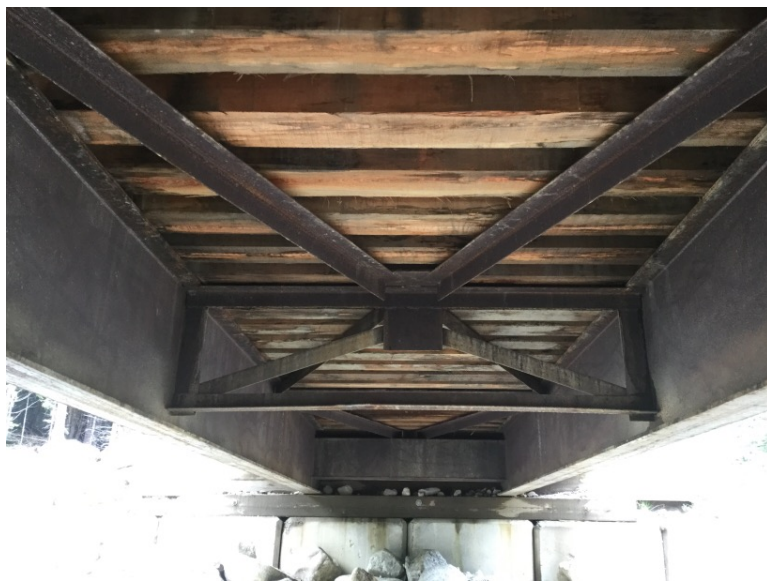
Superstructure

Girders Fair

Diaphragms Fair

Bracing Fair

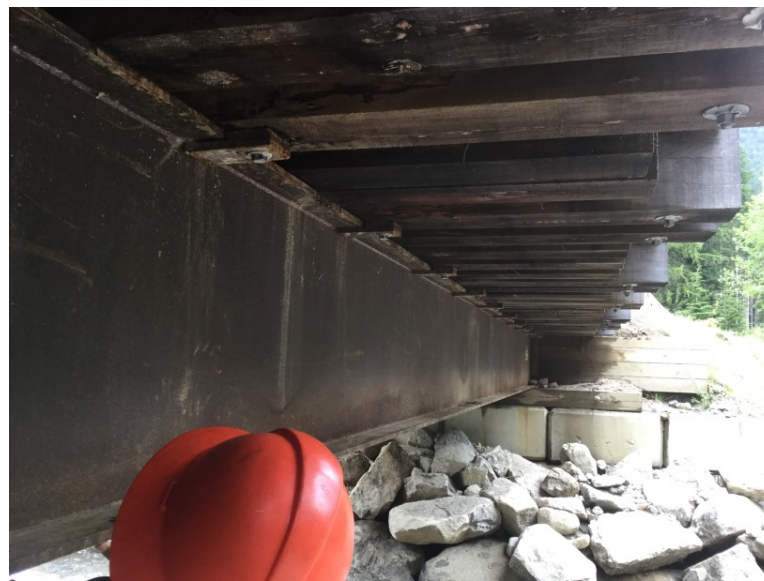
Deck clips

Hardware      Fair
