## CANTELON 0.3km

2020 Inspection

| Crossing Name | Cantelon Creek |
| Structure Class | Permanent Bridge |

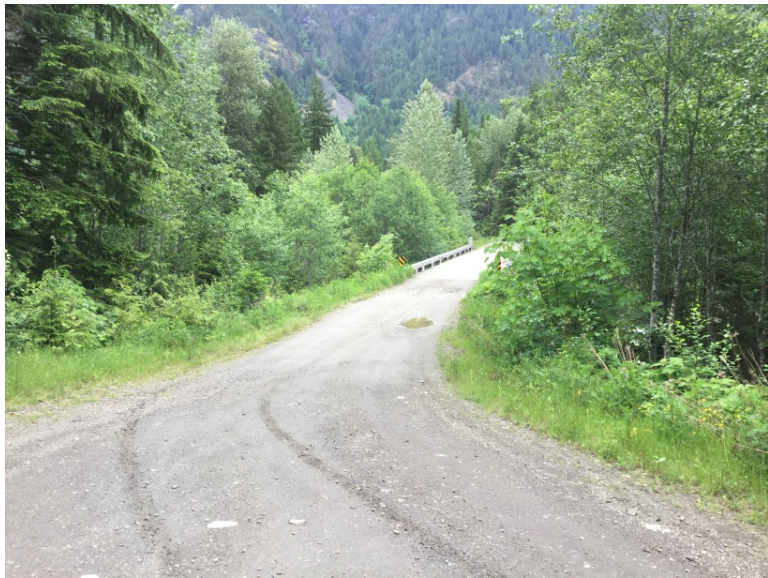
Approach from Left Bank when facing downstream

| Repair Item | Repair Description |
|---|---|
| 2 Approach. Area/sight line brushing. m². Priority:Low | Brush approaches |

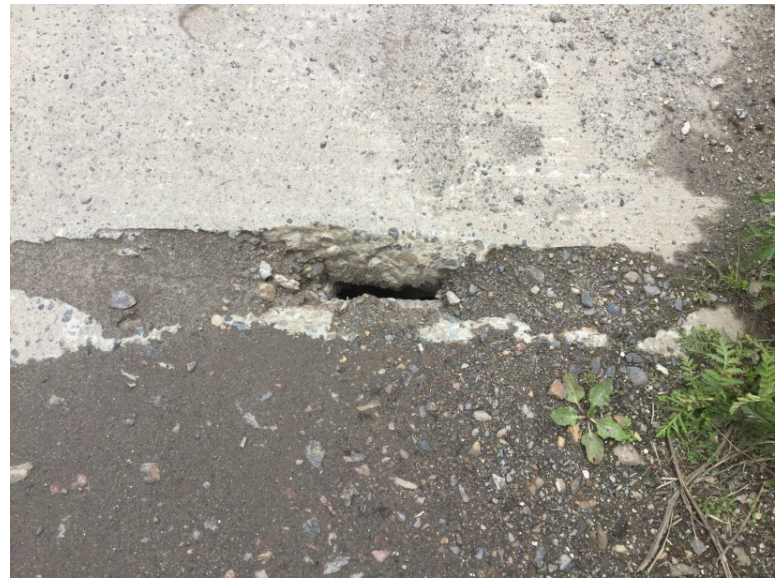
Ballast Wall Fair Damage to both at surface

Damage to left bank ballast wall and deck panel

Repair all damaged concrete consistent with the Concrete Repair Guide for Concrete Bridge Components MoFLNRO (2017). Replace all 4 log fenders with minimum 60m long x 600mm diameter. Brush approaches and post bridge ahead signs. The current load rating of L75 or 68 tonnes to continue.

| Repair Item | Repair Description |
|---|---|
| 3 Structure. Concrete structural maintenance. m². Priority:High | Repair damaged sections of concrete |

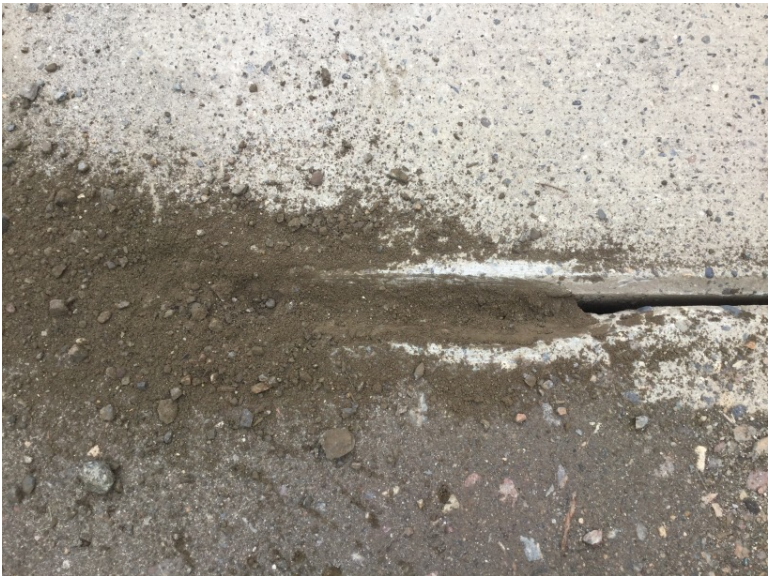
Damage to left bank ballast wall and deck panel

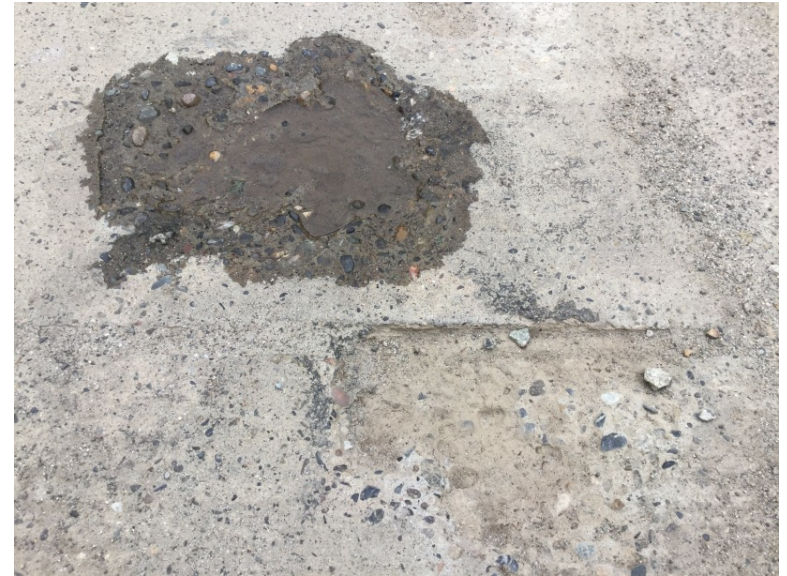
Concrete Deck      Fair      Minor Damage noted

Damage to deck panels on surface

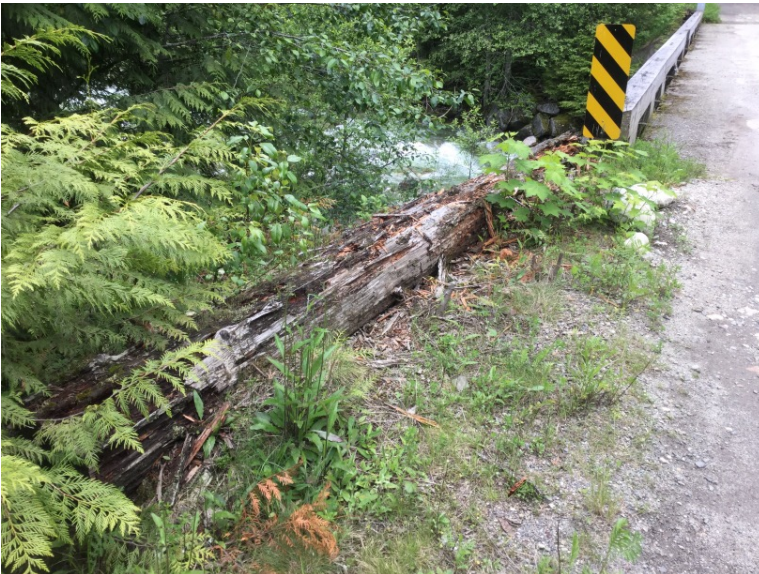
Fender Condition Poor Rotten and undersized

Fender log condition

| Repair Item | Repair Description |
|---|---|
| 4 Approach. Approach fenders (install). # of units. Priority:Medium | Replace fender logs with 6m length x 600mm diameter |

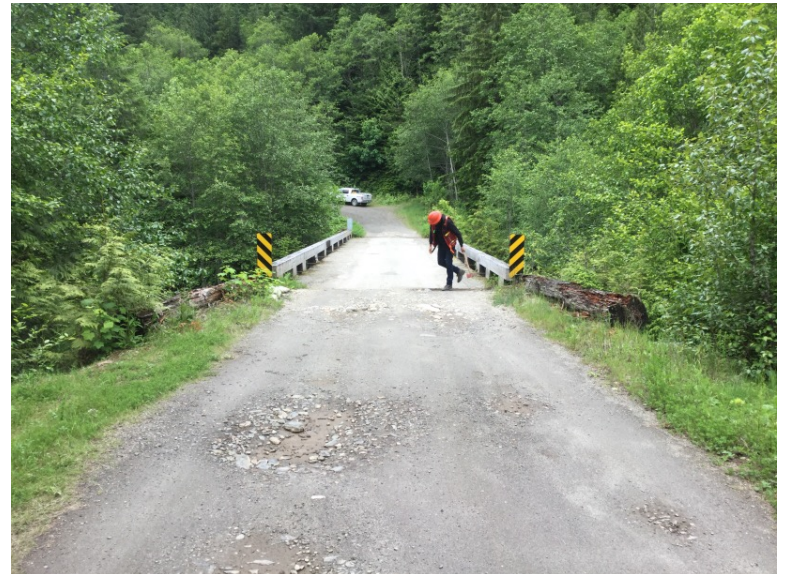
Approach from Right Bank when facing downstream

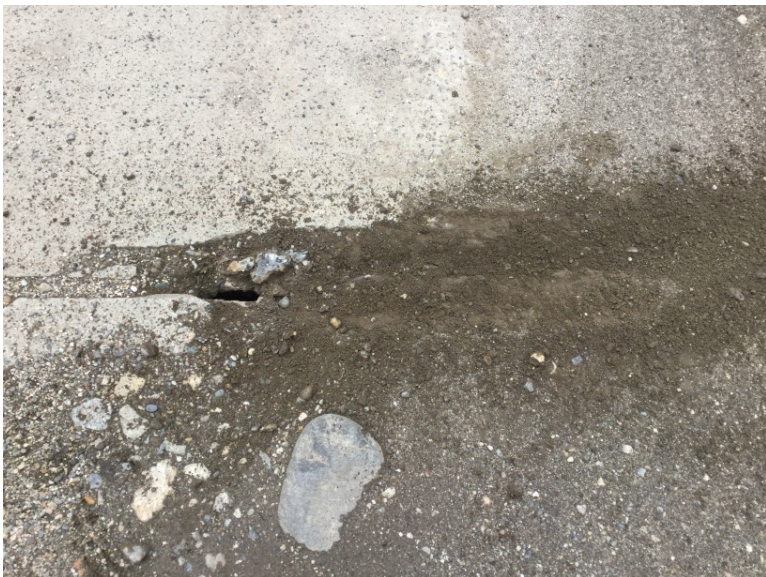
Damage to right bank ballast wall and deck panel

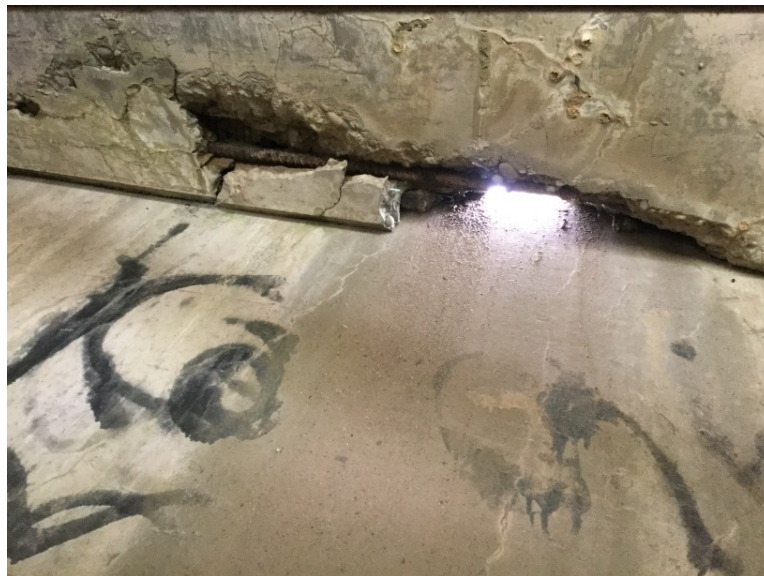
Damaged panel at right bank

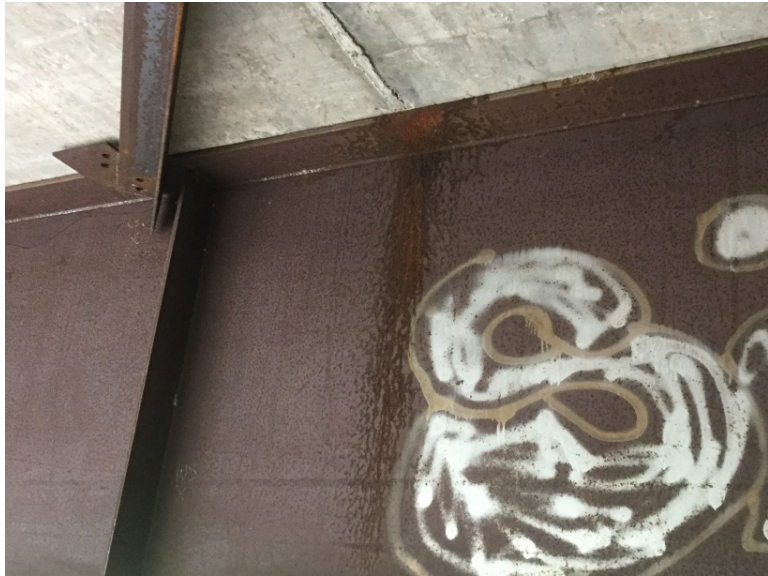
Deck Joints      Fair      Some indications of water getting through

Indications of water getting through deck joints

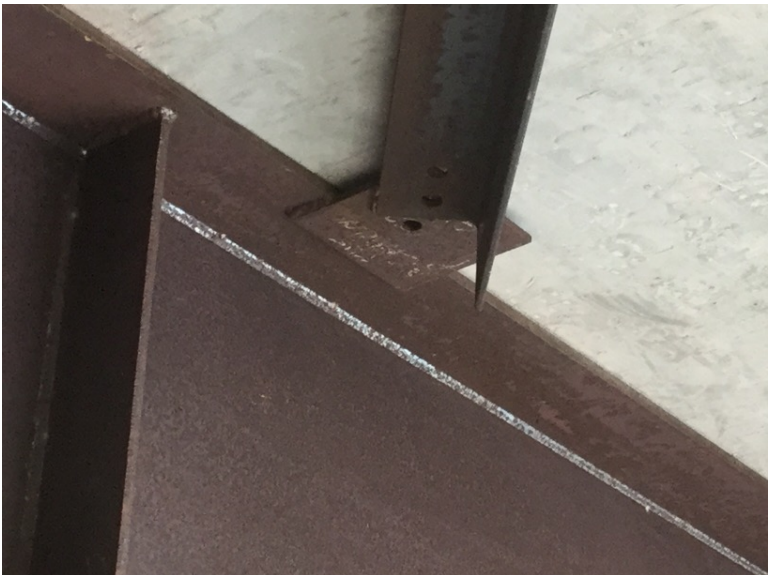
Bracing Fair 1 end bolted and other welded

Bracing that was planned for bolts was welded 1 end

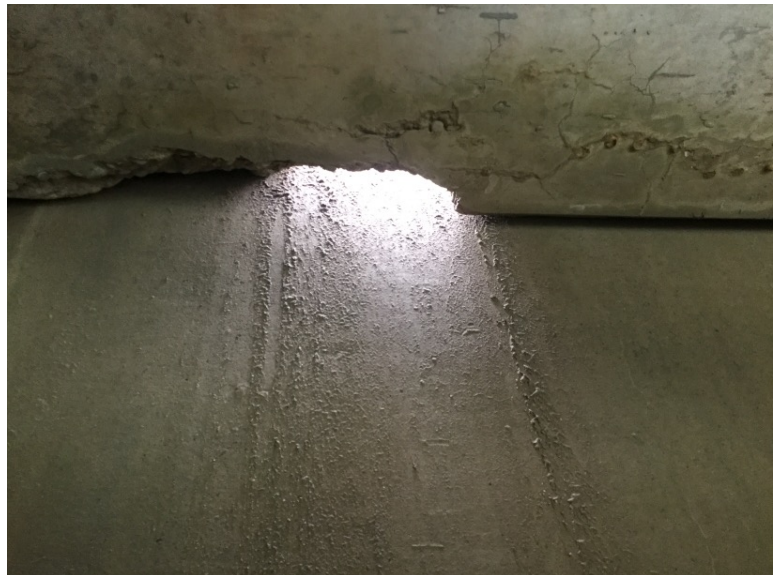
Damage to left bank panel

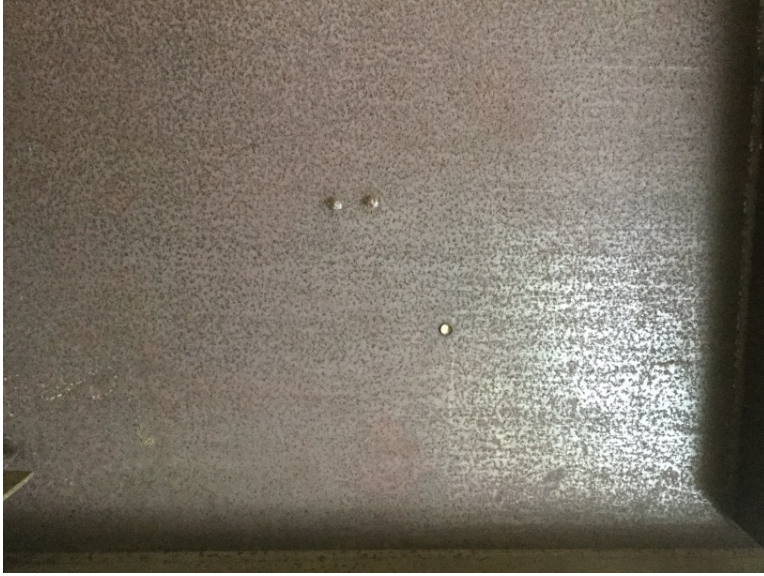
Downstream web damage
