## CHEHALIS 6km

2020 Inspection

| Crossing Name | Pretty Creek |

Date of Inspection 2020-05-21 2:22:06 PM

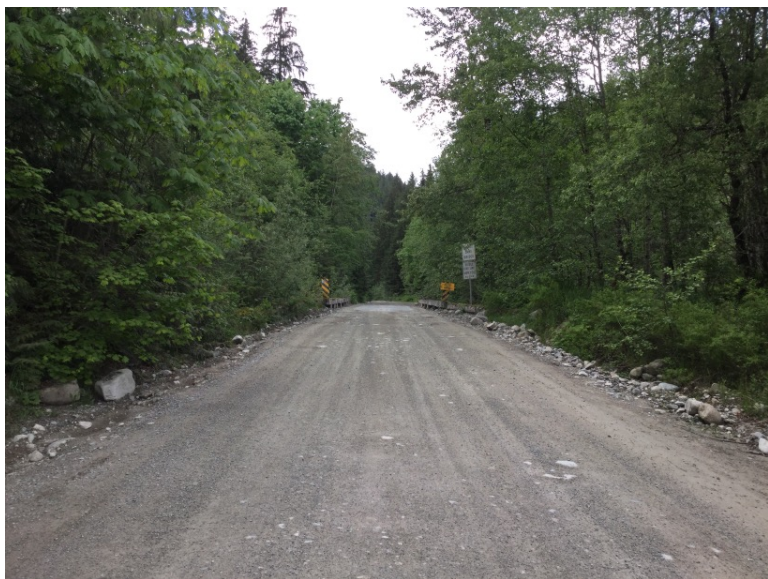
Approach from Right Bank when facing downstream

Road Surface Poor Requires grading

| Repair Item | Repair Description |
|---|---|
| 2 Approach. Approach surfacing grading. m. Priority:Medium | Grade approaches |

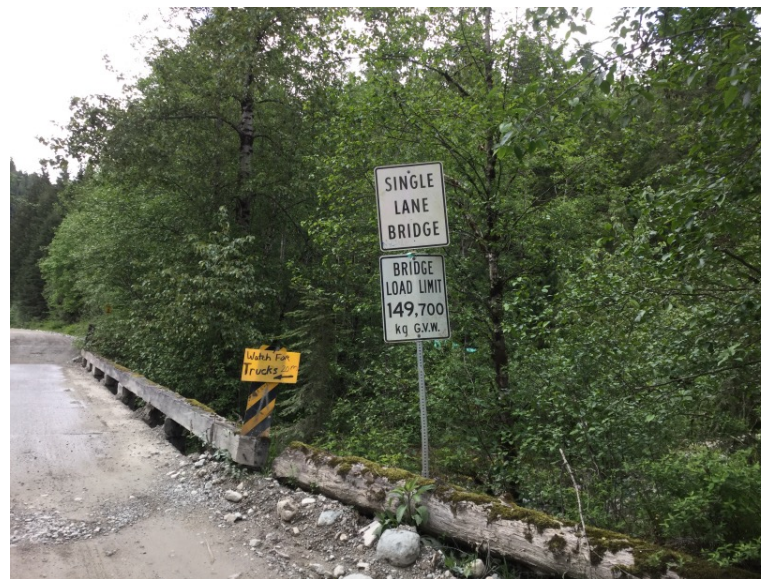
Load Rating Sign

Posted Load Rating 149700

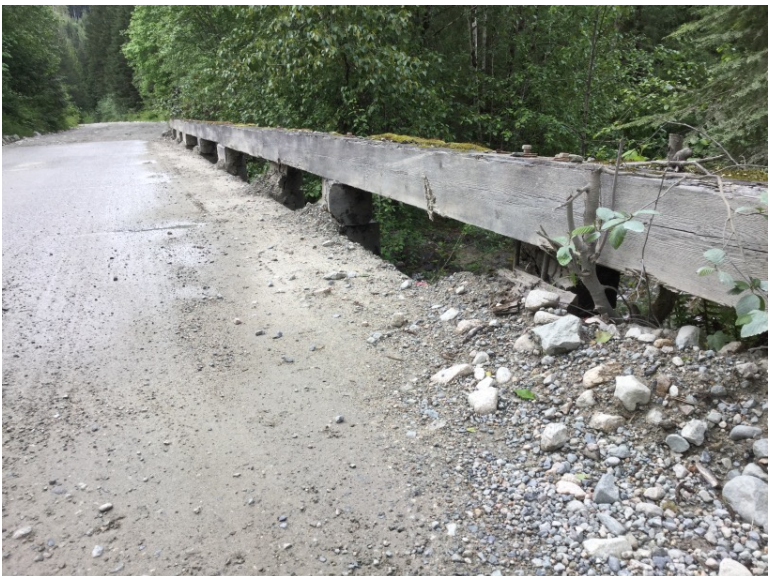
Guard Rail

Curb Rail/Blocks/Posts      Poor      Rotten

Hardware      Poor      Loose rail bolts

Overall Deck Condition      Poor      Due to rail condition

| Repair Item | Repair Description |
|---|---|
| 1 Structure. Full Curb Replacement. . Priority:High | Replace rail, risers and blocks |

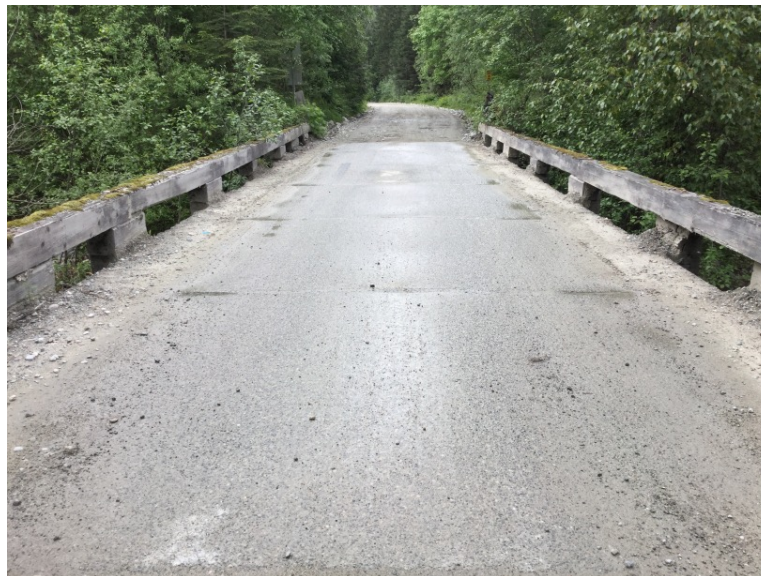
Concrete Deck      Fair

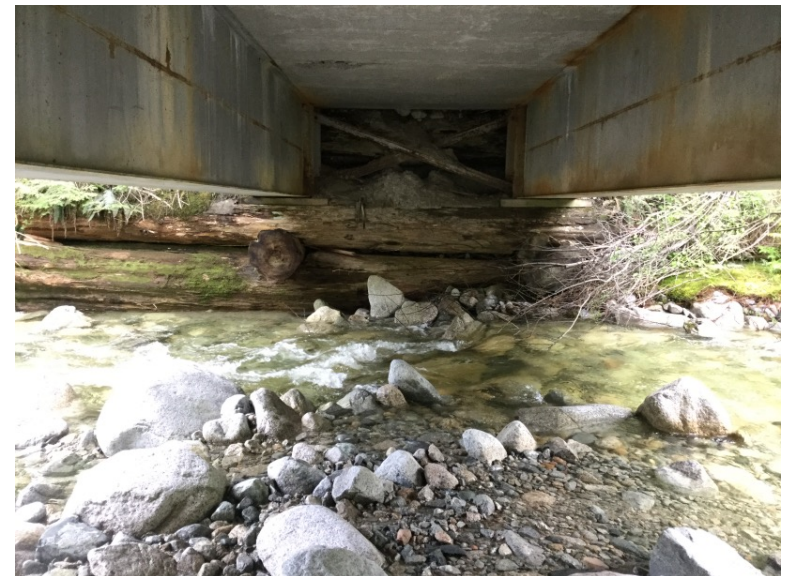
Right Bank Abutment when facing downstream

Log/Timber Cribs Fair Right bank - 2 face logs with up to 40mm sap rot

Tie Backs Fair Right bank - 2 tiebacks both directly under bearing locations with up to 40mm sap rot

Riprap Poor None in front of right abutment

| Item | Monitor Description | Frequency |
|---|---|---|
| 1 | Abutment condition | Anually |

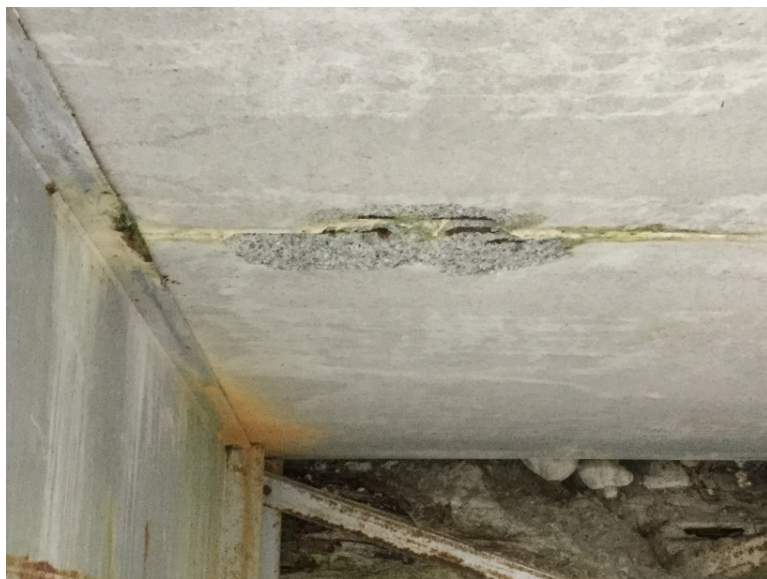
Damage noted to panel 1 and 2 at right approach

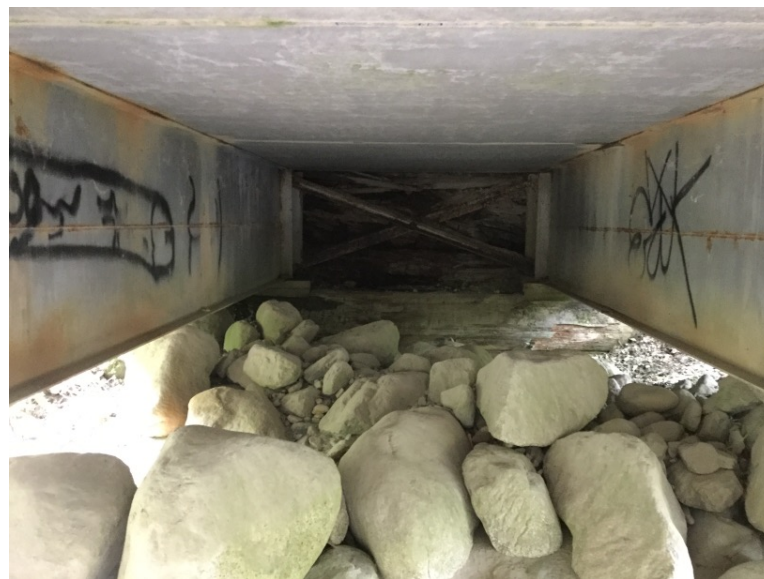
Left Bank Abutment when facing downstream

Bearings Fair Fair to poor - girders settling at left bank

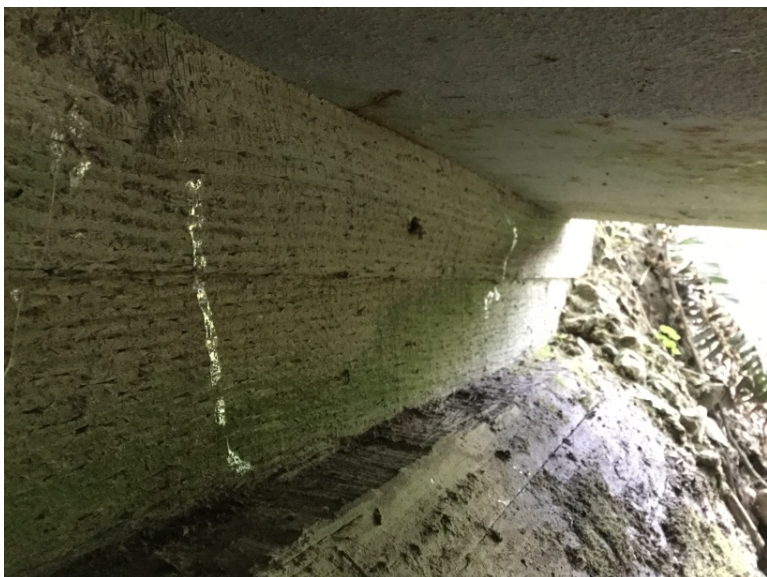
Ballast Wall Fair Rotten logs but functional

Downstream left bank timber condition

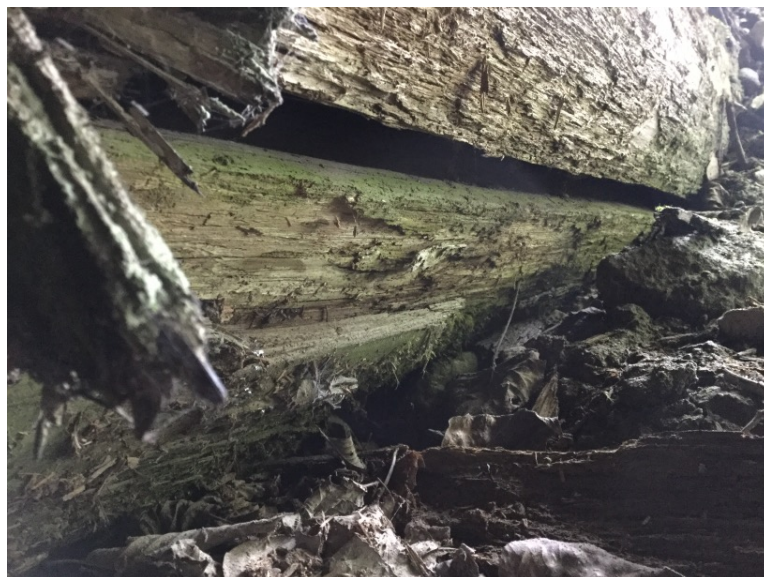
Caps or Sills Fair Left bank - 30mm wide horizontal crack in log sill, full length. Timber shims crushing - appears similar to last year inspection.

Horizontal crack in left bank sill

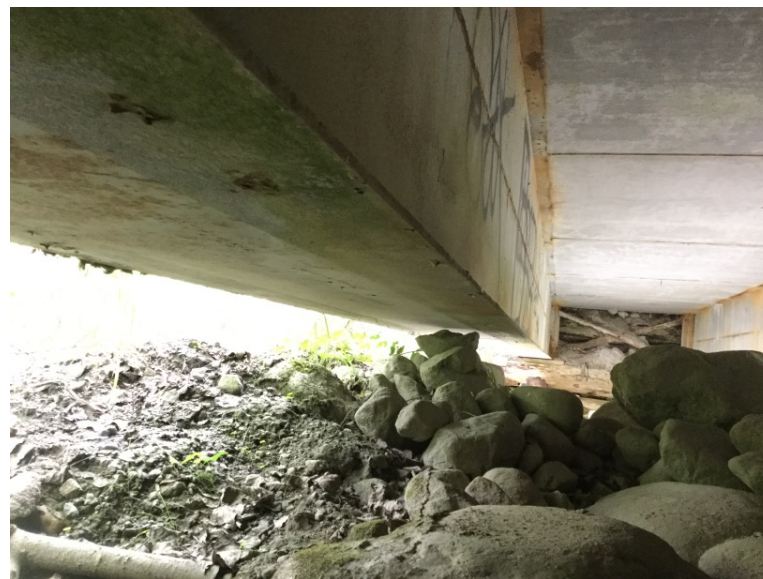
Box girder

Girders Fair Painted box girders with minor corrosion
