CK-2021  
CK-2021

CHEHALIS 10.4km

2020 Inspection

Crossing Name Boulder Creek

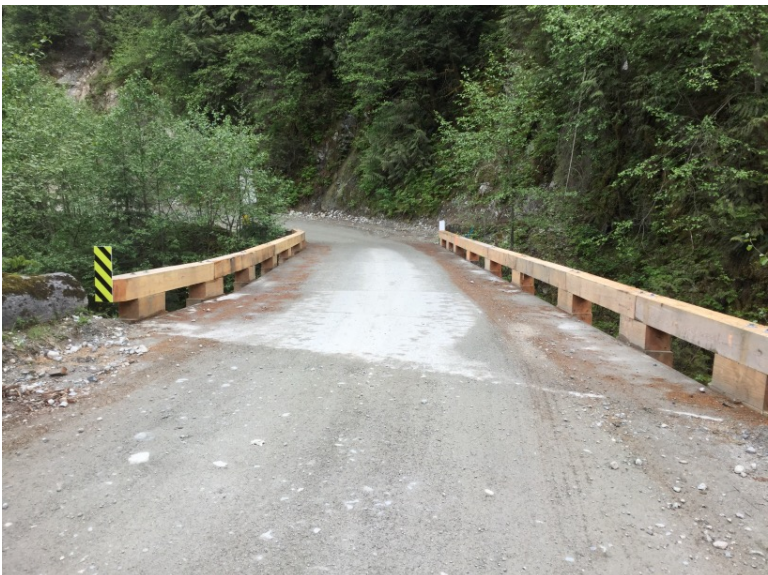
Concrete Deck      Fair      Damage noted along both wheel path

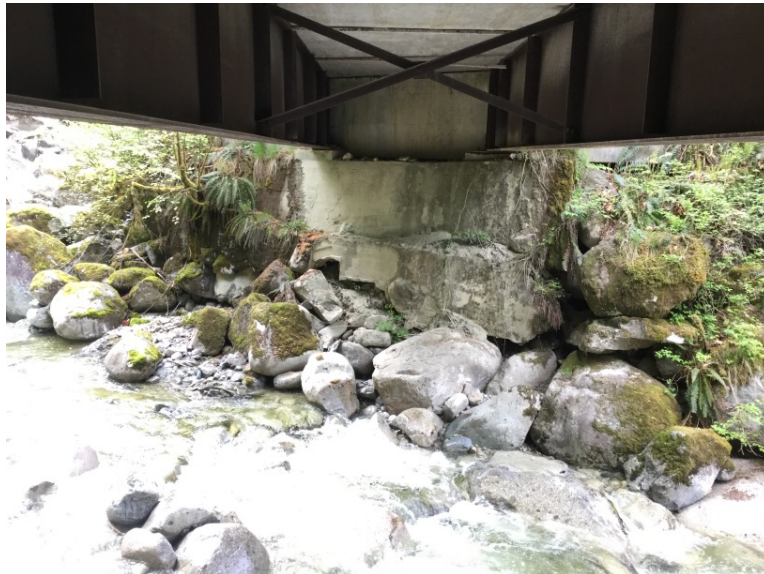
Left Bank Abutment when facing downstream

CIP at left bank, vertical crack noted under upstream girder

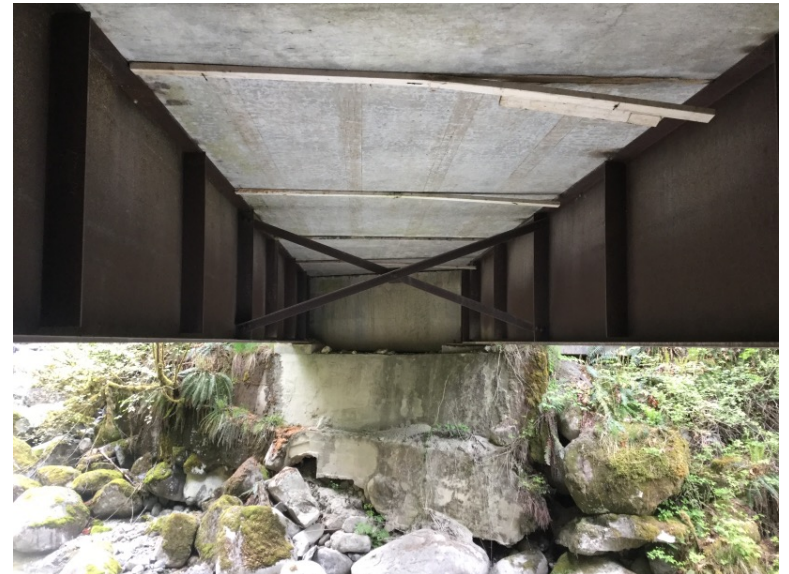
Superstructure

Girders Fair Minor surface corrosion

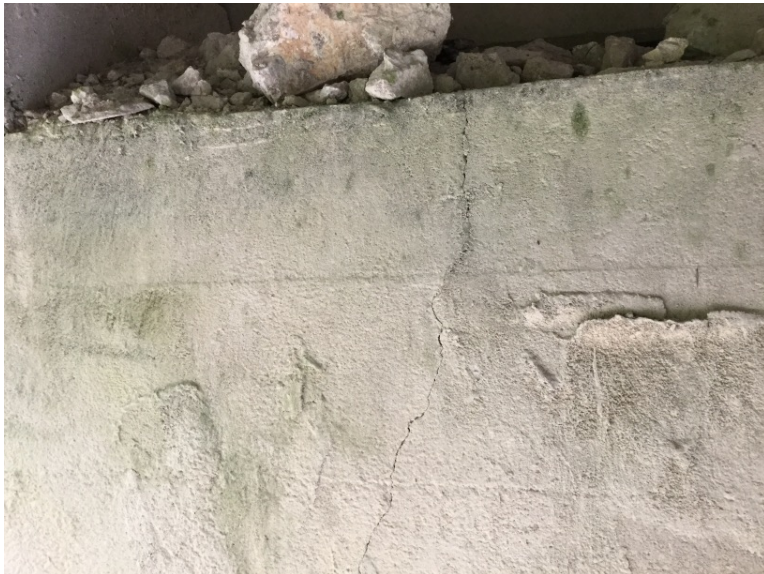
Vertical crack in CIP upstream left bank

Brush approaches and monitor the vertical crack in the concrete abutment under the upstream left bank girder. The current load rating of L150 or 136 tonnes to continue.

| Item | Monitor Description | Frequency |
|---|---|---|
| 1 | Vertical crack in CIP at upstream left bank | Routine Inspection |
