CK-2025  
CK-2025

CHEHALIS 25.6km

2020 Inspection

Crossing Name Second Creek

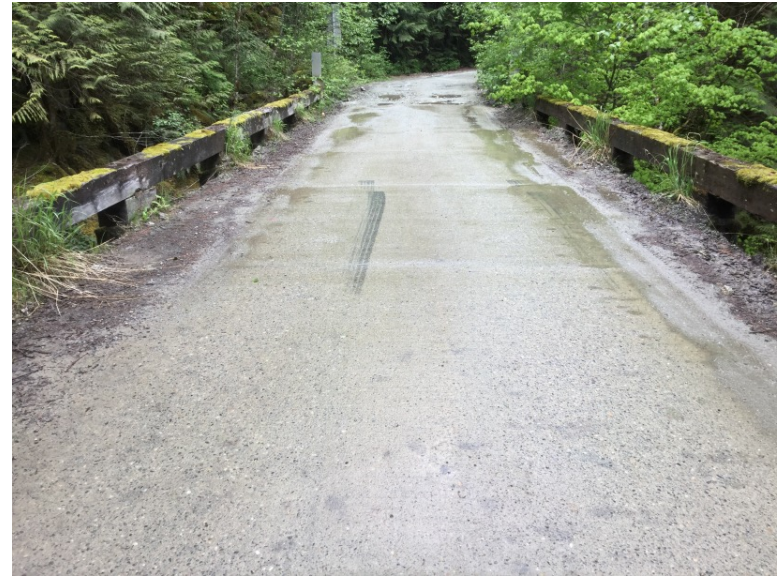
Deck Joints      Good      Water getting through some joints

Overall Deck Condition      Fair

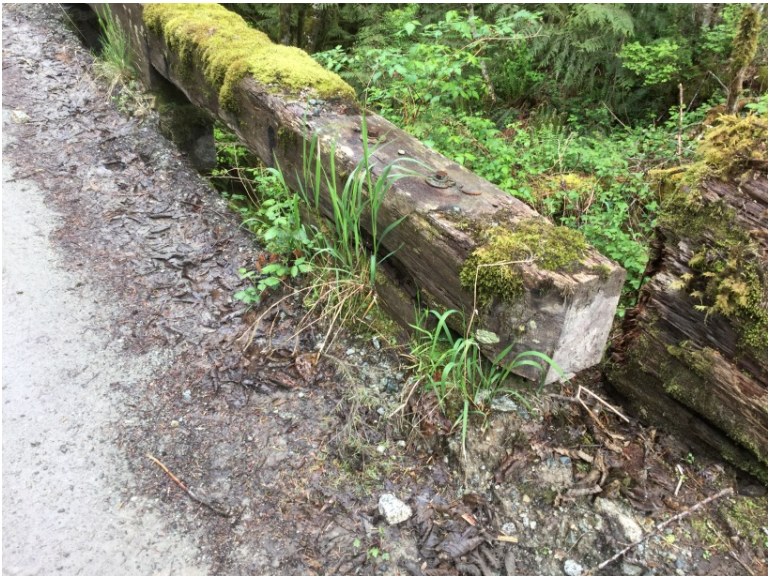
Guard Rail

Curb Rail/Blocks/Posts      Poor      Rotten

Hardware      Poor      Loose rail bolts

| Repair Item | Repair Description |
|---|---|
| 1 Structure. Full Curb Replacement. .<br>Priority:Medium | Replace guardrail, risers and blocks |

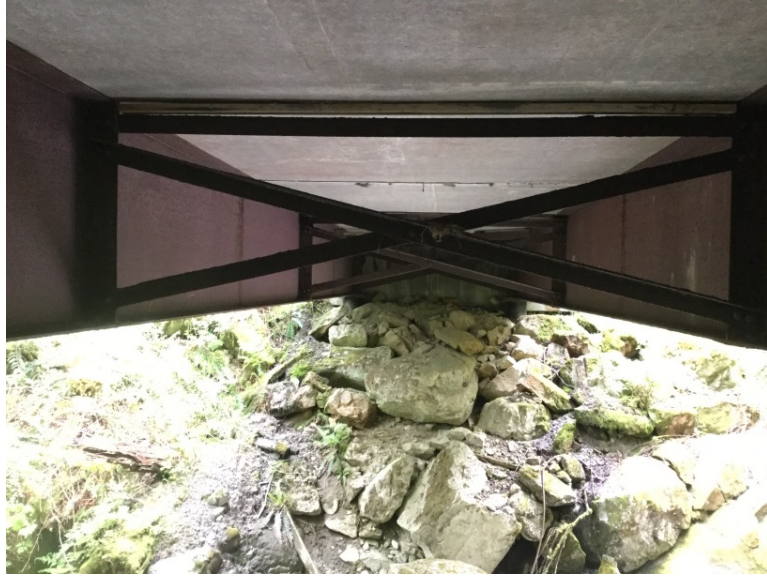
Superstructure

Girders Good Minor corrosion on flanges and web

Bracing Fair Minor corrosion
