CK-2031  
CK-2031

## STATLU 1.7km

2020 Inspection

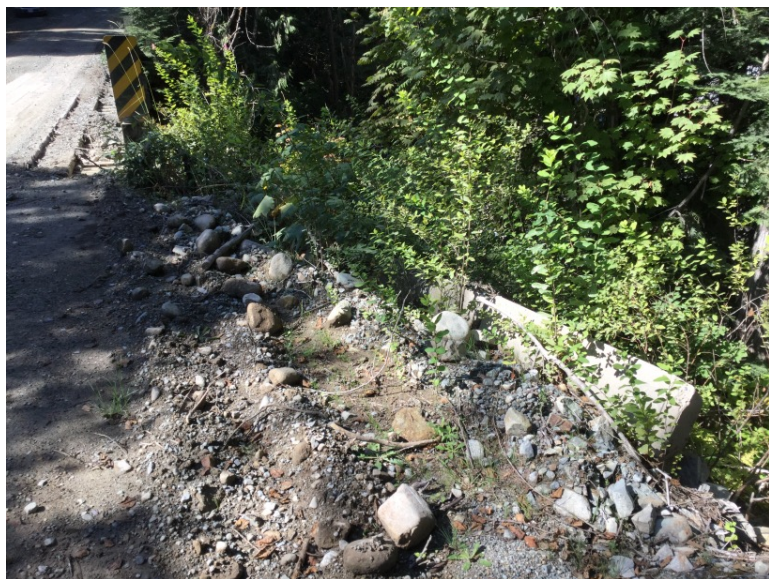
Unconnected no post barriers

Upstream left approach barriers

| Repair Item | Repair Description |
|---|---|
| 1 Approach. Approach fenders (re-Install). # of units. Priority:Low | Reconnect and realign all no post barriers |

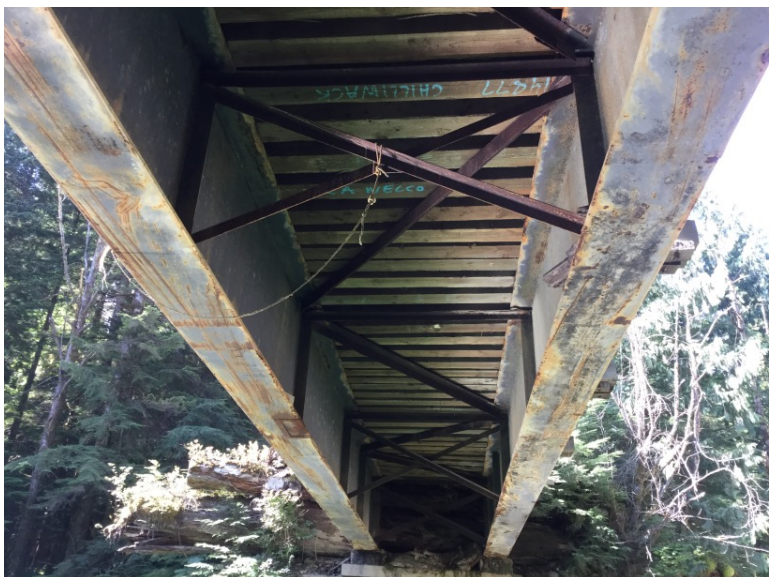
Painted girders with corrosion

Superstructure

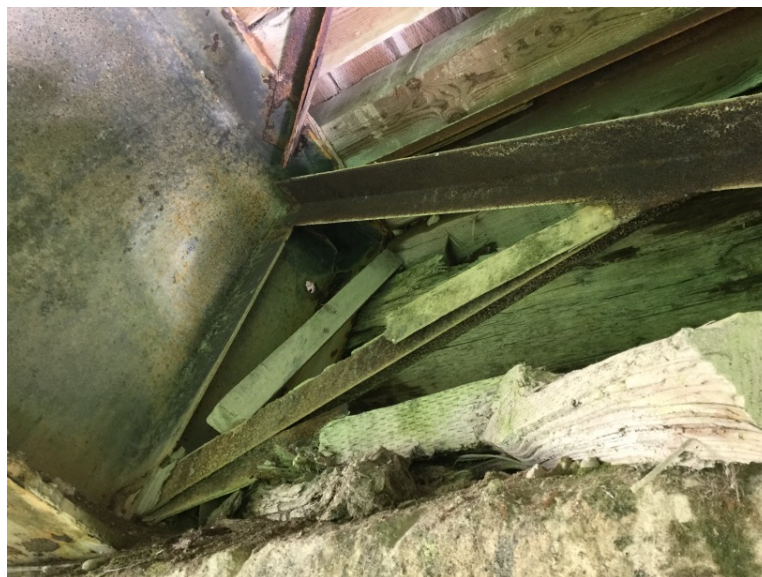
Left bank diaphragm corrosion moderate to heavy

Left bank diaphragm condition

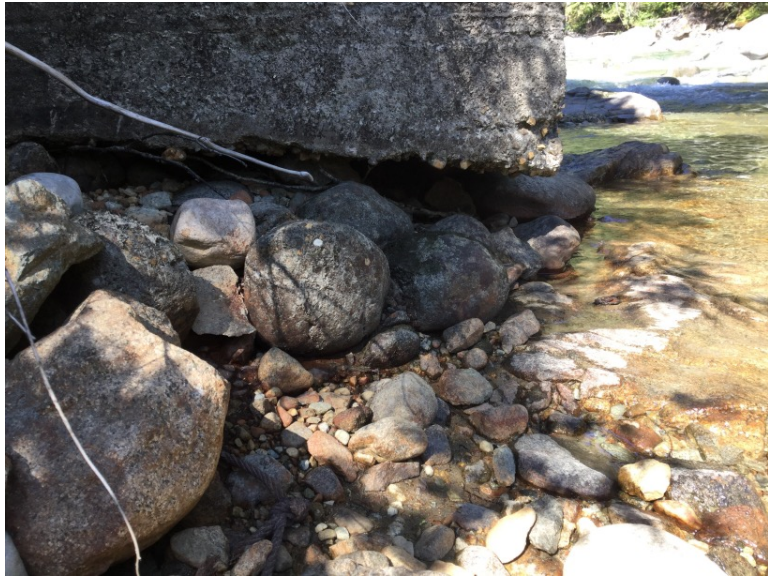
CIP both abutments, right bank scoured under face up to 850mm depth

Scour under right bank CIP extends up to 850mm from face

| Item | Monitor Description | Frequency |
|---|---|---|
| 1 | Scour under right bank CIP | Routine Inspection |

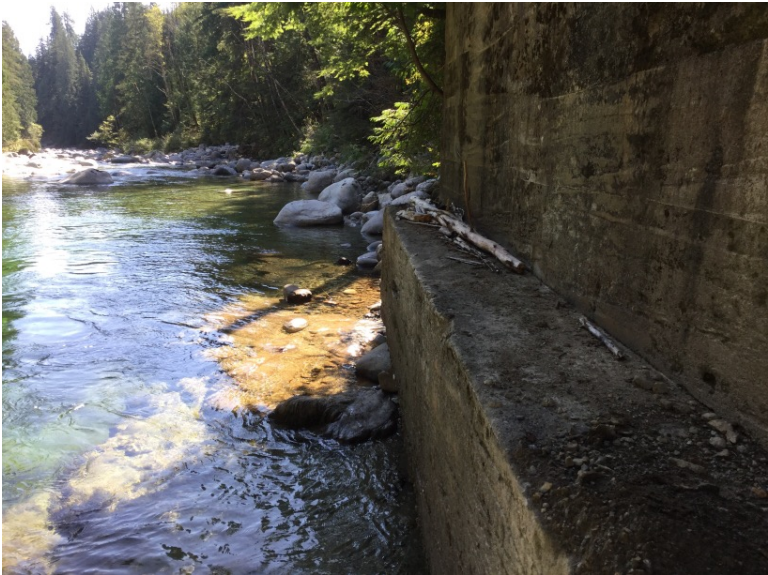
Debris, evidence of stream flow height

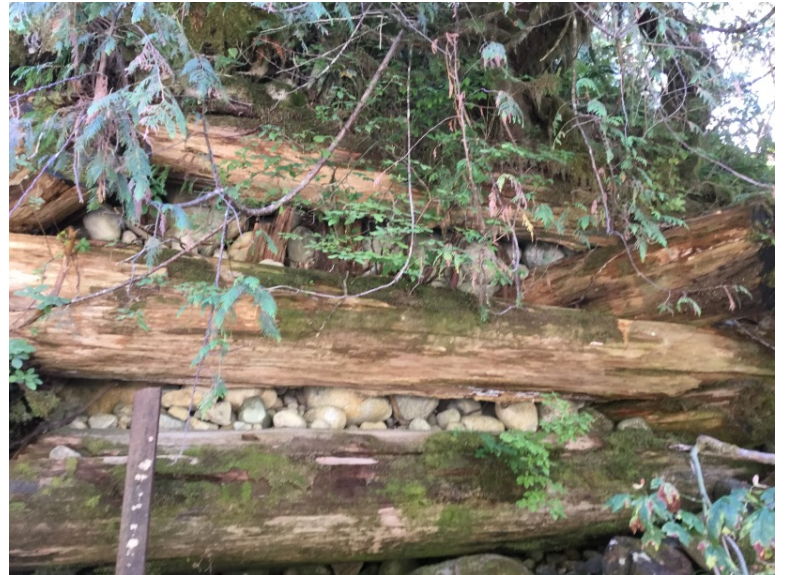
Open face log crib with significant deterioration

Upstream right bank wingwall condition

| 2 | stability of log crib/wingwalls retaining road approach fills | Annually |
