CK-2033  
CK-2033

STATLU 5.7km

2020 Inspection

| Crossing Name | Alice Creek |

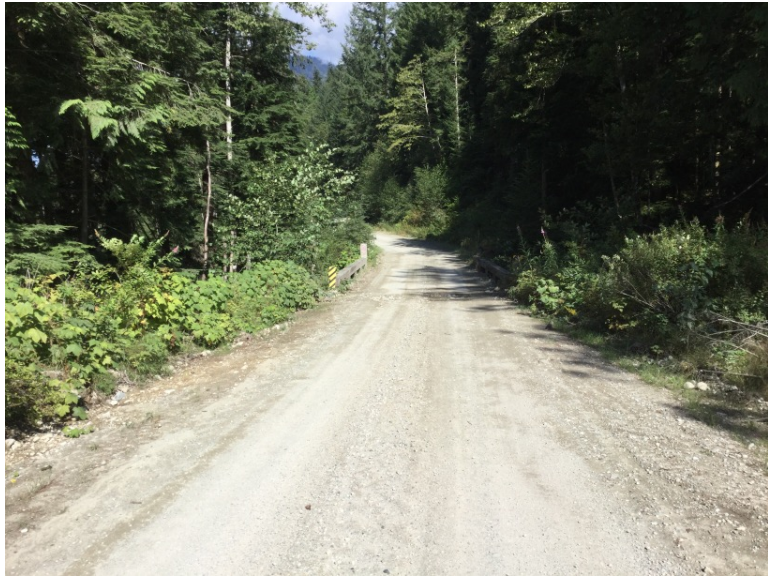
Approach from Left Bank when facing downstream

Delineator Missing  
Left ☐ 0 ☐ 1 ☒ 2 Left approach, downstream delineator is incorrect

Fender Condition Fair Old logs, missing left approach

| Repair Item | Repair Description |
|---|---|
| 3 Structure. Delineator maintenance. . Priority:Low | Replace delineators on left ends with proper left hand delineators |
| 6 Low | Replace missing fender logs |

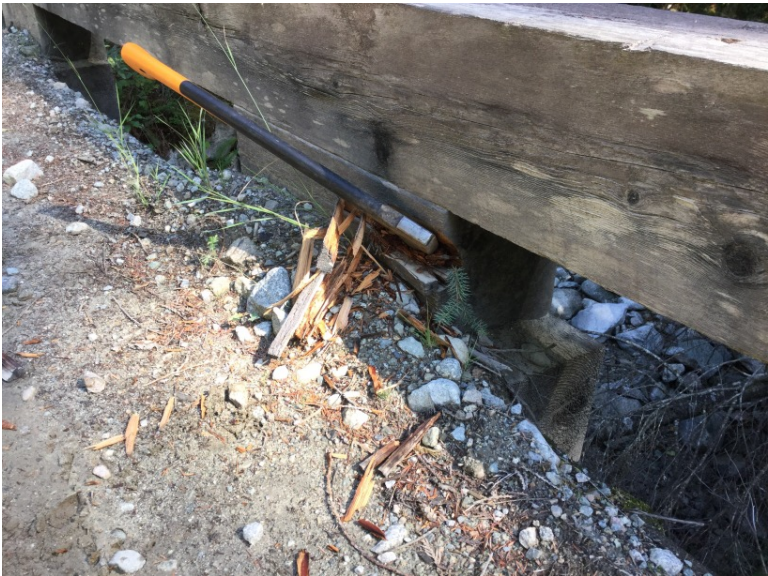
Curb Rail/Blocks/Posts      Poor      Rotten

Hardware      Poor      Loose rail bolts

Overall Deck Condition      Poor      Due to rail condition

Rail condition

| Repair Item | Repair Description |
|---|---|
| 2 Structure. Curb Maintenance. # sites. Priority:Medium | Replace guardrail, risers and blocks |

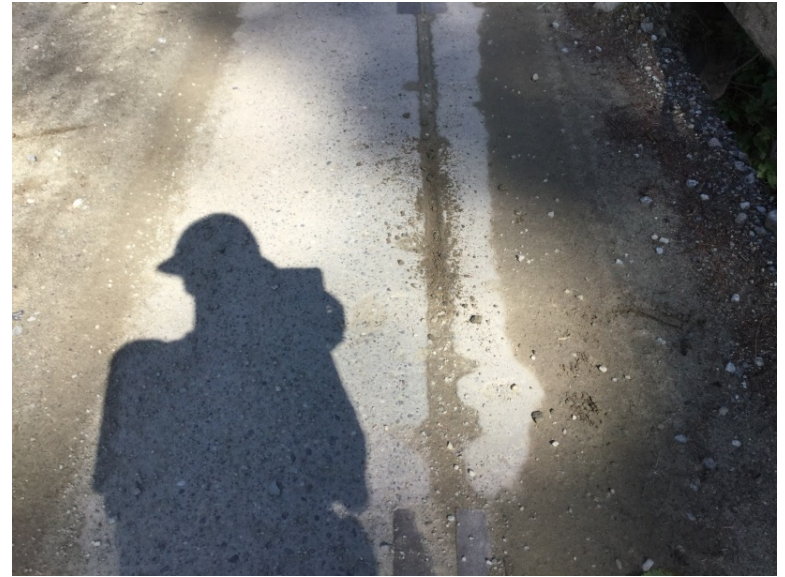
Joint sealant nonexistent

| Repair Item | Repair Description |
|---|---|
| 4 Low | Replace all joint sealant |

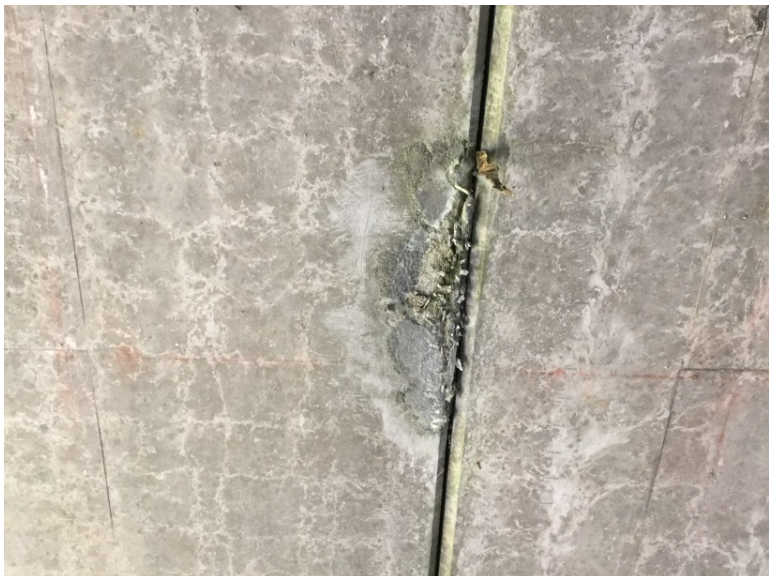
Spall under slab 4 at center
