CK-2040  
CK-2040

MAISAL 2.8km

2020 Inspection

Crossing Name Lower Bentley Creek

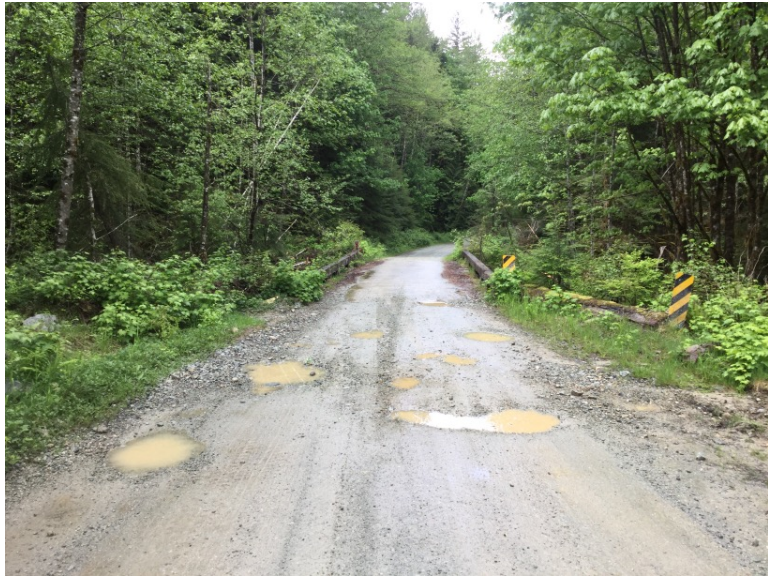
Approach from Right Bank when facing downstream

Bridge Ahead Signs  
Missing ☐ 0 ☐ 1 ☒ 2

Brushing Required Y

| Repair Item | Repair Description |
|---|---|
| 1 Approach. Approach surfacing grading. m. Priority:Low | Brush approaches |
| 2 Approach. Bridge Ahead Signs. # of signs. Priority:Low | Post bridge ahead signs |

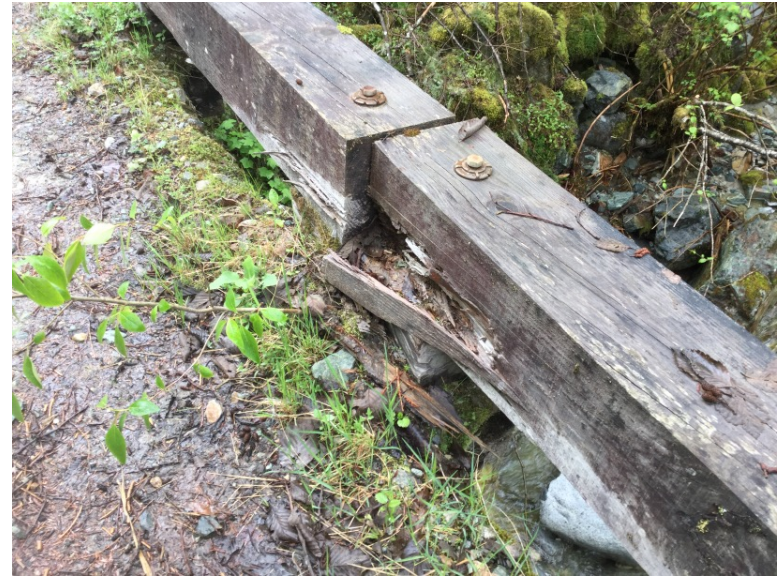
Guard Rail

Curb Rail/Blocks/Posts      Poor      Rotten

Hardware      Poor      Loose rail bolts

| Repair Item | Repair Description |
|---|---|
| 3 Structure. Full Curb Replacement. . Priority:Medium | Replace rail, risers and blocks |

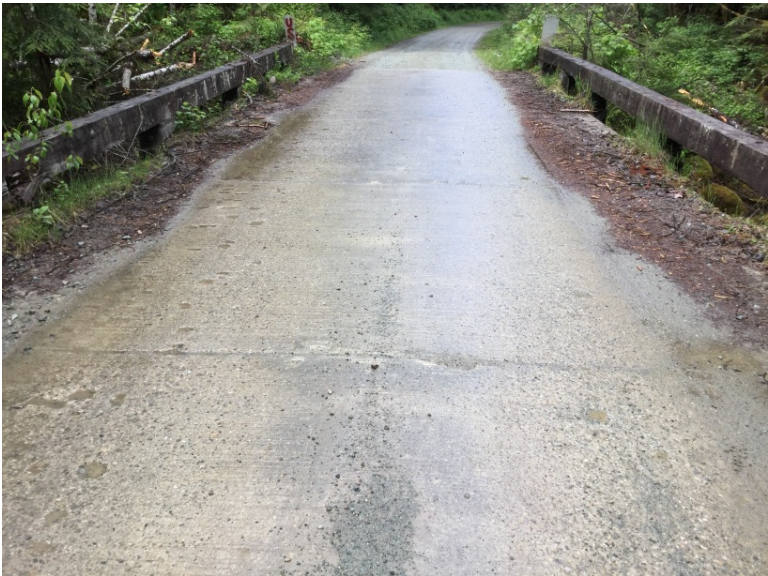
Concrete Deck      Fair

Overall Deck Condition      Poor      Due to rail condition

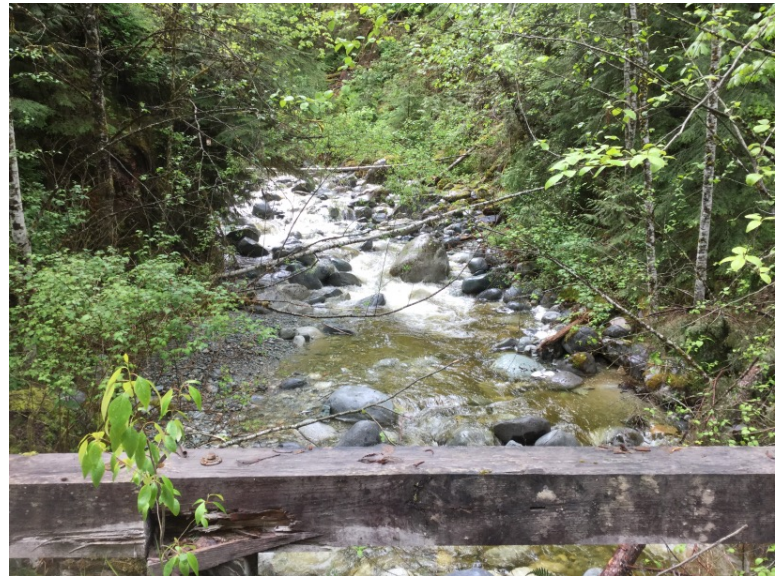
Upstream from Crossing

Comments Riprap is round and not keyed together and subject to scour  
Trees in stream, noted immediately up and downstream from crossing

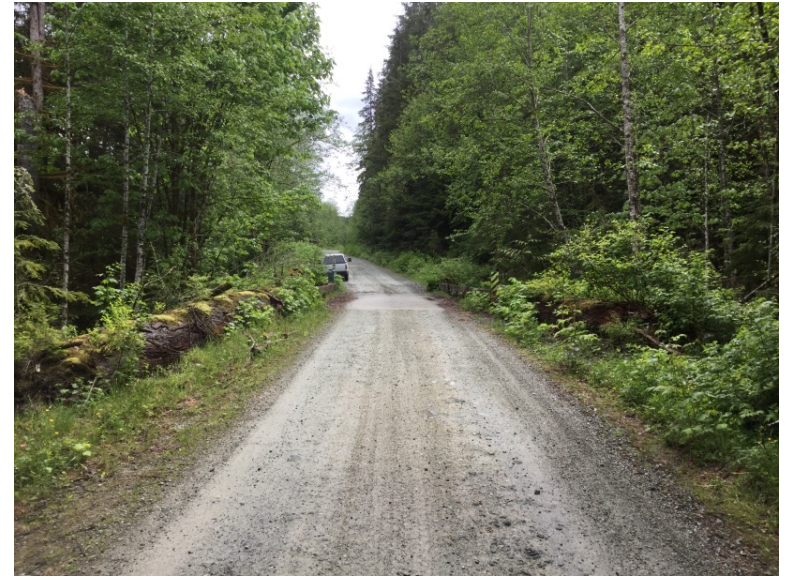
Approach from Left Bank when facing downstream

Delineator Missing  
Left ☐ 0 ☒ 1 ☐ 2

| Repair Item | Repair Description |
|---|---|
| 4 Structure. Delineator maintenance. . Priority:Low | Replace missing delineator |

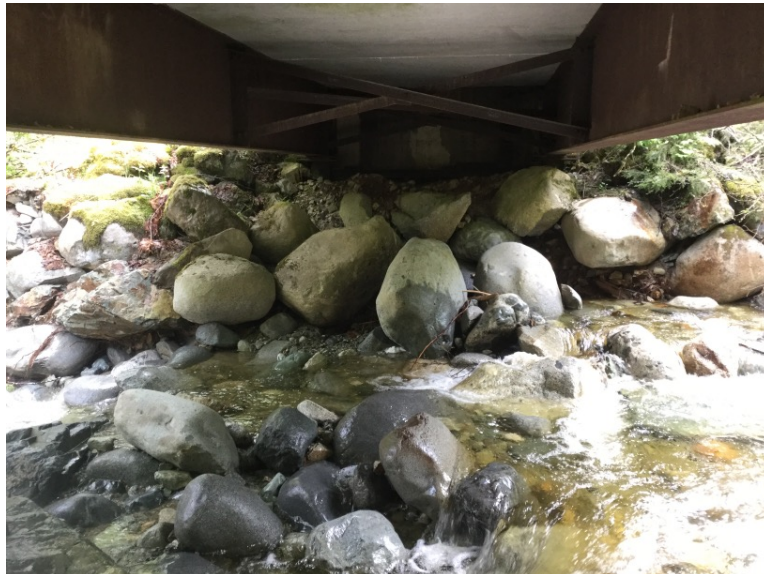
Right Bank Abutment when facing downstream

Riprap Fair Round, not well graded and slightly scoured

| Item | Monitor Description | Frequency |
|---|---|---|
| 1 | Riprap condition | Routine Inspection |
