CK-2042  
CK-2042

## FLEETWOOD 4km

2020 Inspection

Crossing Name Maisal Creek

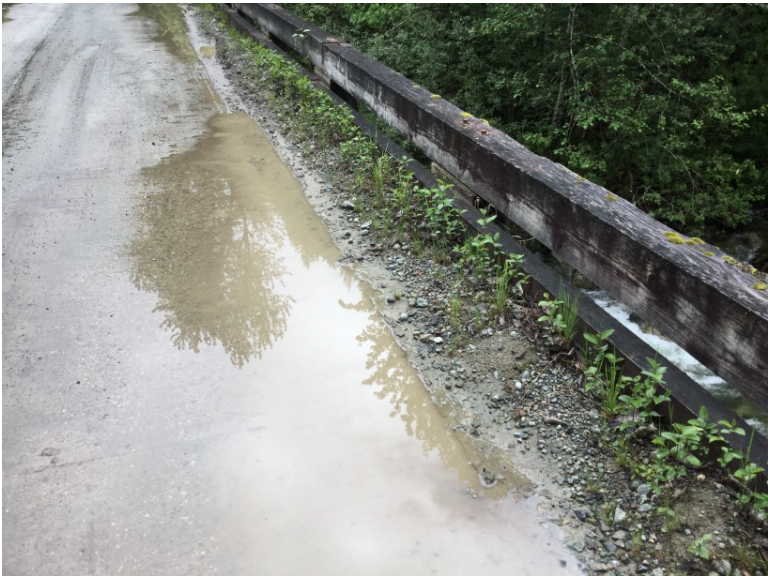
Running Surface      Fair      Sediment collecting on deck

Sediment on deck

| Repair Item | Repair Description |
|---|---|
| 3 Structure. Clean Deck. # of delineators. Priority: High | Clean sediment from deck |

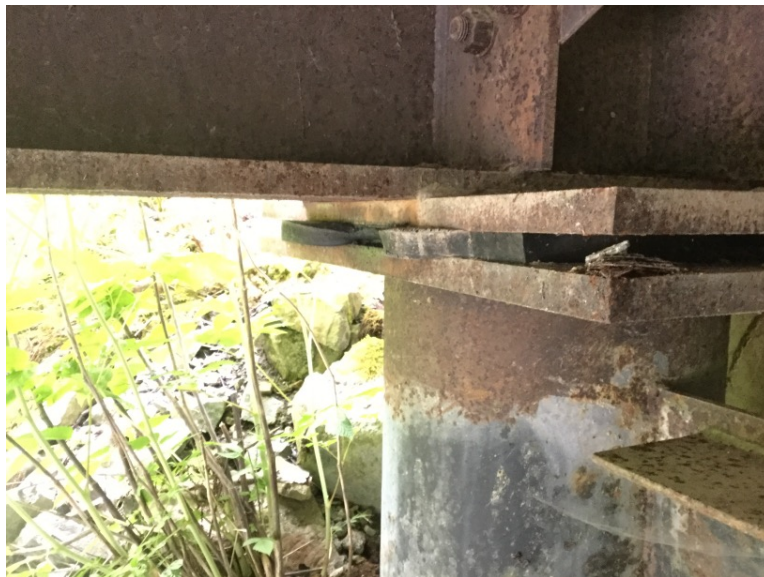
Bearings Fair All 4 bearing pads bulging

Typical bearing pad condition in all 4 cases

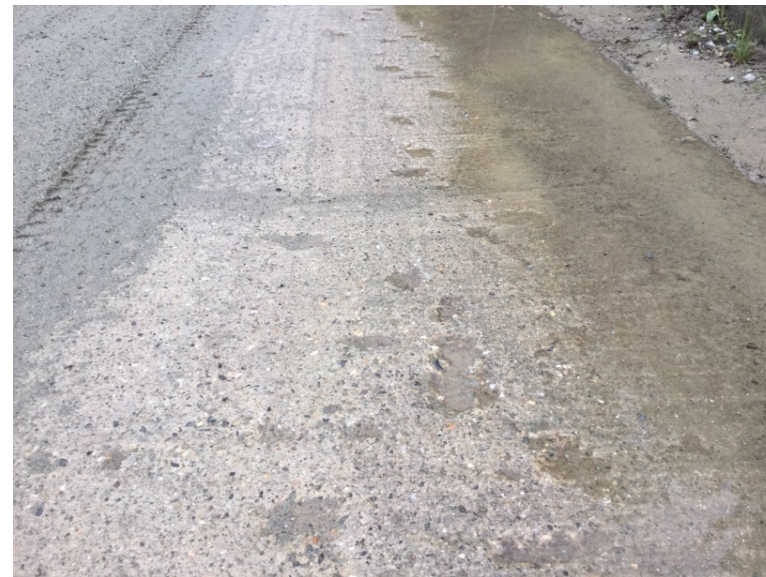
Concrete Deck      Fair      Minor damage noted along both wheel path locations

Minor damage noted on wheel path
