CK-2045  
CK-2045

CHEHALIS-MYSTERY 1.5km

2020 Inspection

Crossing Name Mystery creek

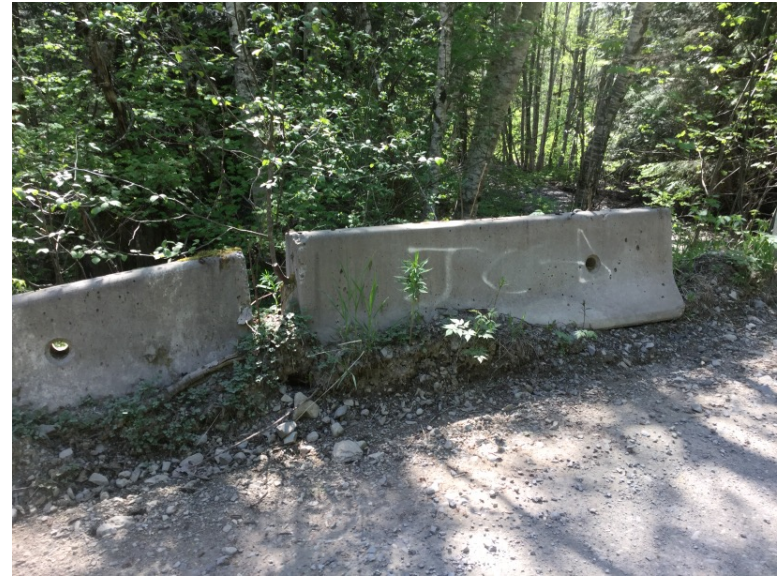
No post barriers not properly connected

Approach Barrier

| Repair Item | Repair Description |
|---|---|
| 1 Structure. Curb Maintenance. # sites. Priority:Medium | Reconnect and realign the approach barriers at the left approach and downstream right approach |

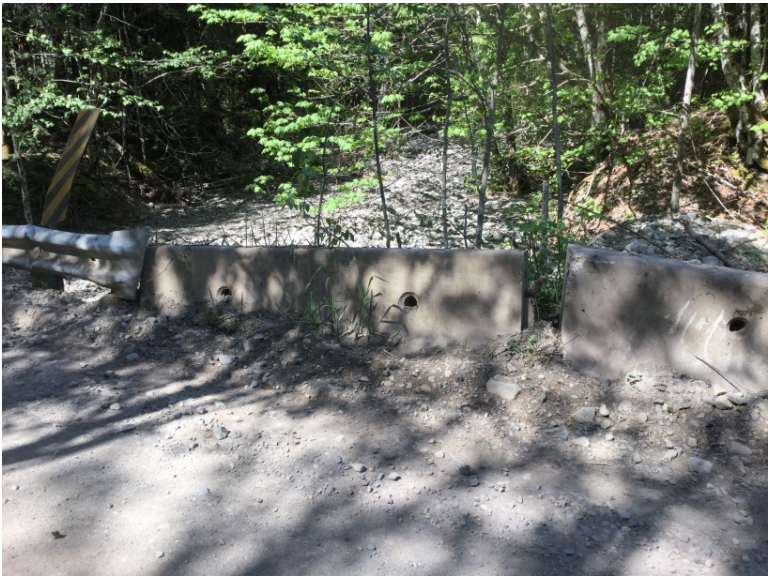
Approach Barrier

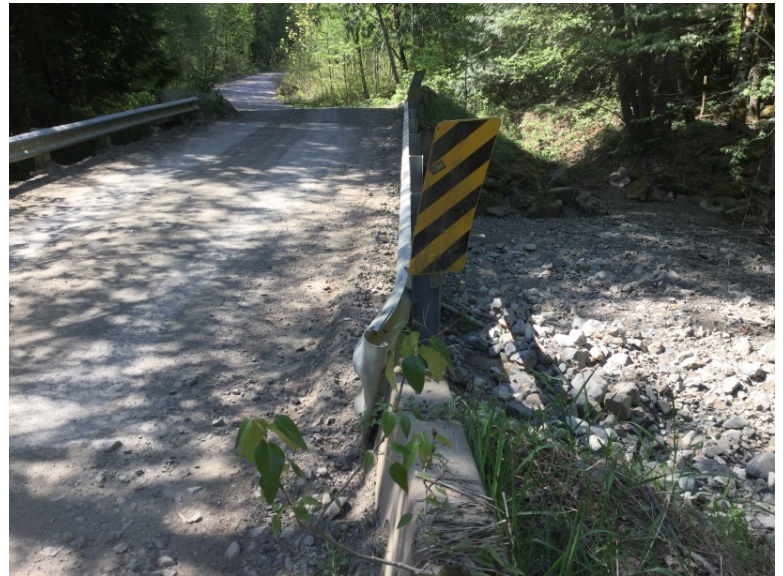
Curb Rail/Blocks/Posts      Fair      Minor damage noted at upstream left and downstream right approaches

Upstream left approach guardrail condition

| Repair Item | Repair Description |
|---|---|
| 4 Structure. Curb Maintenance. # sites. Priority:Low | Repair damage noted to guardrail at upstream left and downstream right banks |

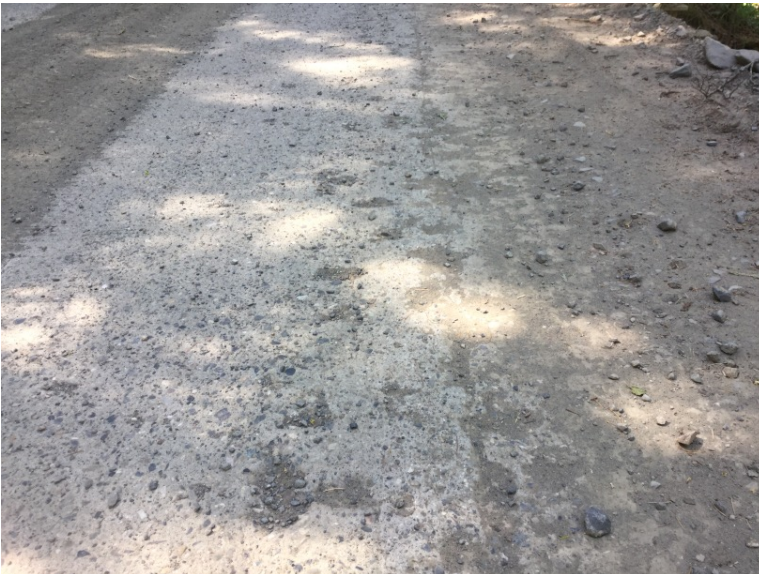
Wear noted on wheel path

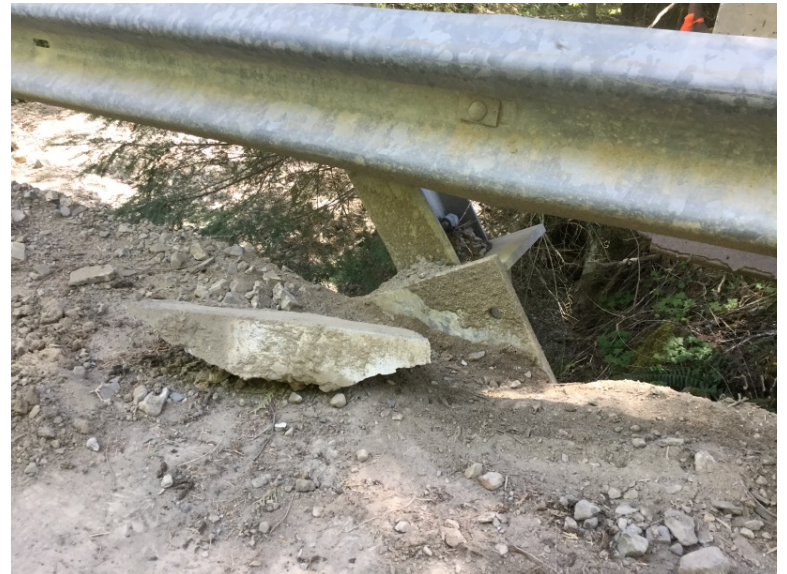
Downstream right approach damage to deck at steel riser location

Repair the damage noted to the concrete slab as per the Concrete Repair Guide for Concrete Bridge Components MoFLNRO (2017) located at the downstream right bank and reattached the riser at this location. Repair the damage noted to the guardrail at the downstream right and upstream left banks. Reconnect and realign all concrete no post barriers. Replace the missing delineator and clean the sediment accumulations off deck. There is significant bedload located at the crossing, monitor and clean accordingly. The current load rating of L75 or 68 tonnes to continue.

| Repair Item | Repair Description |
|---|---|
| 2 Structure. Concrete structural maintenance. m². Priority:Medium | Repair damage noted to the deck at downstream right approach at steel riser location. Realign and reattach steel riser |

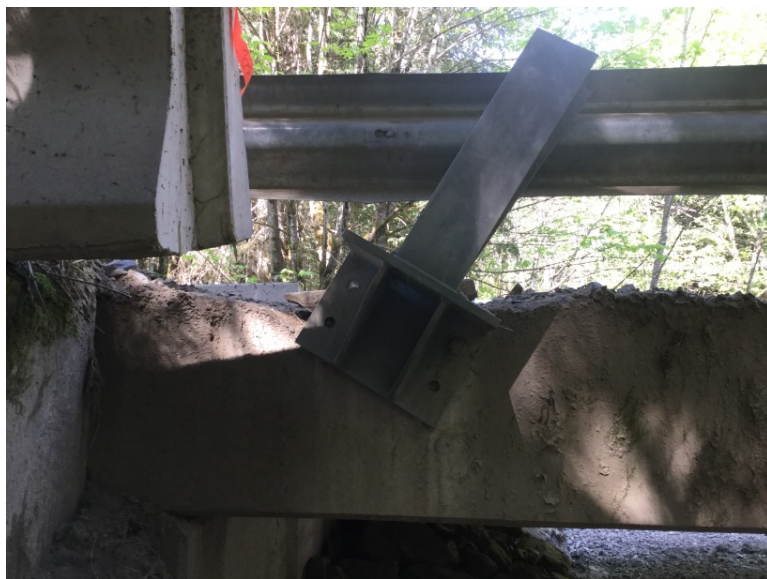
Downstream right approach steel riser condition

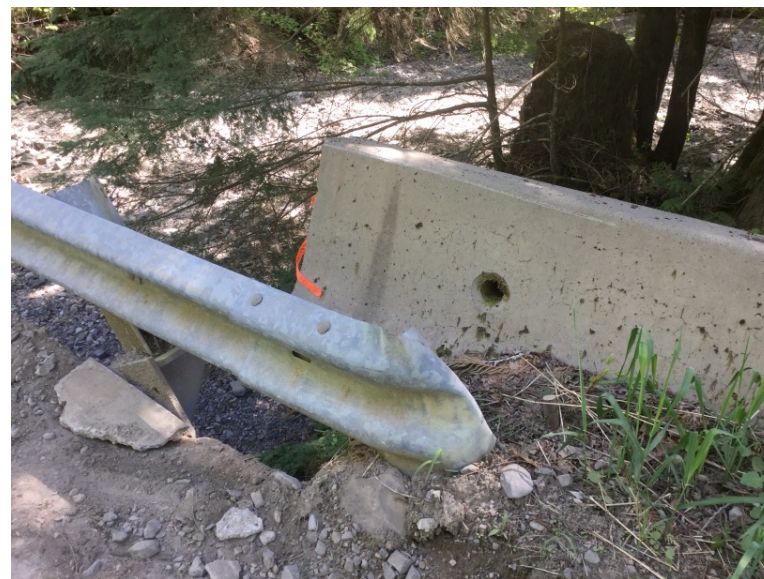
Downstream right approach barrier alignment
