2046  
CK-2046

## CHEHALIS-MYSTERY 4.7km

2020 Inspection

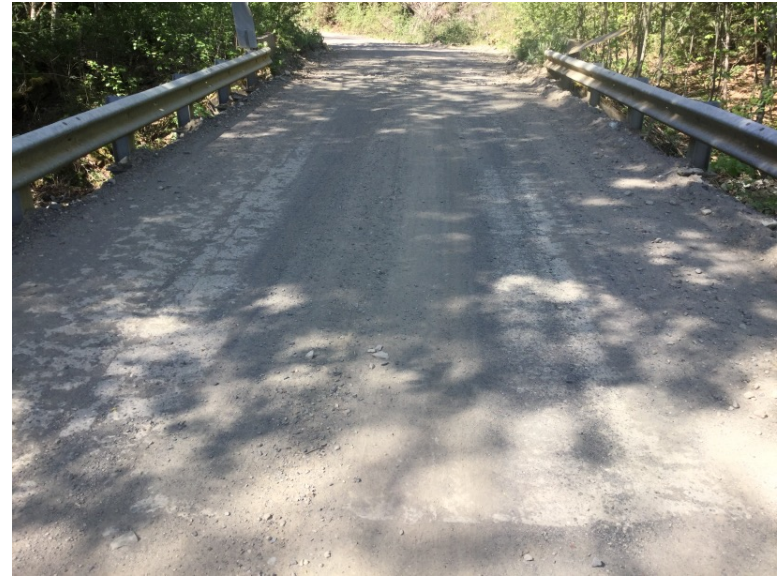
Deck

Running Surface      Fair      Sediment collecting on deck

| Repair Item | Repair Description |
|---|---|
| 1 Structure. Clean Deck. # of delineators. Priority:Medium | Remove sediment from deck |

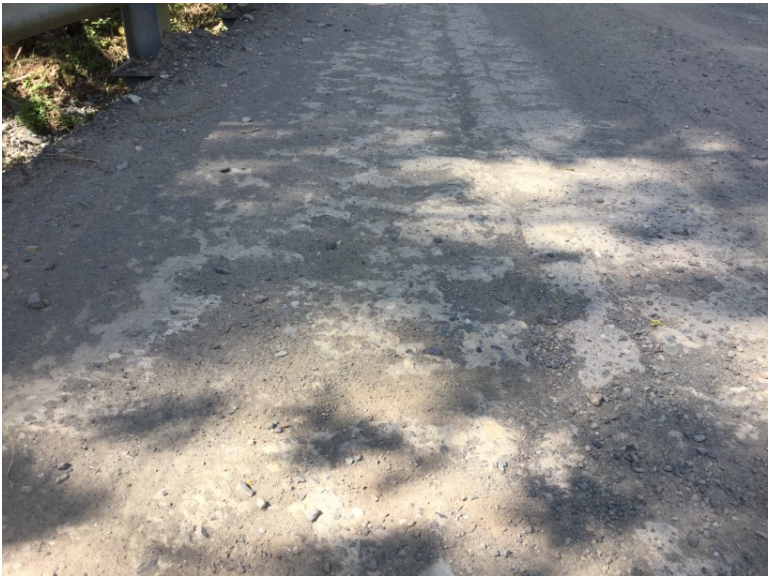
Concrete Deck      Fair      Concrete has significant wear along wheel path, likely due to tracked equipment

Wear on wheel path noted

Repair the damage noted to the running surface consistent with the Concrete Repair Guide for Concrete Bridge Components MoFLNRORD (2017). Repair the damage (or replace) to the riser located at upstream right bank. Replace the missing delineator. Remove the sediment accumulations from the deck and post bridge ahead signs. Monitor bedload accumulations. The current load rating of L75 or 68 tonnes to continue.

| Repair Item | Repair Description |
|---|---|
| 3 Structure. Concrete structural maintenance. m². Priority:Medium | Repair damage to surface |

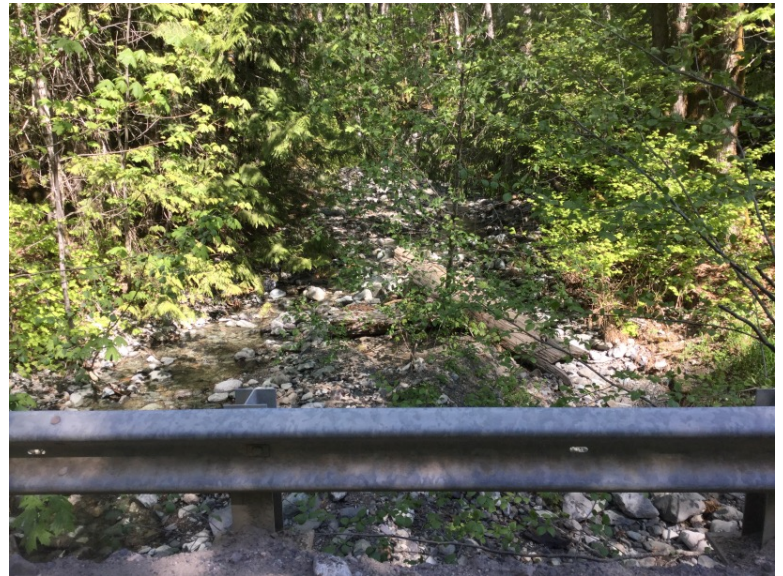
Upstream from Crossing

Comments Stream appears to transport bedload and organic material

| Item | Monitor Description | Frequency |
|---|---|---|
| 1 Bedload | | Routine Inspection |

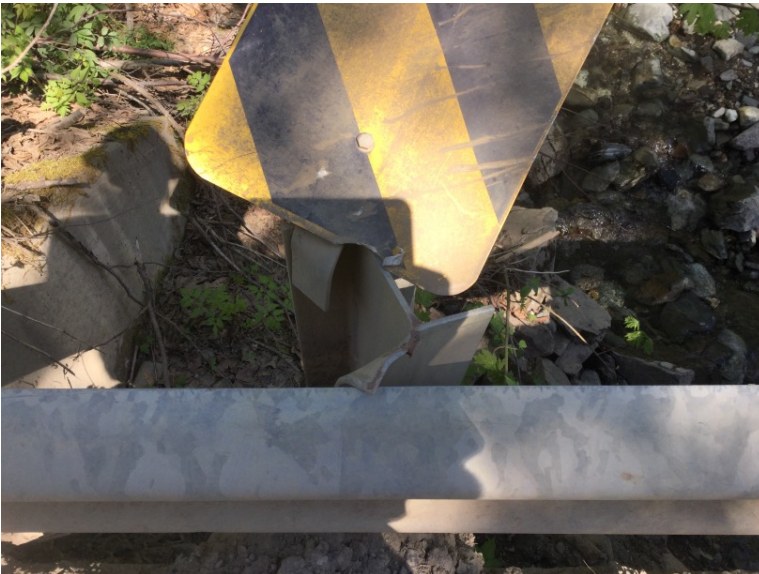
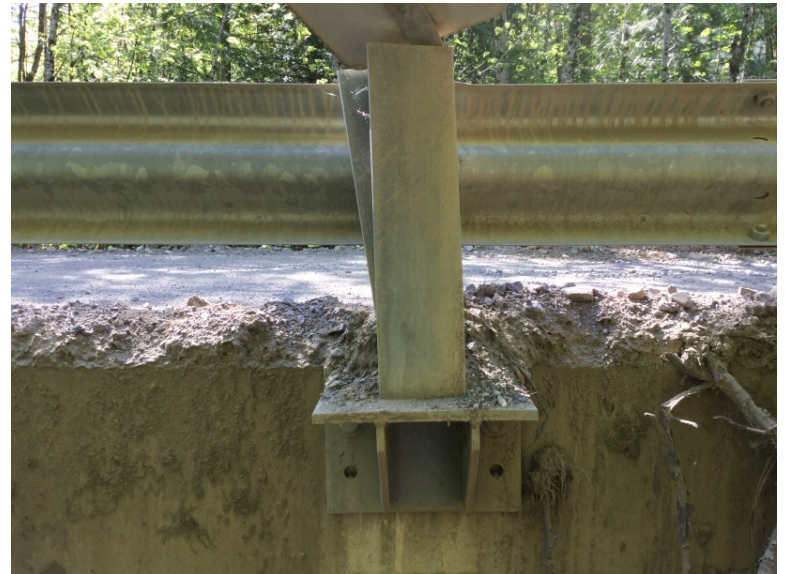
Curb Rail/Blocks/Posts      Fair      Single steel riser damage noted

Upstream right approach riser damage

| Repair Item | Repair Description |
|---|---|
| 2 Structure. Delineator maintenance. . Priority:Low | Repair damage (or replace) to upstream right bank riser and delineator |
