CK-2048

CHILLIWACK LAKE 1km

2020 Inspection

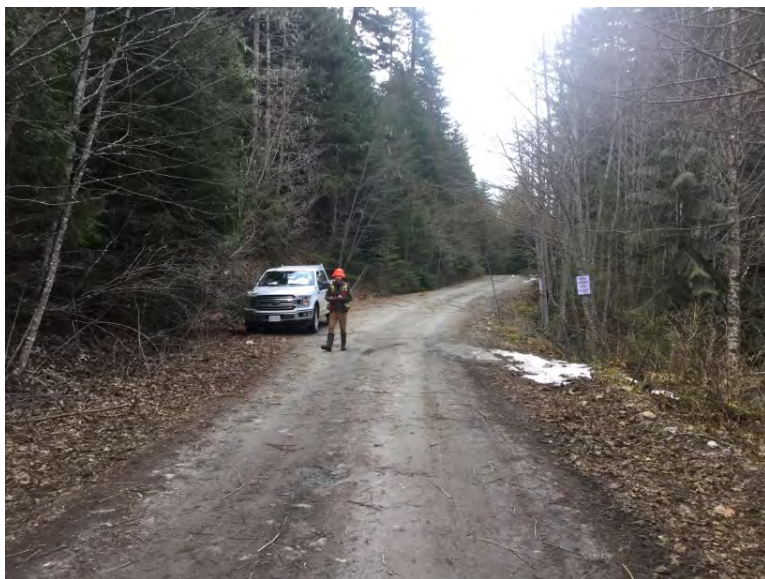
Approach from Right Bank when facing downstream

Road Surface Poor Large potholes

| 2 | Medium | Grade road |

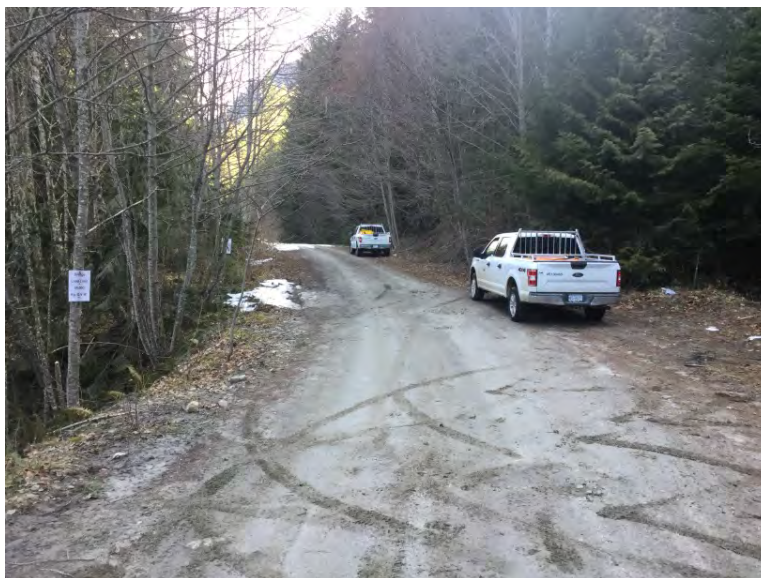
Approach from Left Bank when facing downstream

Brushing Required Y

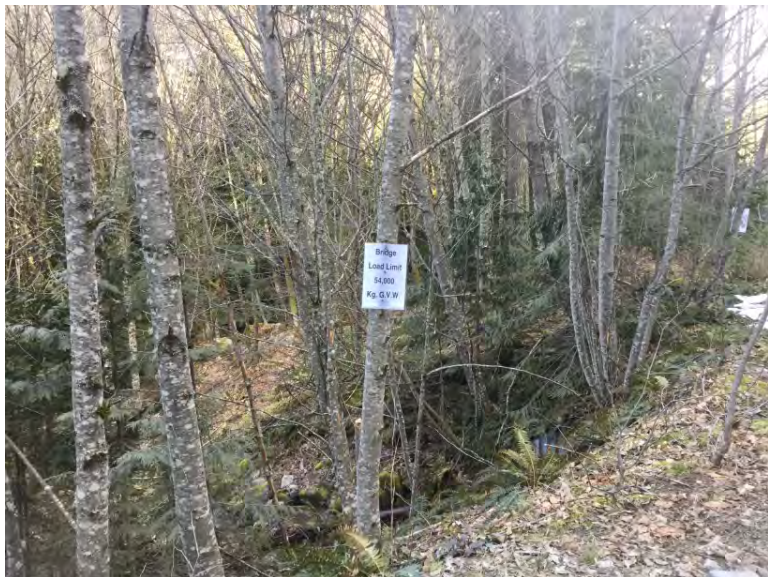
Load Rating Sign

Posted Load Rating 54000

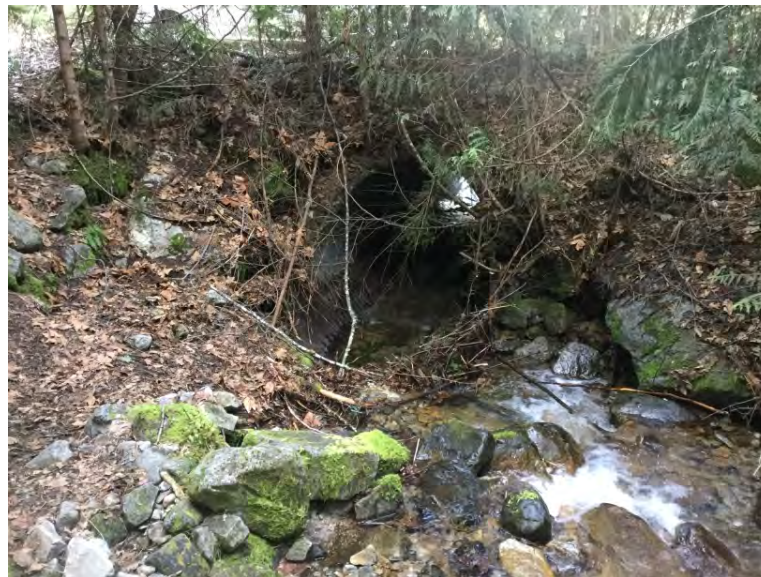
Inlet      **Fair**      Debris and aggradation occurringOutlet      **Fair**      2m drop but stableOverall      **Fair**Rip Rap      **Good**Roof      **Good**Sidewalls      **Good**

Comments Remove vegetation and bedload at inlet, and remove vegetation at outlet

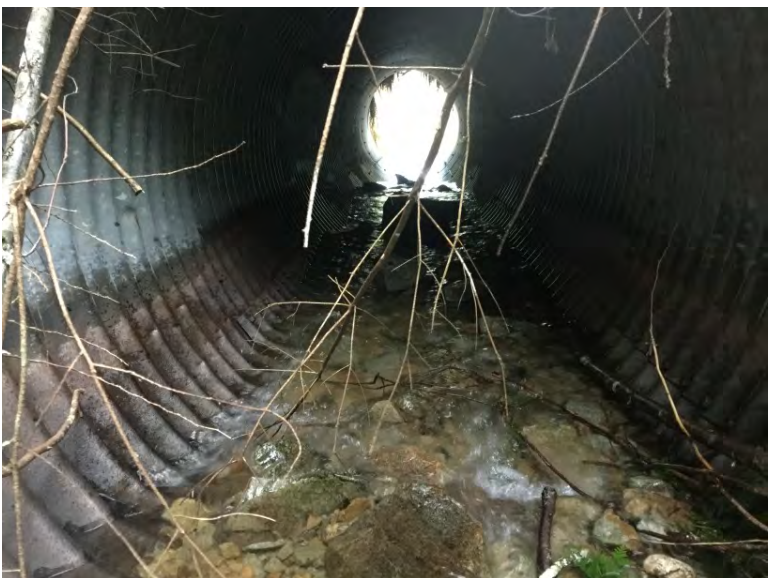
Looking through culvert from inlet

Fill      **Good**Floor      **Fair**      minor corrosion and bedload starting to accumulate within

| 1 | Bedload at inlet and within culvert | Routine Inspection |
