CK-2065  
CK-2065A

TAMIHI 8.3km

2020 Inspection

Crossing Name Fumerol Creek

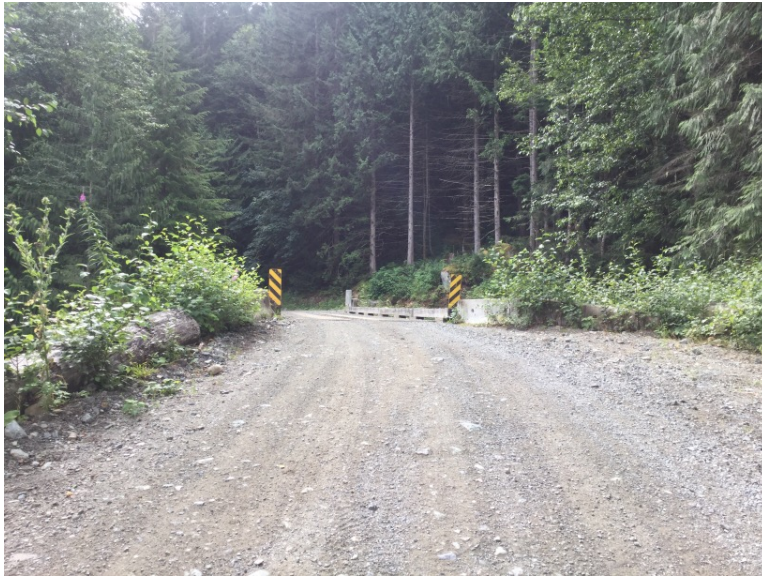
Approach from Left Bank when facing downstream

steep VC left approach limits visibility

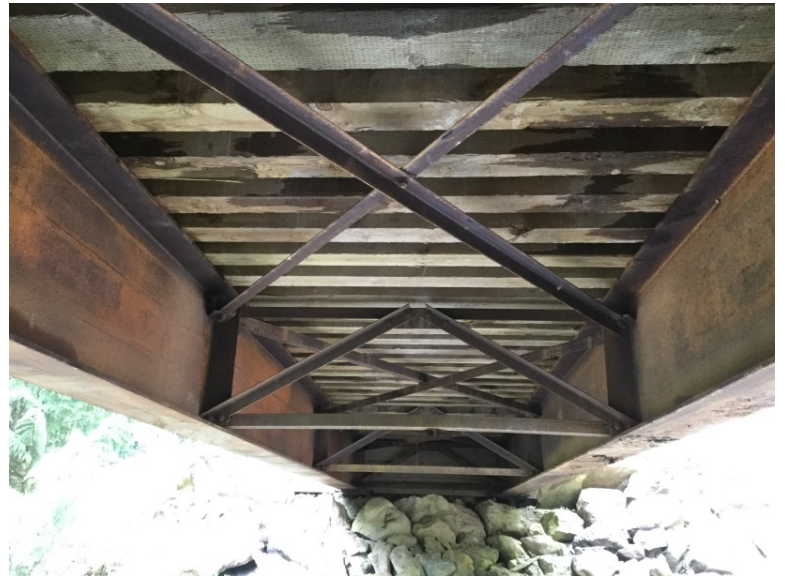
Superstructure

Girders Fair Recycled girders with minor corrosion

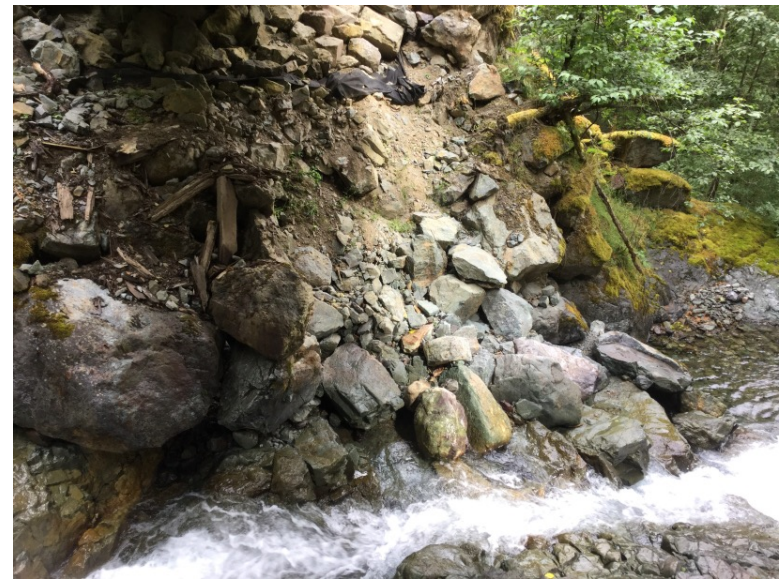
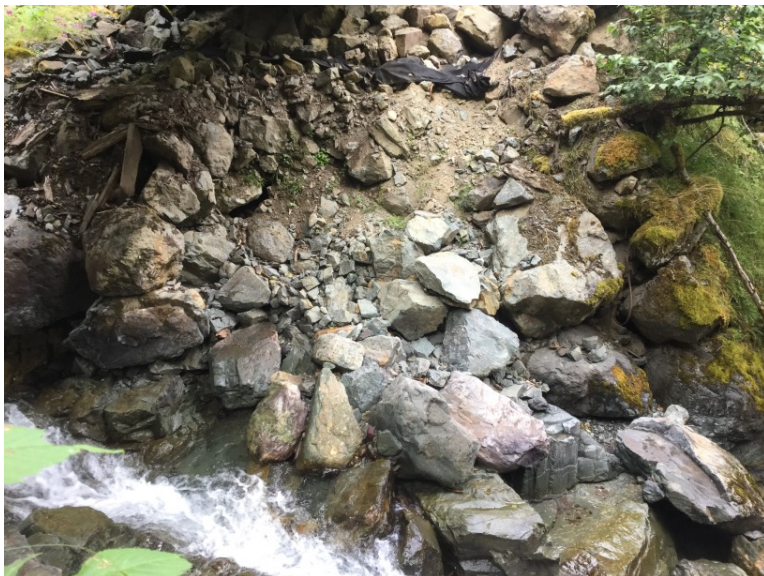
Downstream left bank riprap failure  
Top of head scarp 3m from downstream pipe column

Riprap Fair Failed downstream left bank but does not appear any different from last years inspection

Downstream left bank riprap failure

Monitor the riprap condition at the downstream left bank. The current load rating of L100 or 91 tonnes to continue.

1 Downstream left bank riprap condition
