CK-2074  
CK-2074B

## CHIPMUNK 8.3km

2020 Inspection

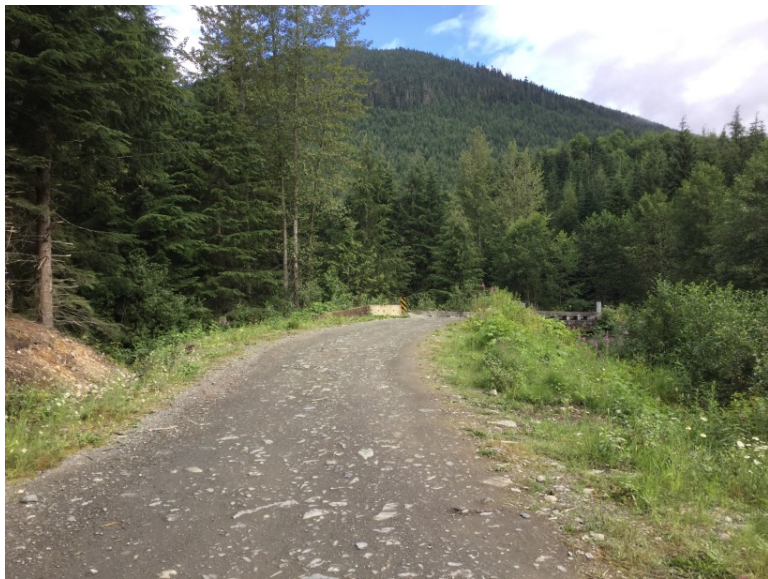
Approach from Right Bank when facing downstream

Bridge Ahead Signs  
Missing ☐ 0 ☒ 1 ☐ 2

| Repair Item | Repair Description |
|---|---|
| 1 Approach. Add Warning Signs. # of signs. Priority:Low | Post bridge ahead signs |

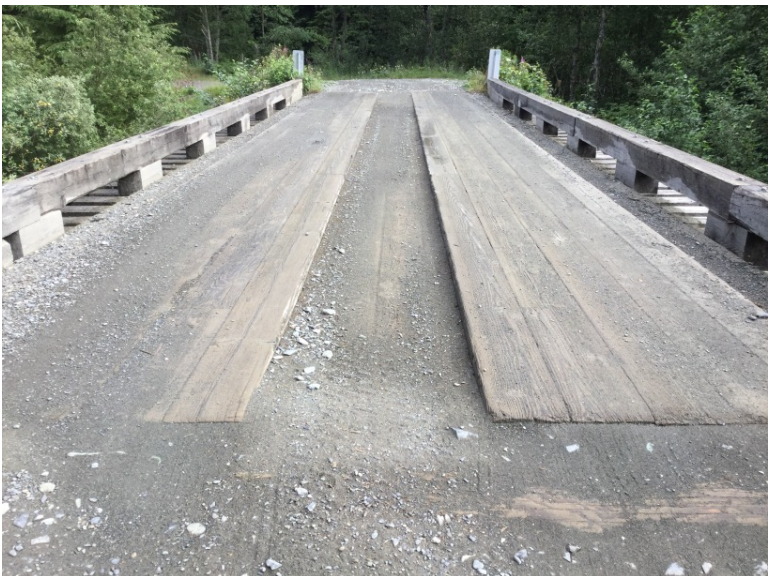
Deck to Girder Bolts      Poor      None

Overall Deck Condition      Fair

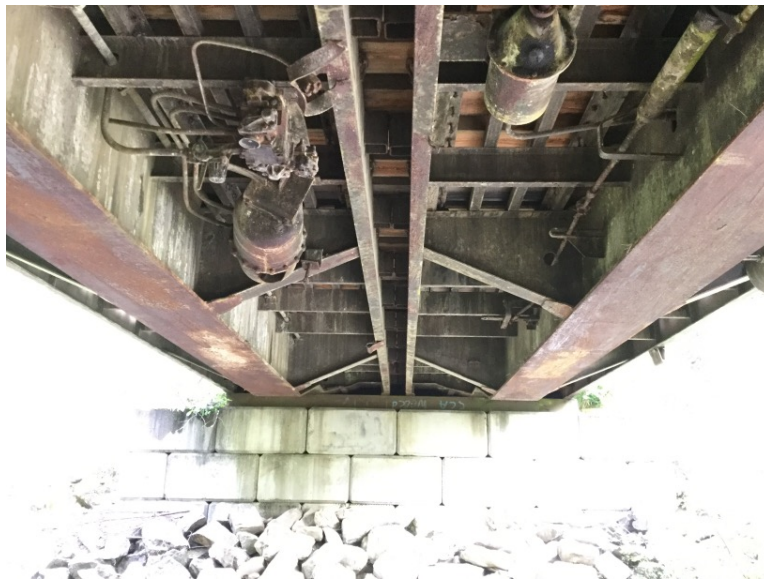
Superstructure

Girders Fair Railcars

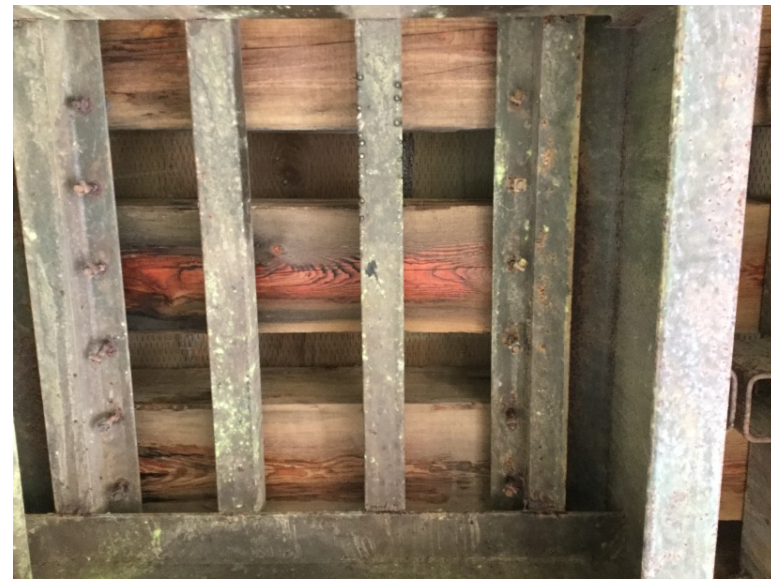
Deck from underneath

Sub Deck      Fair      Treated
