CK-2076

FOLEY 4.4km

2020 Inspection

| Crossing Name | Foley Creek |

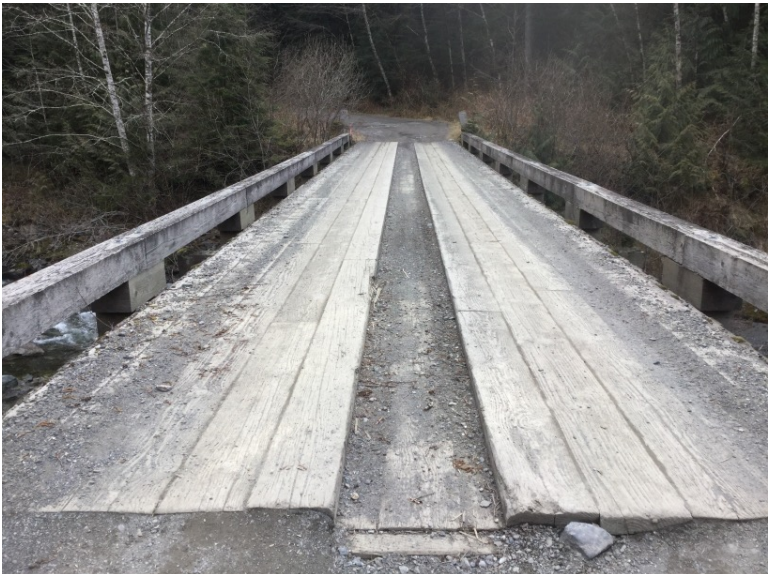
Deck

| Running Surface | Poor | Road does not appear to be maintained - large potholes |

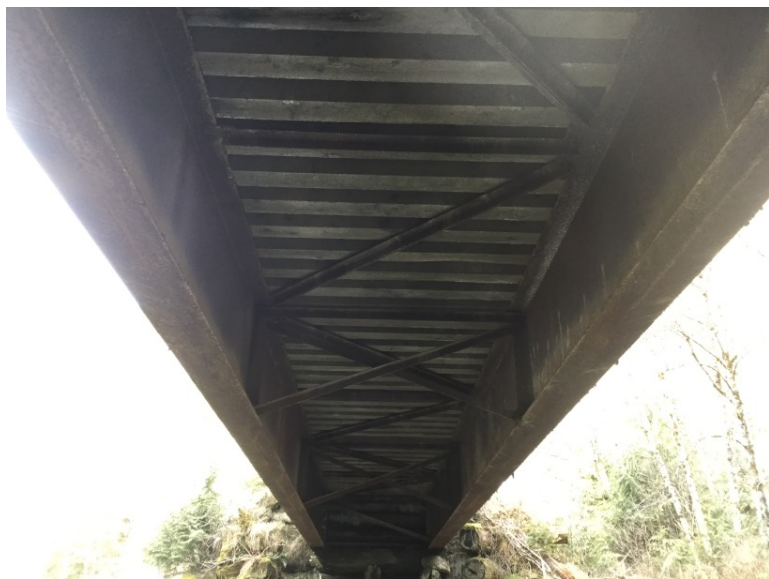
Superstructure

Girders Fair Light corrosion

Hardware Fair Light corrosion

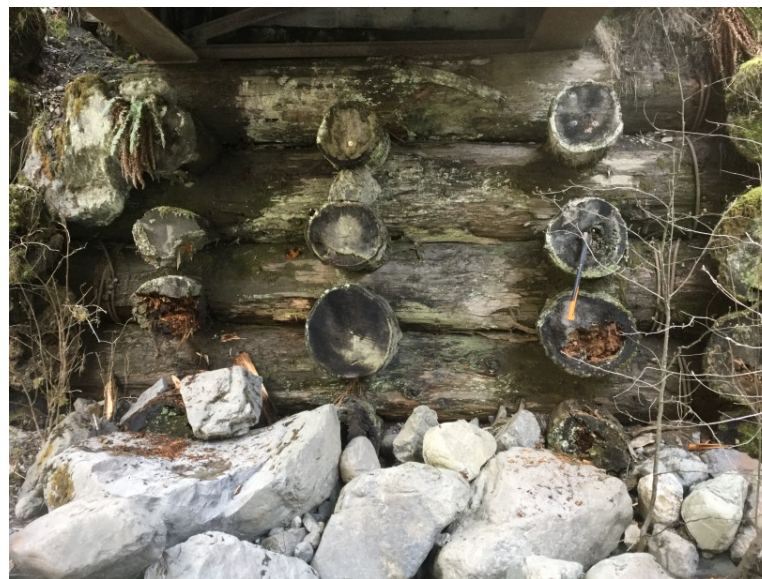
4x face logs with up to 60mm sap rot in locations

Fair to poor - 5x with end splitting and rot

Crib condition at left bank

Brush and grade approaches, and post bridge ahead signs. The crib is 34 years old and at the end of its industrial life. Monitor its condition and plan to replace soon. I recommend annual inspections be completed. The current load rating of L60 or 54 tonnes to continue.

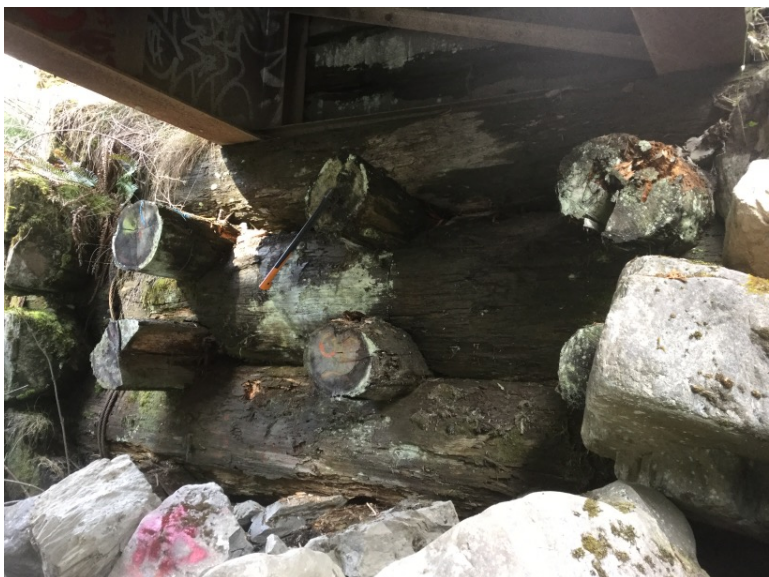
Crib condition at right bank
