CK-2077

AIRPLANE 0.1km

2020 Inspection

| Crossing Name | Foley Creek | | |

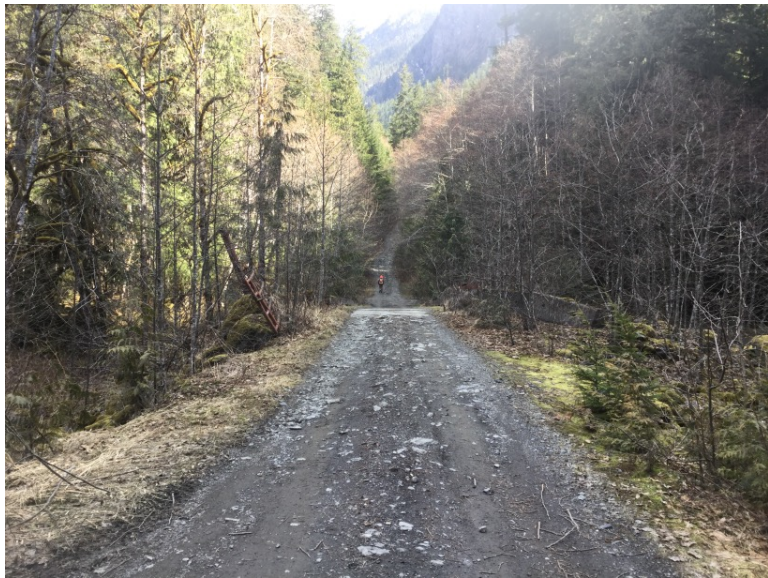
Approach from Left Bank when facing downstream

Road Surface Poor

Road requires maintenance

| Repair Item | Priority | Repair Description |
|---|---|---|
| 3 | Medium | Brush and grade approaches |

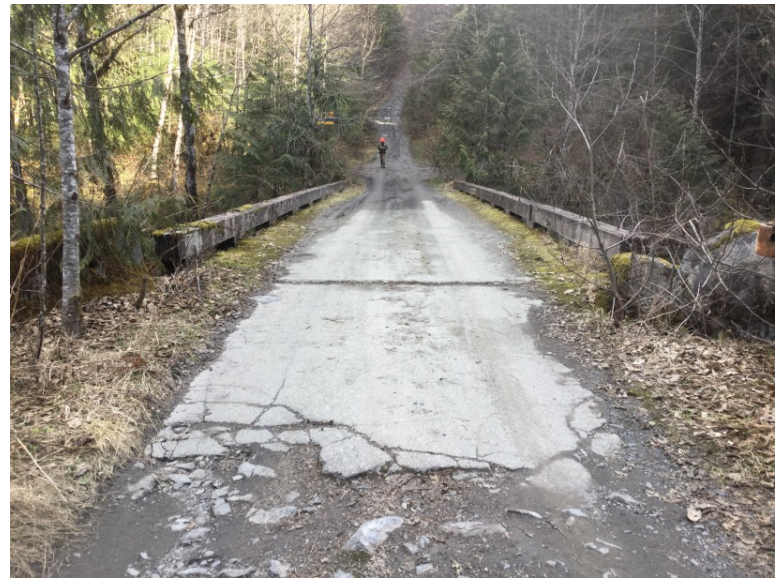
| Running Surface | Fair | sediment on deck |

| Concrete Deck | Unrated | Concrete slabs are covered with ashphalt overlay |

| Repair Item | Priority | Repair Description |
|---|---|---|
| 2 | Medium | Clean sediment from deck and post bridge ahead signs |

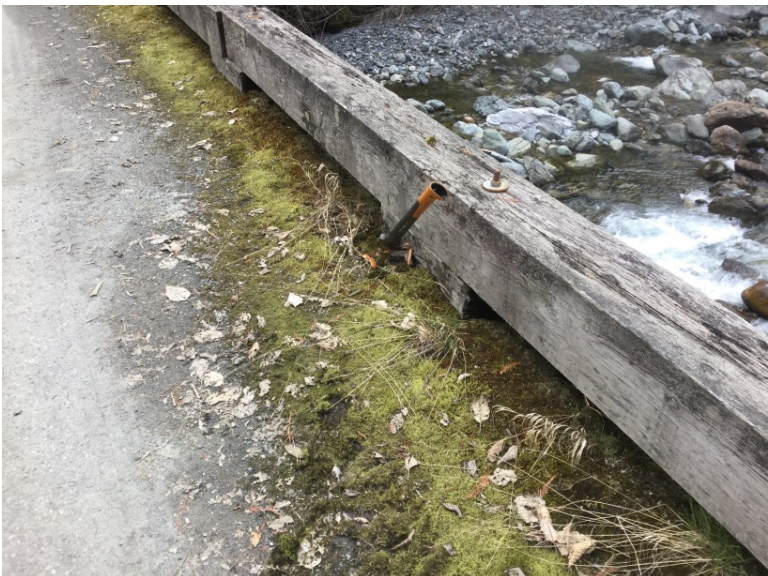
Guard Rail

| Curb Rail/Blocks/Posts | Poor | Rotten |

| Overall Deck Condition | Poor | Due to rail condition |

| Repair Item | Priority | Repair Description |
|---|---|---|
| 1 | High | Replace guardrail and risers |

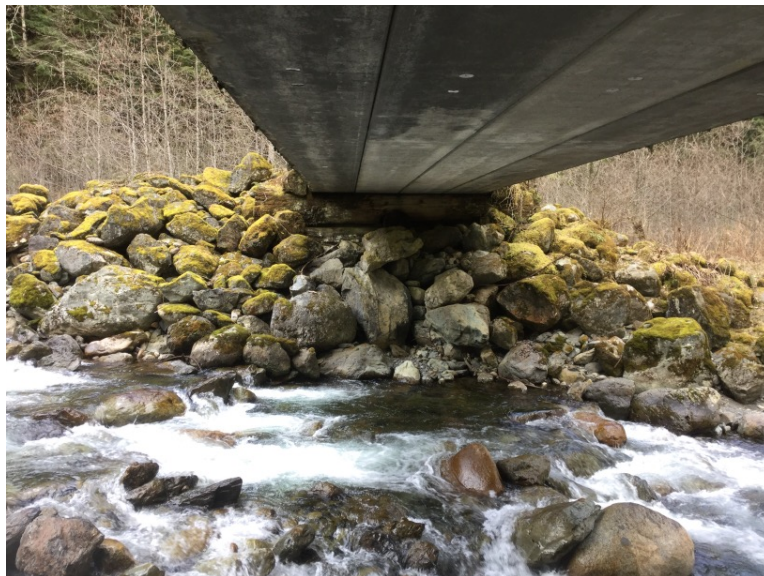
Left Bank Abutment when facing downstream

Log/Timber Cribs Fair

5x right bank, 3x left bank and both have Large diameter Cw with up to 30mm sap rot

| Item | Monitor Description | Frequency |
|---|---|---|
| 1 | crib condition | Every routine inspection |

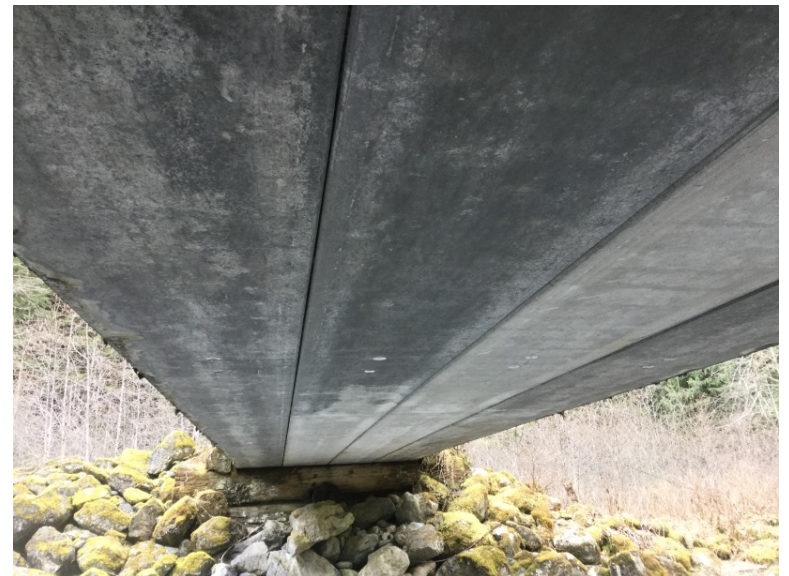
Superstructure

Girders Fair

4 concrete slabs - minor damage noted upstream left bank

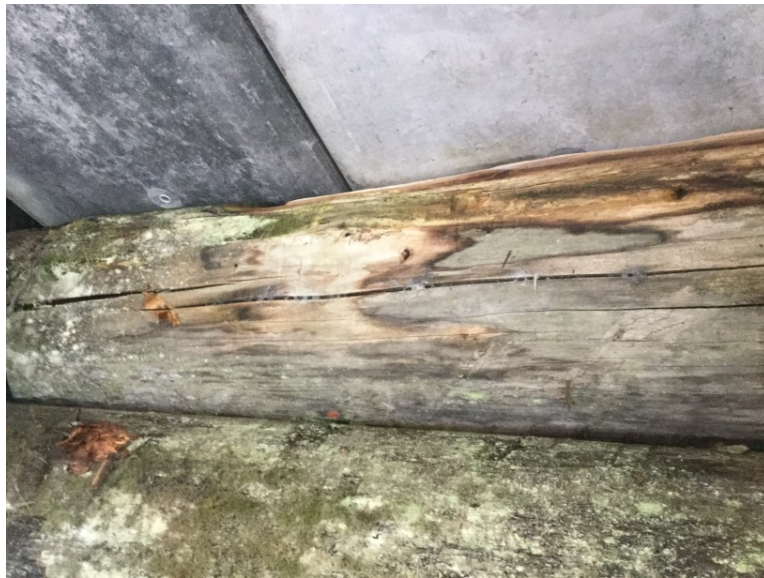
Horizontal crack on top face log right bank

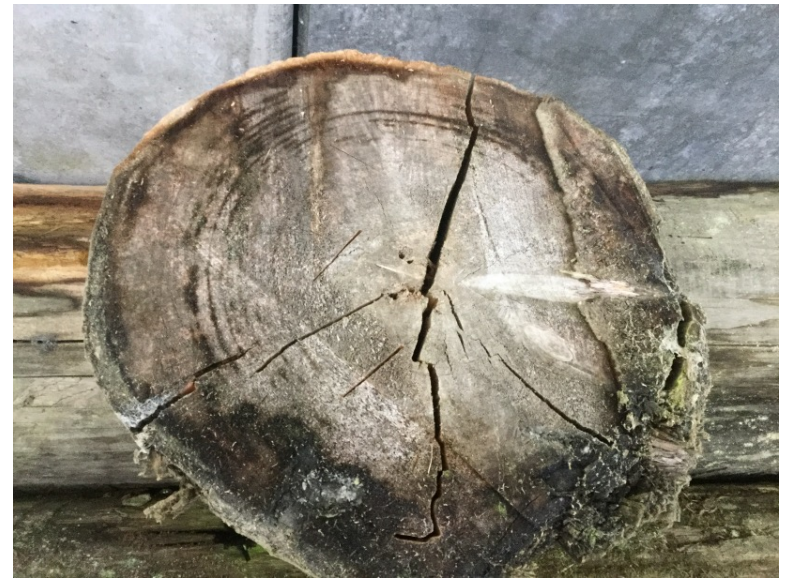
Tie Backs Fair

End splitting

End splitting on tieback log at right bank

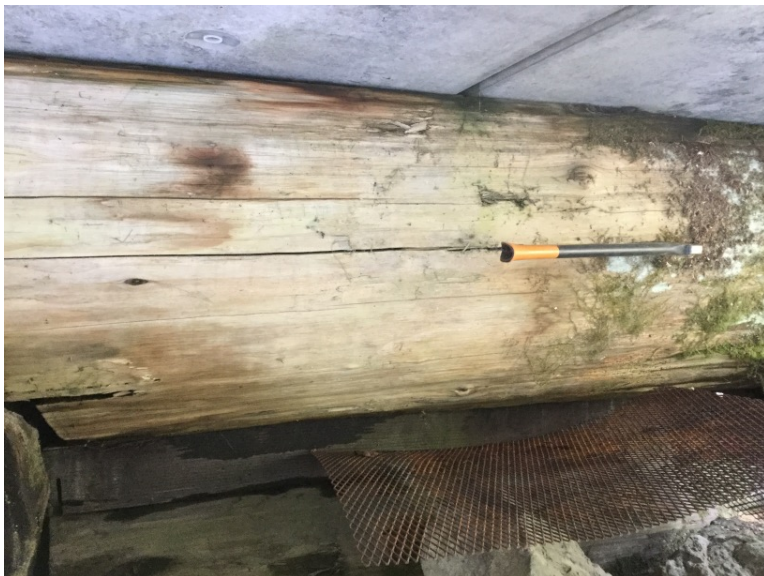
Horizontal crack on top face log left bank
