CK-2085

CHILLIWACK SOUTH 0.1km

2020 Inspection

| Crossing Name | Chilliwack River |

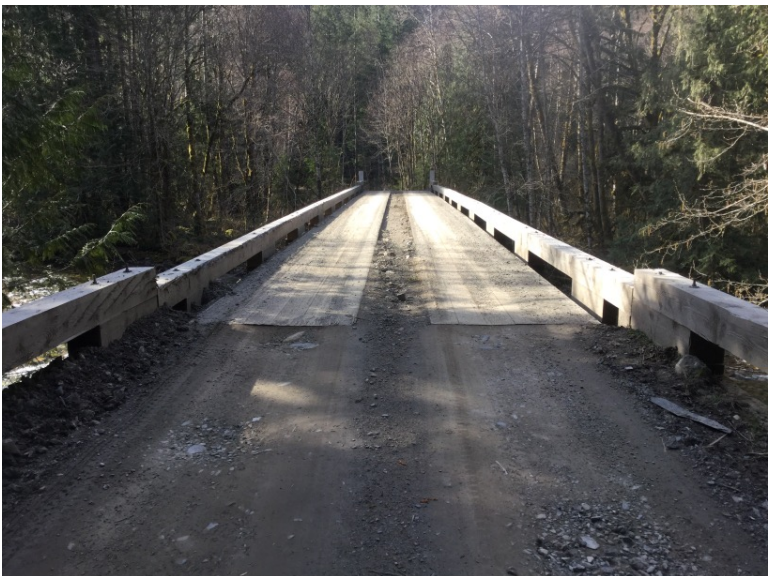
Overall Deck Condition      Good

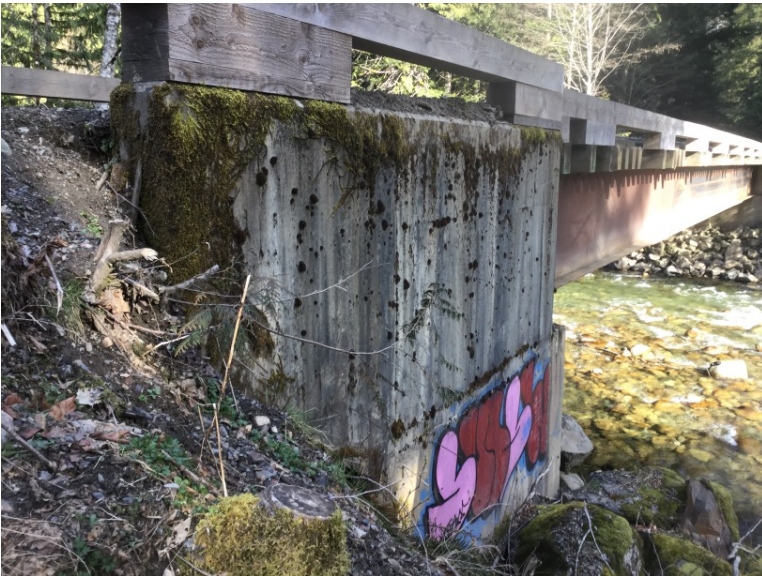
Upstream left bank wing wall

Wing Wall Good Both abutments

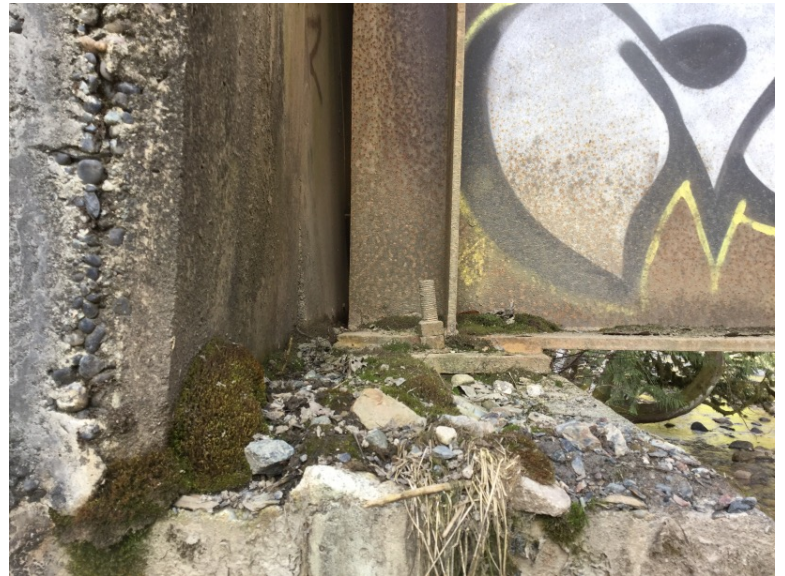
Bearings Fair Bearing bolts slightly bent to fill side on left abutment

Upstream left bank bearing bolt

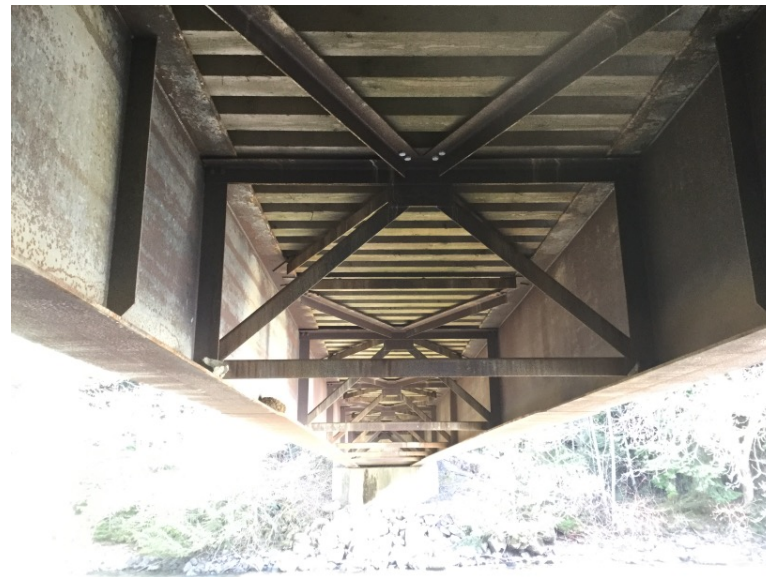
Girders Fair Light corrosion

Superstructure

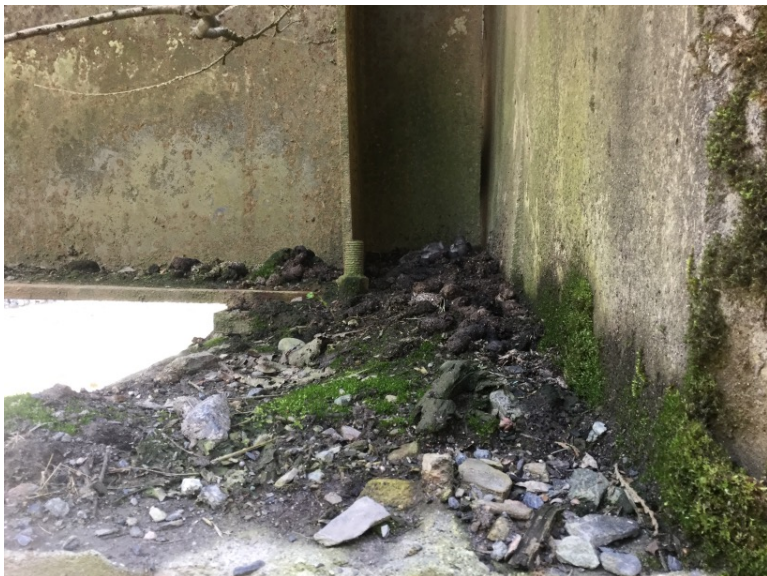
Downstream left bank bearing bolts

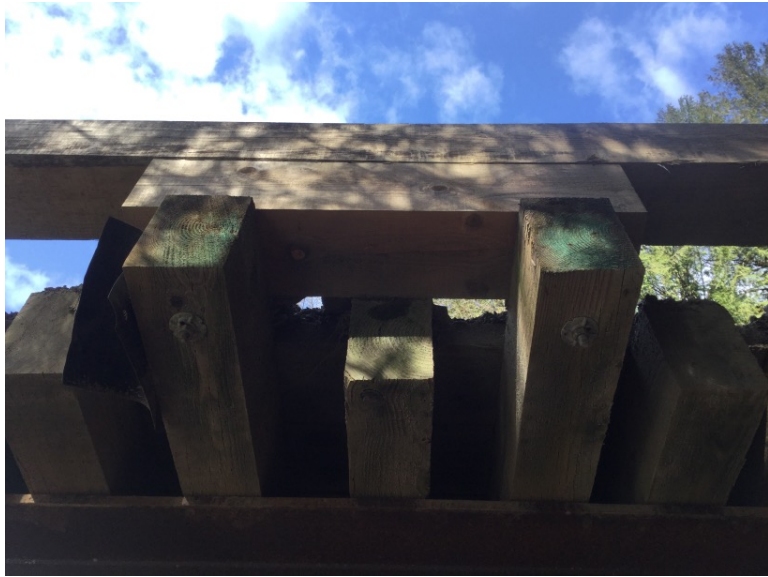
Timber risers span 3 ties

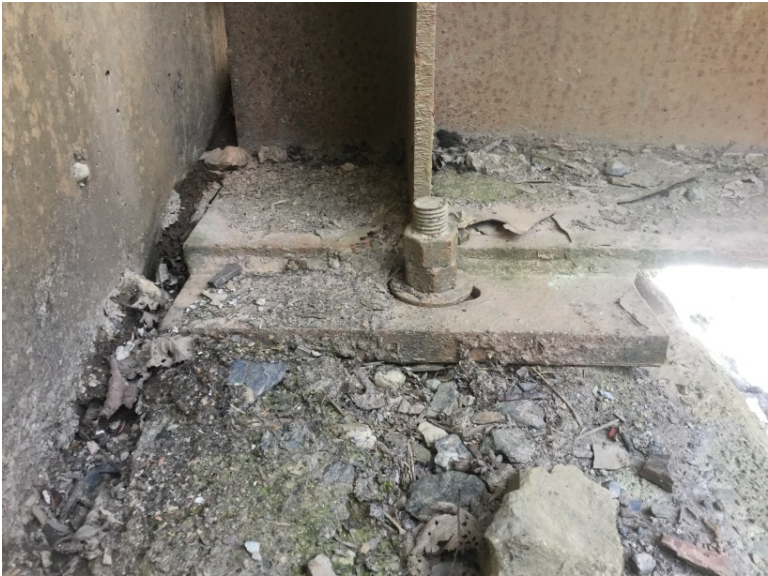
Slotted bearing holes at right bank
