CK-2087

DEWDNEY 5.2km

2020 Inspection

| Crossing Name | Cedar Flat Creek | | |

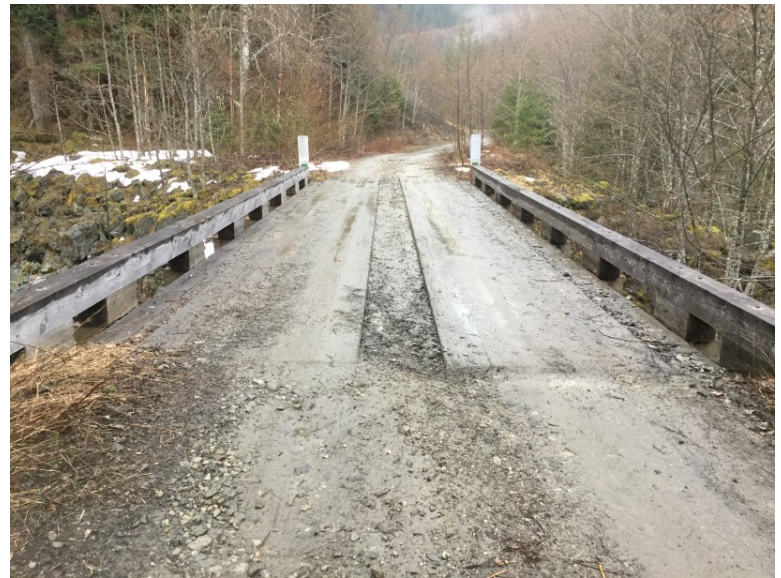
Deck

Fair

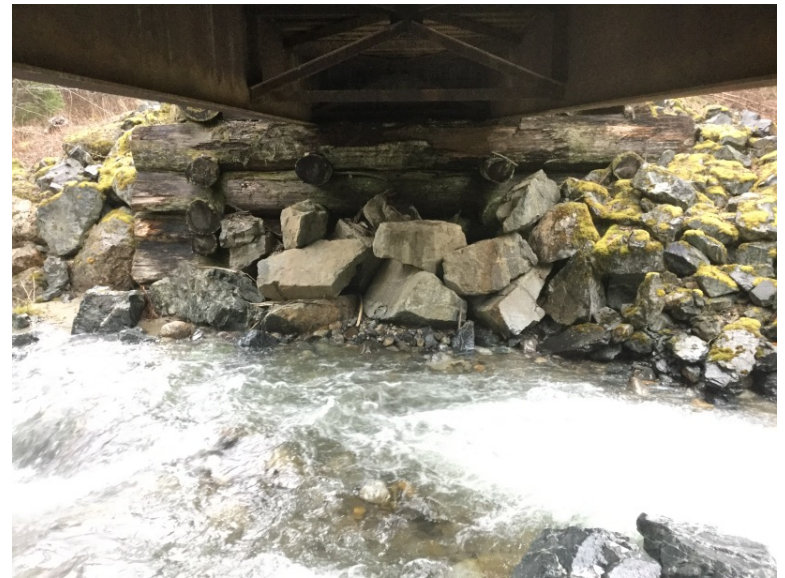
Right Bank Abutment when facing downstream

Log/Timber Cribs Fair 4x, closed face with up to 70mm sap rot

Tie Backs Fair Up to 70mm sap rot, split ends

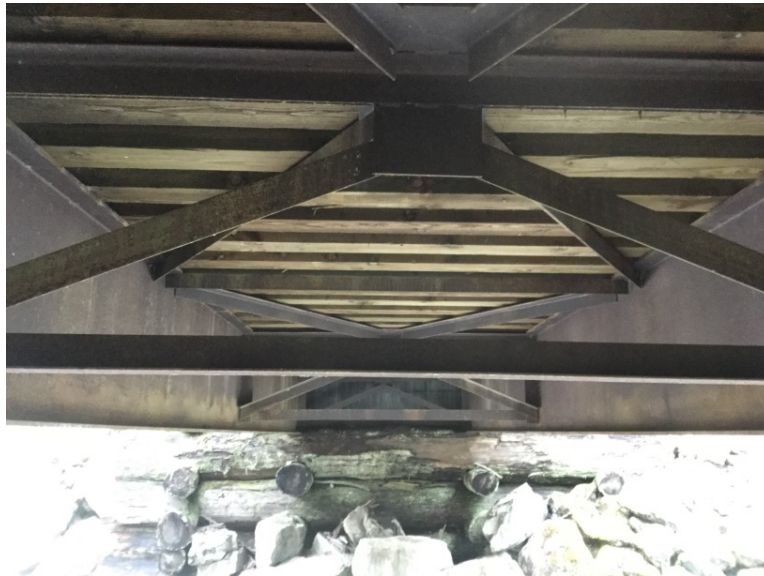
Superstructure

Girders Fair Minor corrosion

Diaphragms Fair 4 welded bays

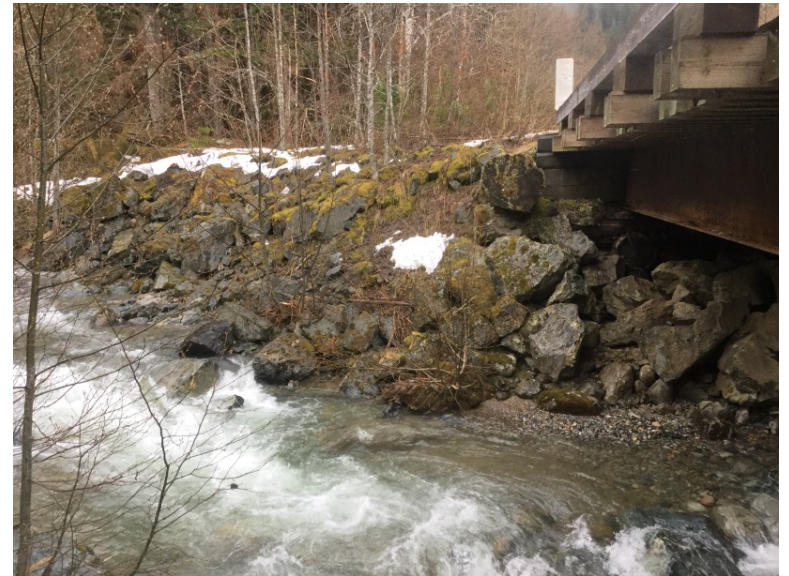
Riprap Fair Upstream left bank erosion noted

Upstream left bank riprap failure

| Item | Monitor Description | Frequency |
|---|---|---|
| 2 | Riprap scour | Routine Inspection |

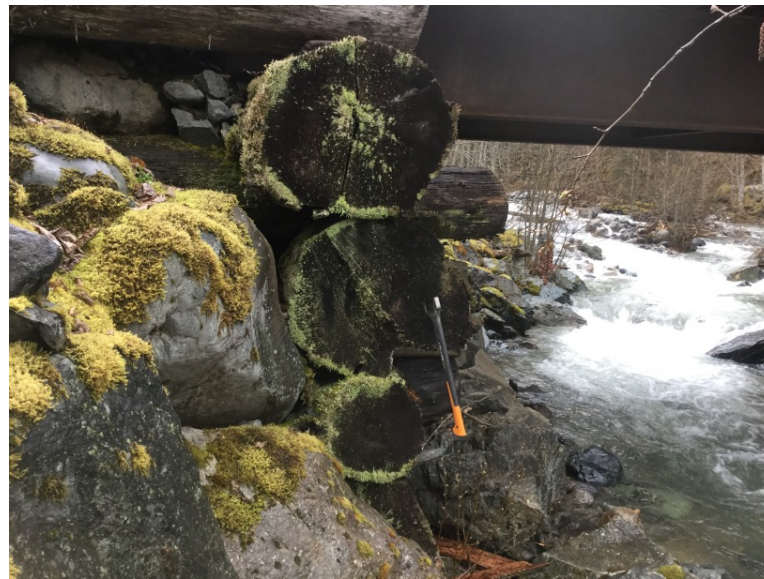
Bearings Fair Downstream right bank slightly lower than upstream - monitor condition

Downstream right bank face log ends

| Item | Monitor Description | Frequency |
|---|---|---|
| 1 | Crib (face log and tieback log) condition | Routine Inspection |
