CK-2092  
CK-2092

## FLORENCE LAKE 3.9km

2020 Inspection

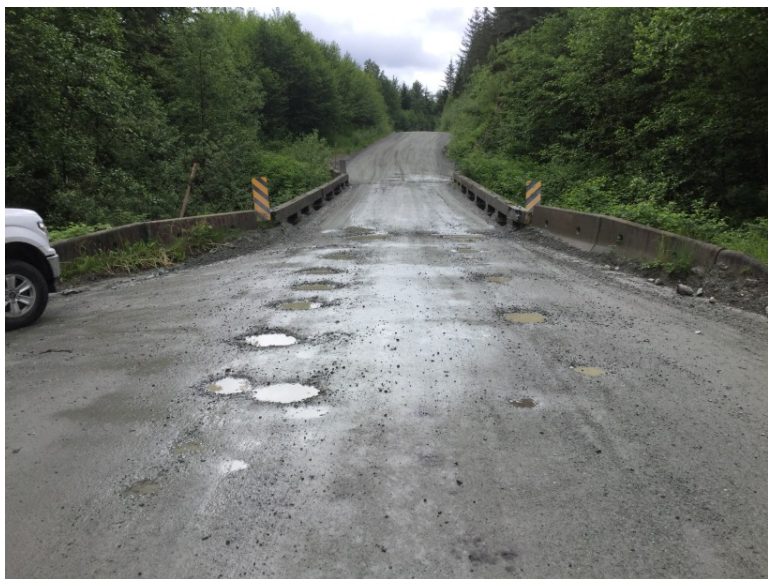
Approach from Left Bank when facing downstream

Road Surface Poor Potholes at both approaches

| Repair Item | Repair Description |
|---|---|
| 2 Approach. Approach surfacing grading. m.<br>Priority:Medium | Grade approaches |

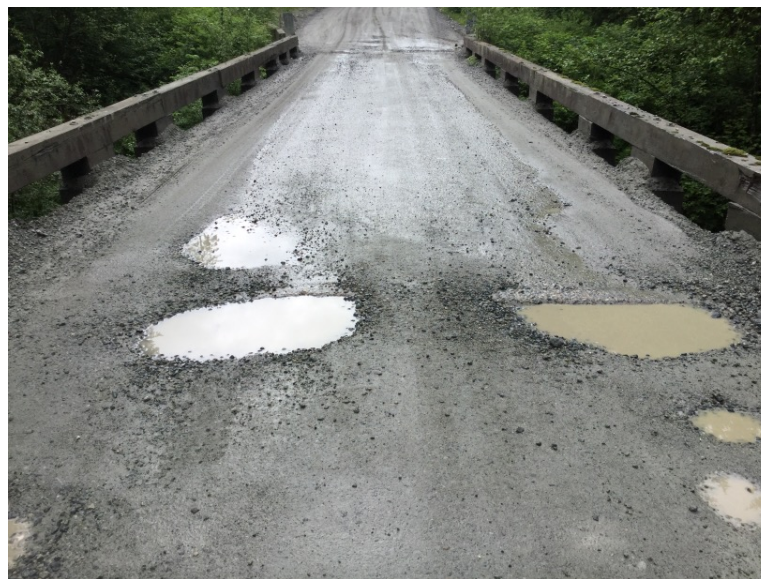
Overall Deck Condition      Poor      Due to rail condition

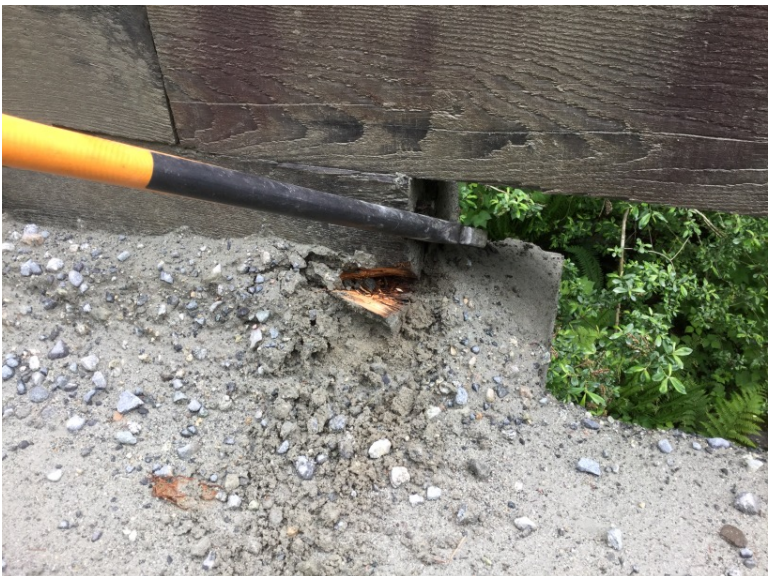
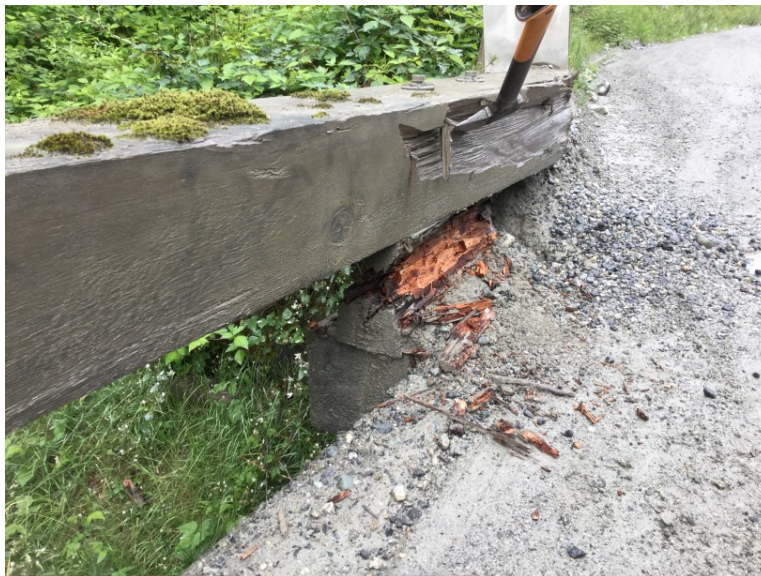
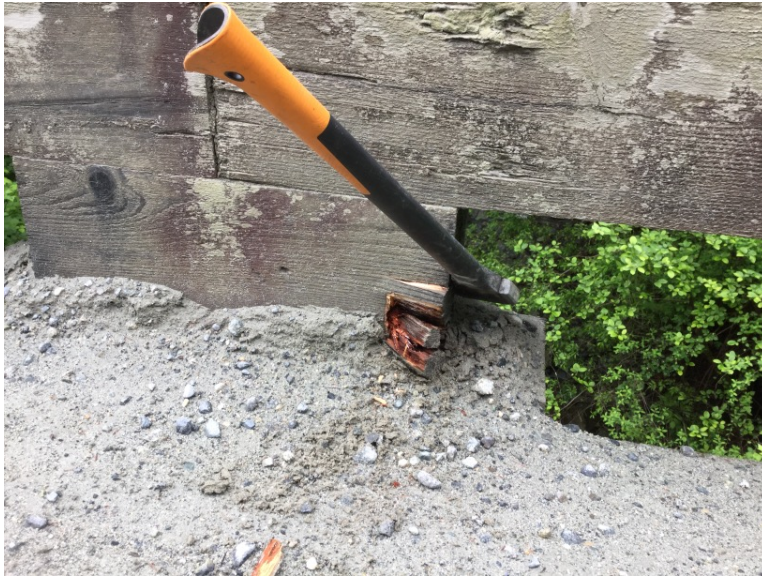
Curb Rail/Blocks/Posts      Poor      Rotten

Hardware      Poor      Loose rail bolts

Replace the guardrail, risers and blocks. Grade approaches. The current load rating of L75 or 68 tonnes to continue.

| Repair Item | Repair Description |
|---|---|
| 1 Structure. Full Curb Replacement. .<br>Priority:Medium | Replace guardrail, risers and blocks |

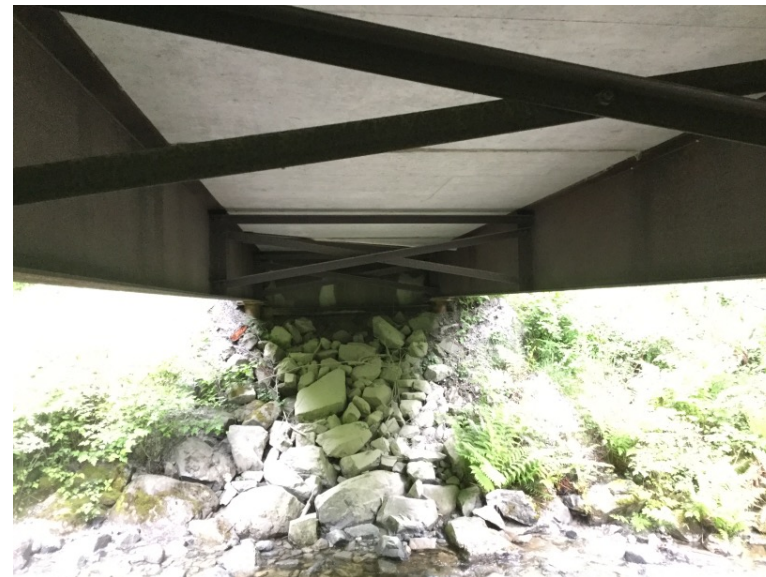
Superstructure

Girders Good Minor corrosion noted
