CK-2094  
CK-2094

## FLORENCE LAKE 7.5km

2020 Inspection

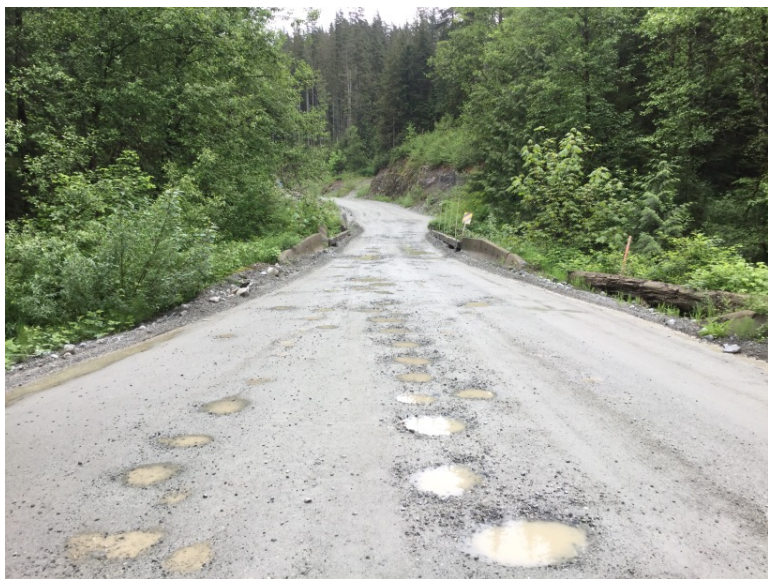
Approach from Right Bank when facing downstream

Road Surface Poor Potholes on approaches and over deck

| Repair Item | Repair Description |
|---|---|
| 3 Medium | Grade approaches |

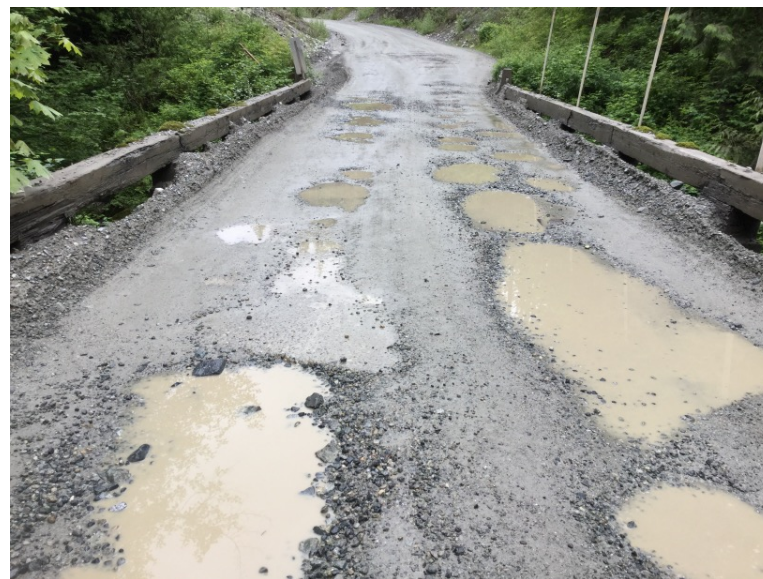
Running Surface      Poor      Potholes on approaches and over deck

Overall Deck Condition      Poor      Due to rail condition

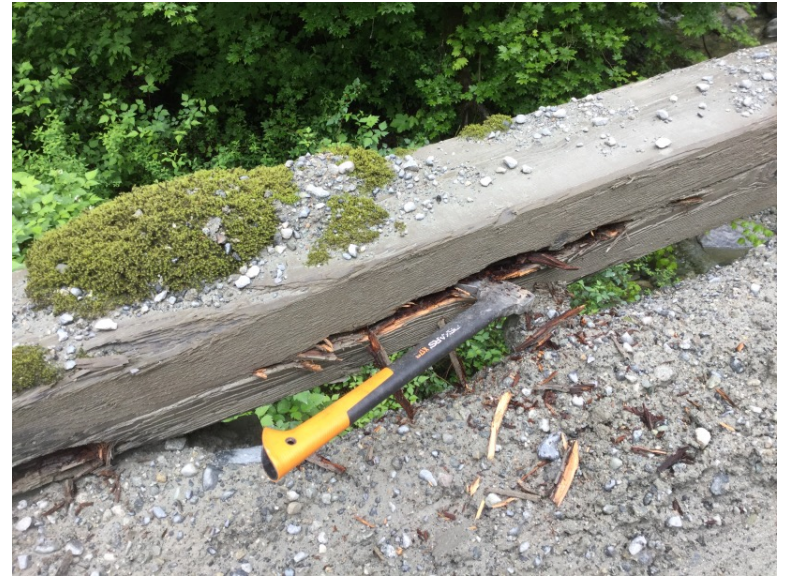
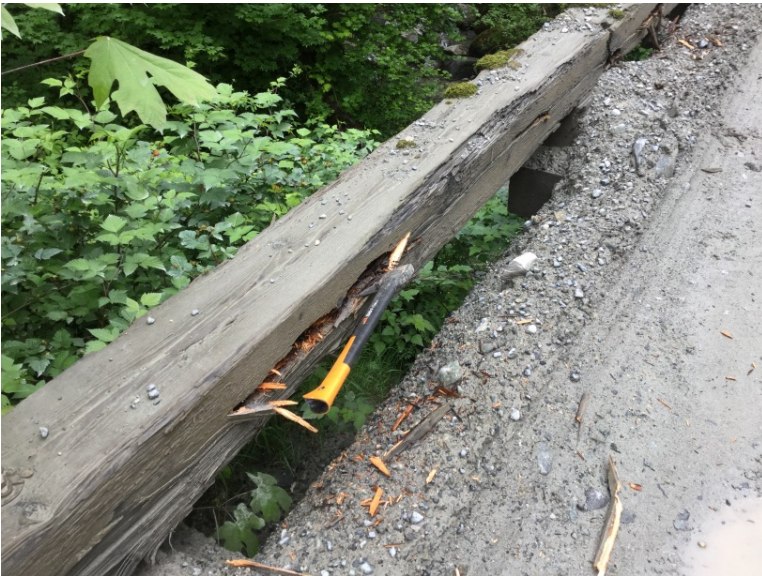
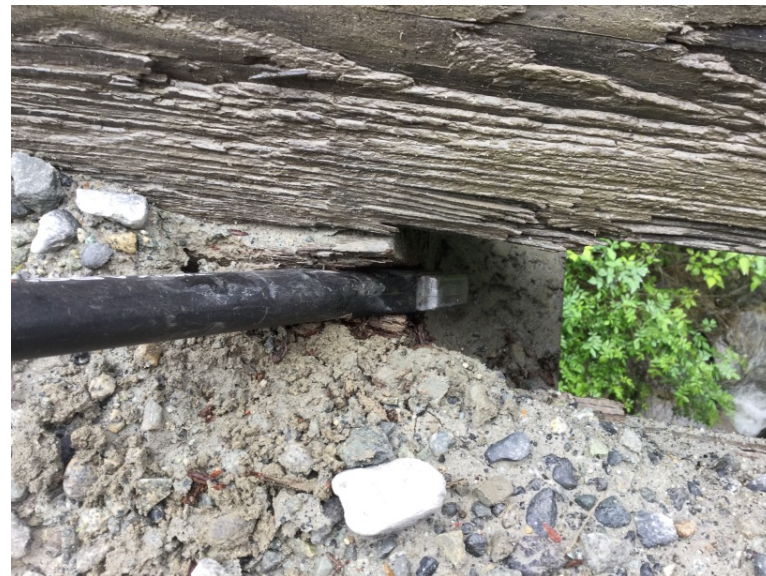
Guard Rail

Curb Rail/Blocks/Posts      Poor      Rotten

| Repair Item | Repair Description |
|---|---|
| 2 Structure. Full Curb Replacement. .<br>Priority:Medium | Replace guardrail, risers and blocks and replace grading strip |

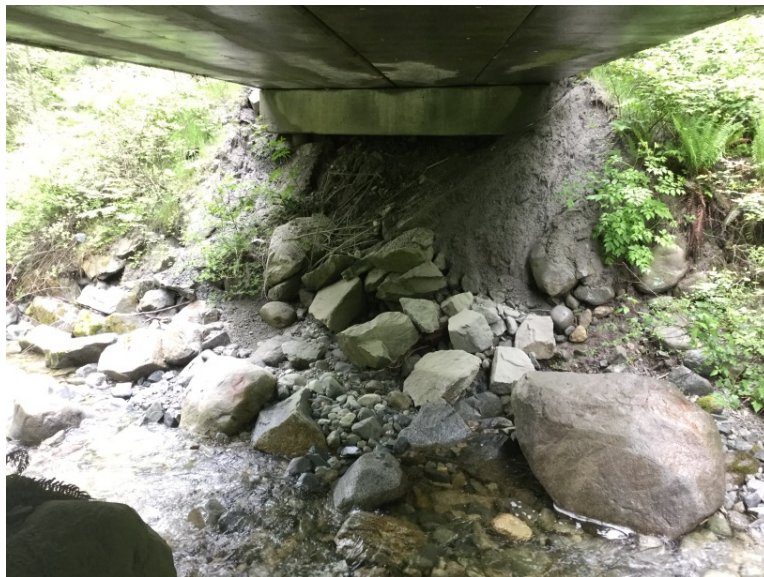
Right Bank Abutment when facing downstream

Riprap Fair Very little at either abutment but still functional

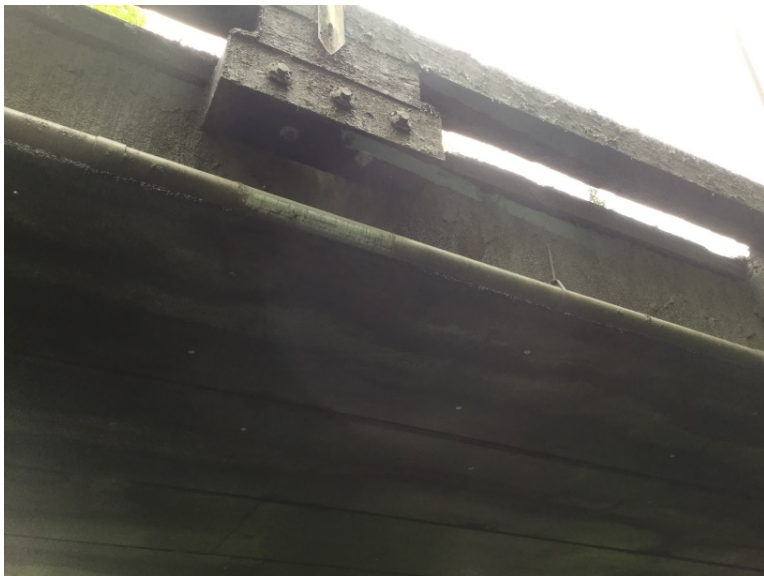
Utilities located at downstream end
