CK-2095  
CK-2095

## FLORENCE LAKE 9.2km

2020 Inspection

Date of Inspection 2020-05-26 10:53:33 AM

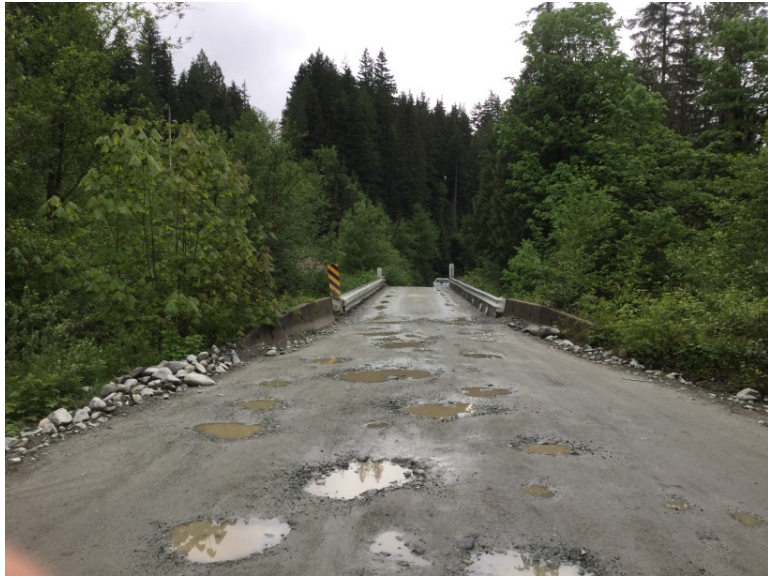
Approach from Right Bank when facing downstream

| Repair Item | Repair Description |
|---|---|
| 1 Approach. Approach surfacing grading. m. Priority:Low | Grade approaches |

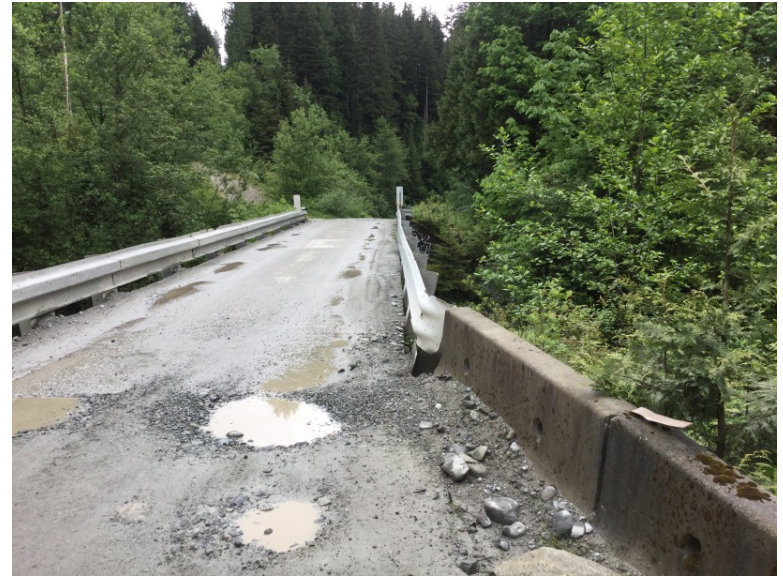
Curb Rail/Blocks/Posts      Fair      Different style W beam with damage noted throughout; however all still functional

Guard Rail condition at downstream right bank

| Repair Item | Repair Description |
|---|---|
| 3 Structure. Full Curb Replacement. . Priority:Medium | Replace all guardrail with HSS |

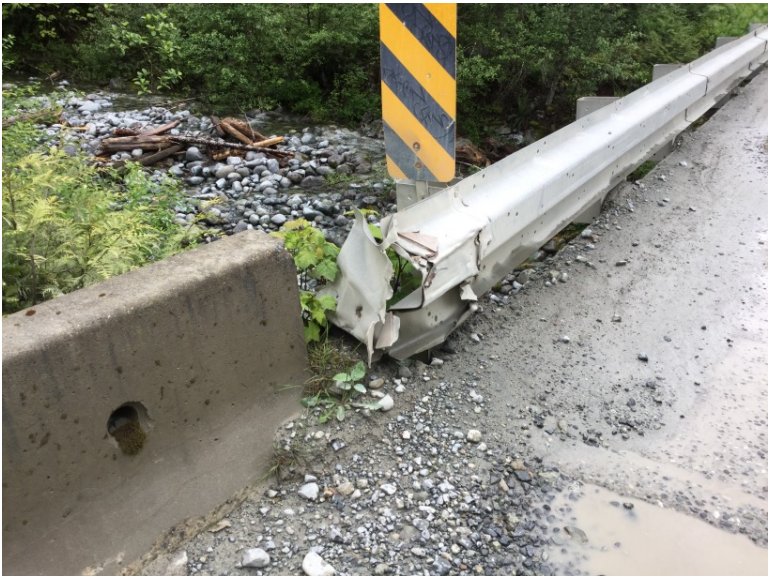
Guard Rail condition at upstream right bank

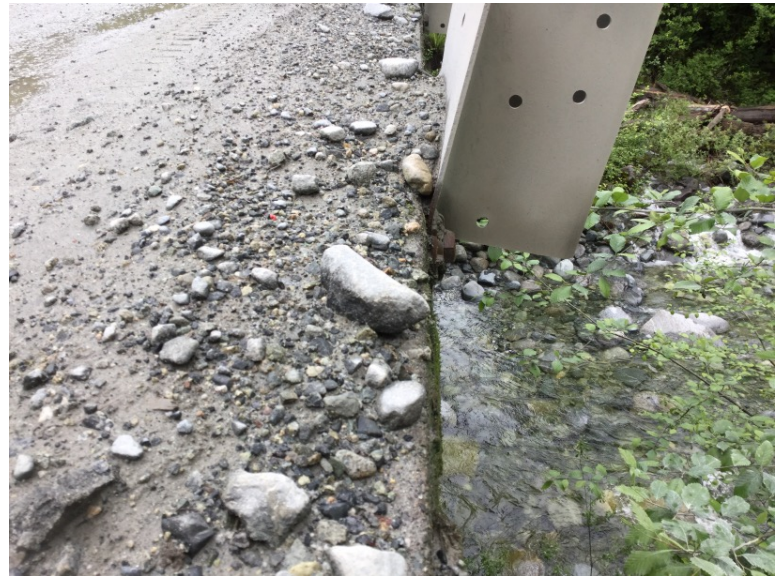
Guard Rail at downstream right bank

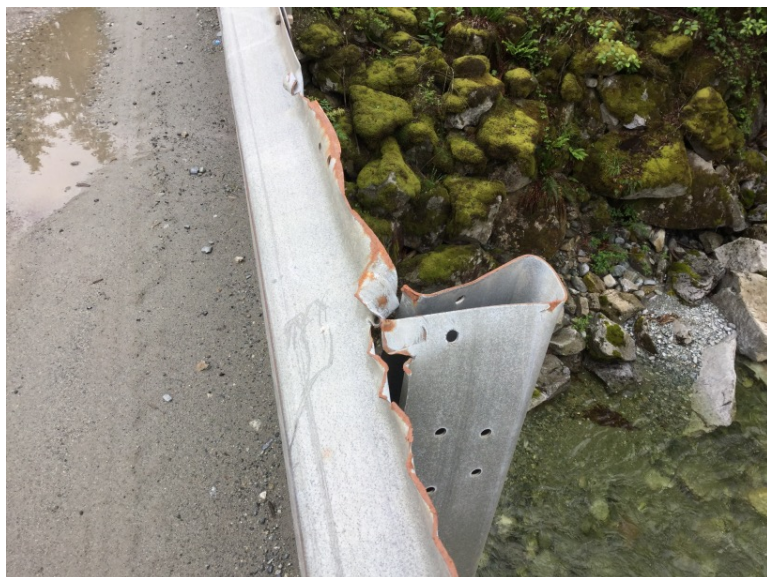
Guard Rail condition at upstream near center span

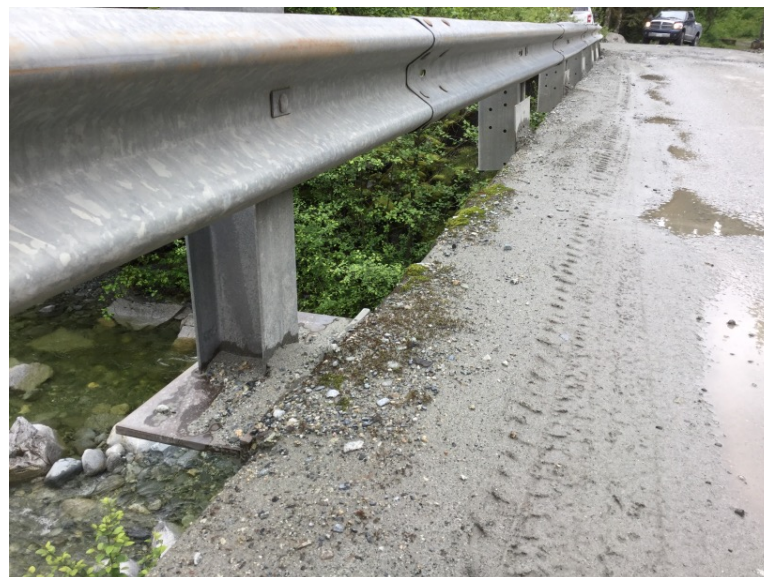
Downstream risers are different at downstream end

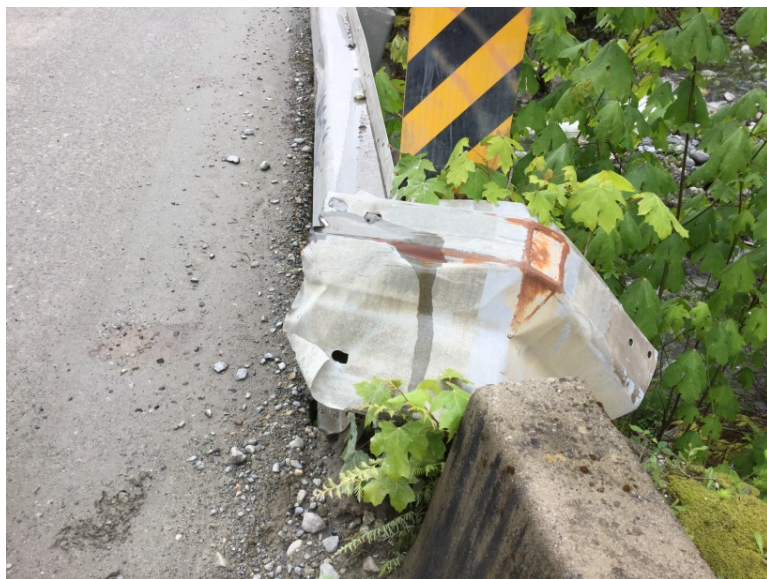
Guardrail damage at upstream left bank

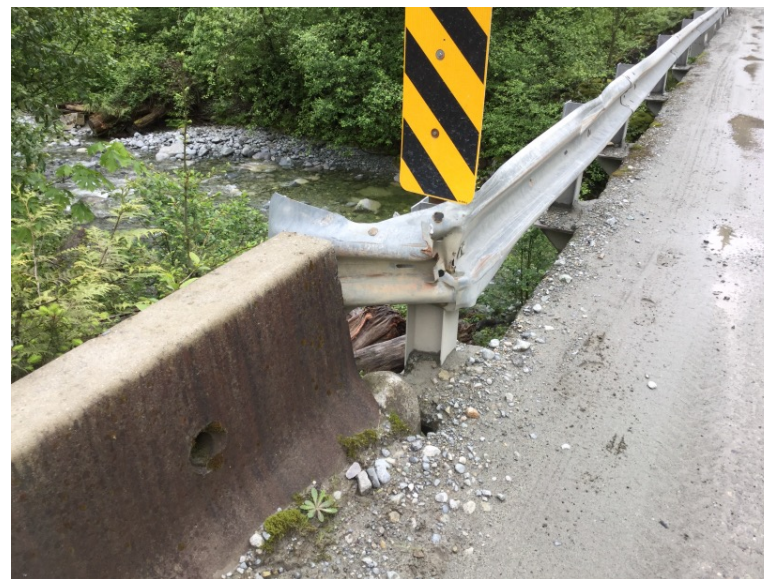
Guardrail condition at downstream left bank

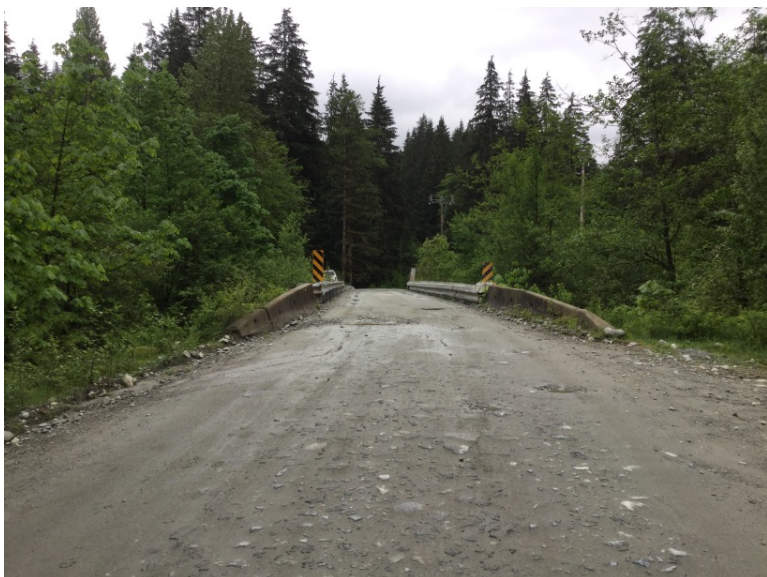
Approach from Left Bank when facing downstream

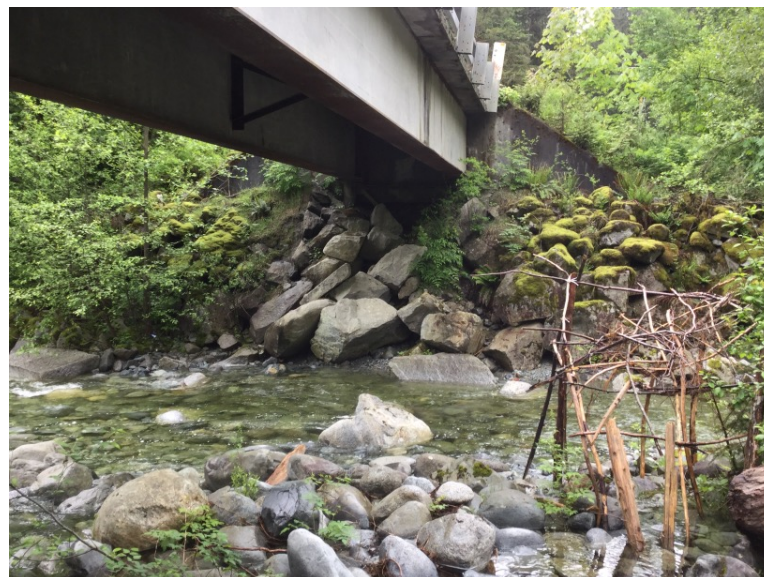
Large boulders but not well graded or keyed together

Right Bank Abutment when facing downstream

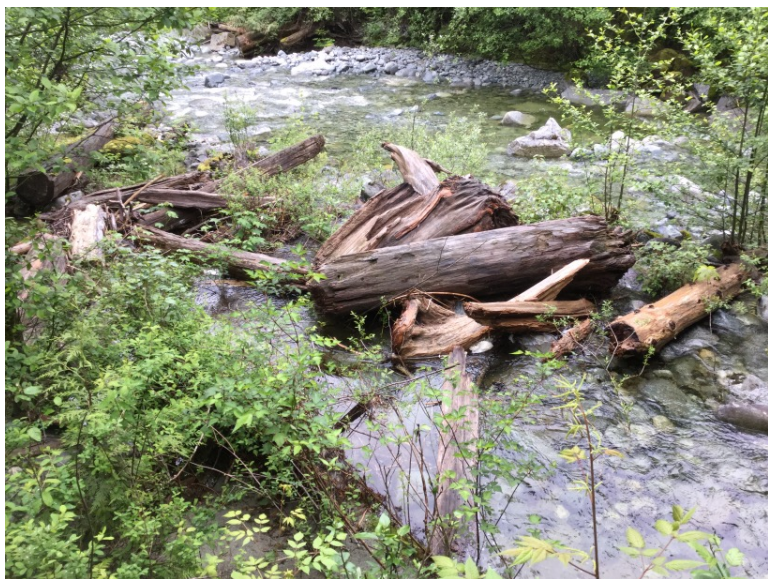
Debris accumulations throughout stream

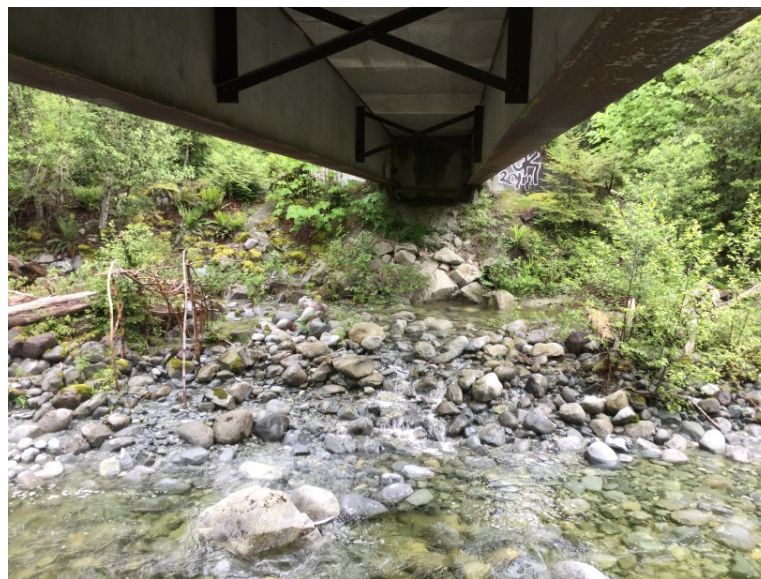
Left Bank Abutment when facing downstream
