CK-2097  
CK-2097

FLORENCE LAKE 13.2km

2020 Inspection

Structure Class Permanent Bridge

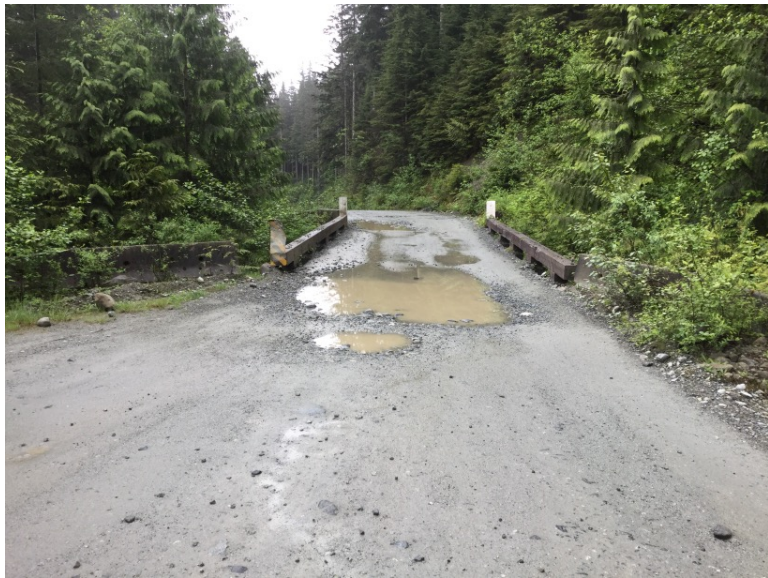
Approach from Left Bank when facing downstream

Road Surface Poor Large potholes at both approaches

| Repair Item | Repair Description |
|---|---|
| 2 Approach. Area/sight line brushing. m². Priority:Low | Brush approaches |
| 3 Approach. Approach surfacing grading. m.<br>Priority:Medium | Grade approaches |

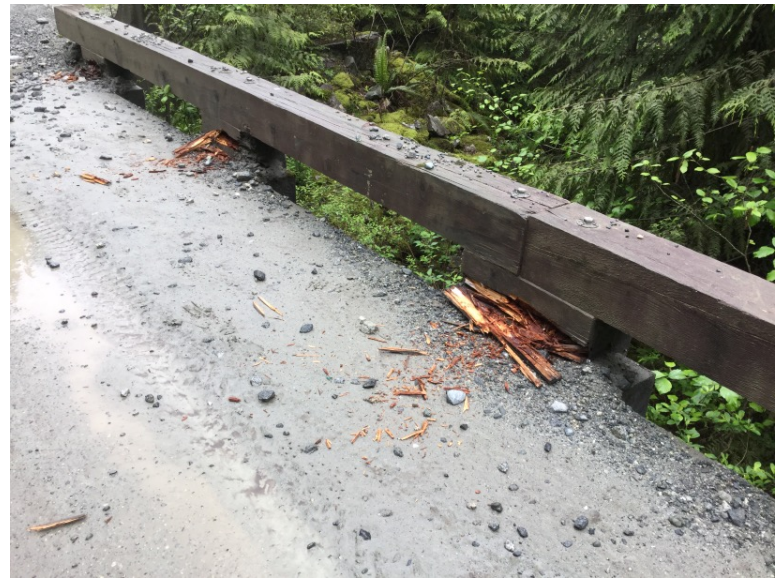
Guard Rail

Curb Rail/Blocks/Posts      Poor      Rotten

Hardware      Poor      Loose rail bolts

| Repair Item | Repair Description |
|---|---|
| 1 Structure. Full Curb Replacement. .<br>Priority:Medium | Replace guardrail, risers and blocks |

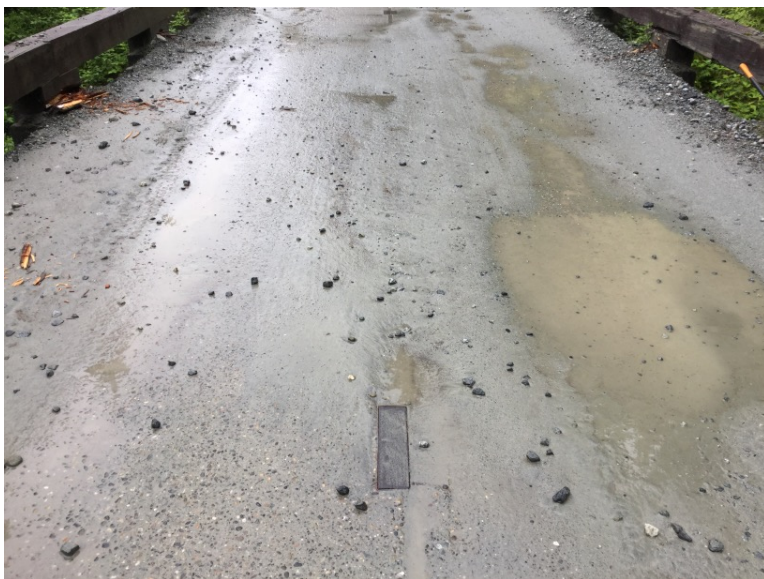
Shear connectors

Welded/grouted  
shear connectors **Good** **Welded**

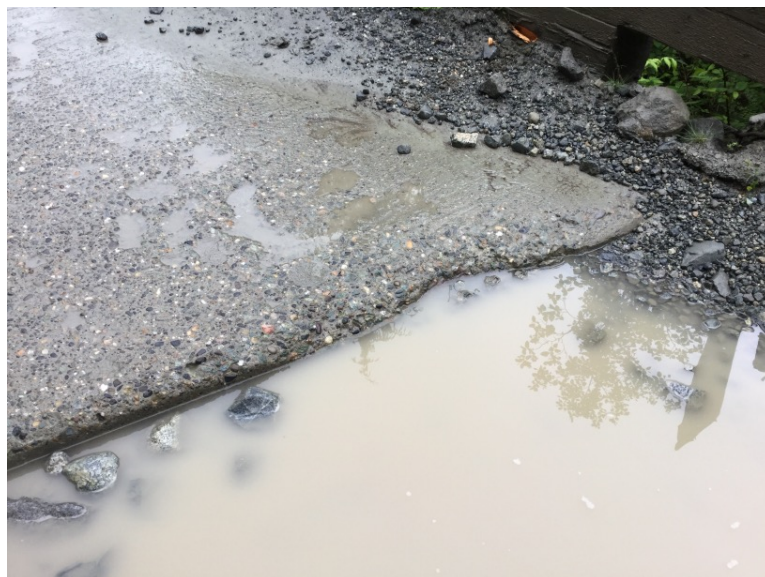
Concrete wear at downstream right bank
