CK-2098  
CK-2098

## FLORENCE LAKE 13.6km

2020 Inspection

| Crossing Name | Sayers Creek |

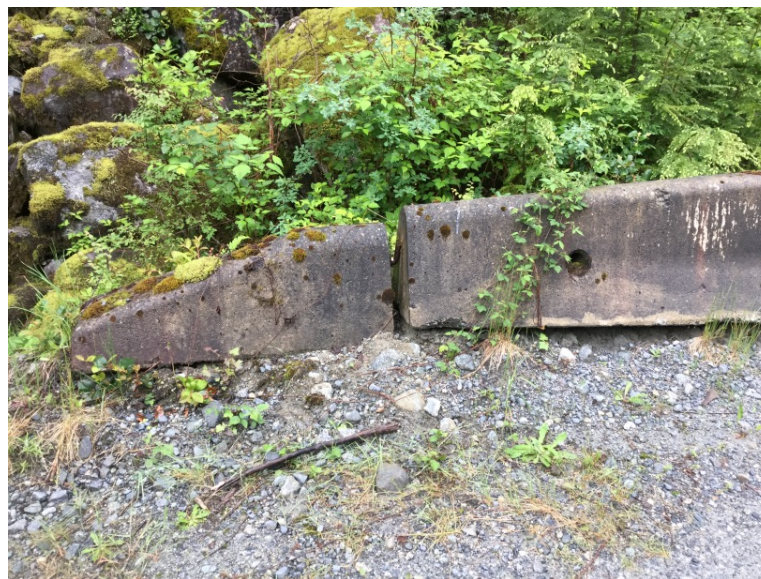
Reattach bullnoses at right bank and add to upstream left bank barriers

Bullnoses not attached at right approach

| Repair Item | Repair Description | |
|---|---|---|
| 2 Approach. Approach fenders (re-Install). # of units. Priority:Low | Reattach bull noses at right approach and add bull nose to upstream left approach | |

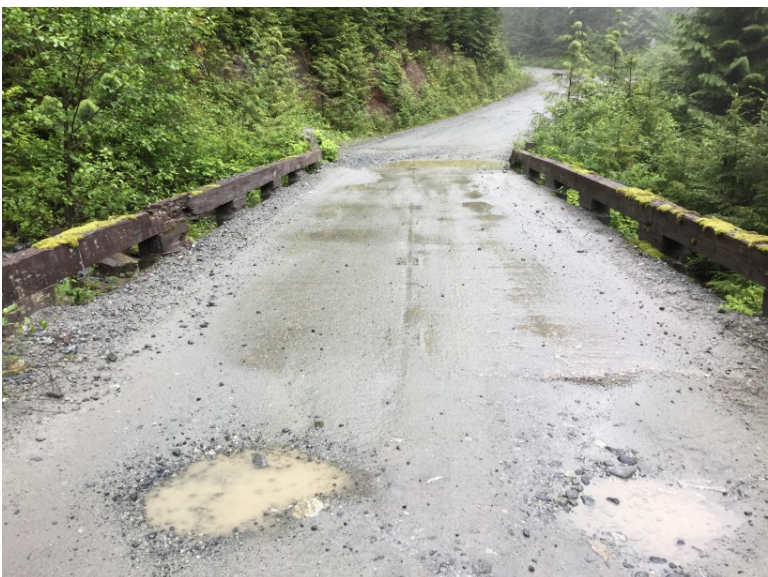
Running Surface      Fair

Concrete Deck      Good

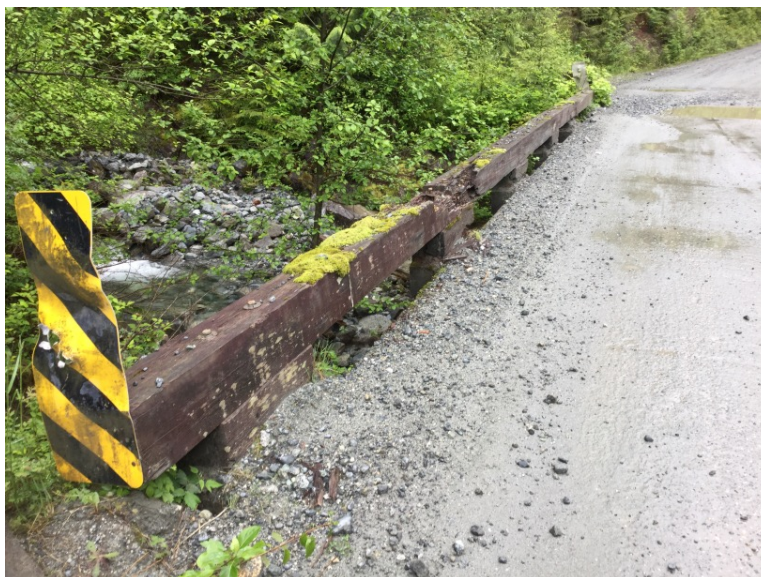
Guard Rail

Curb Rail/Blocks/Posts      Poor      Rotten

Hardware      Poor      Loose rail bolts

Overall Deck Condition      Poor      Due to rail condition

| Repair Item | Repair Description | |
|---|---|---|
| 1 Structure. Full Curb Replacement. .<br>Priority:Medium | Replace guardrail, risers and blocks | |

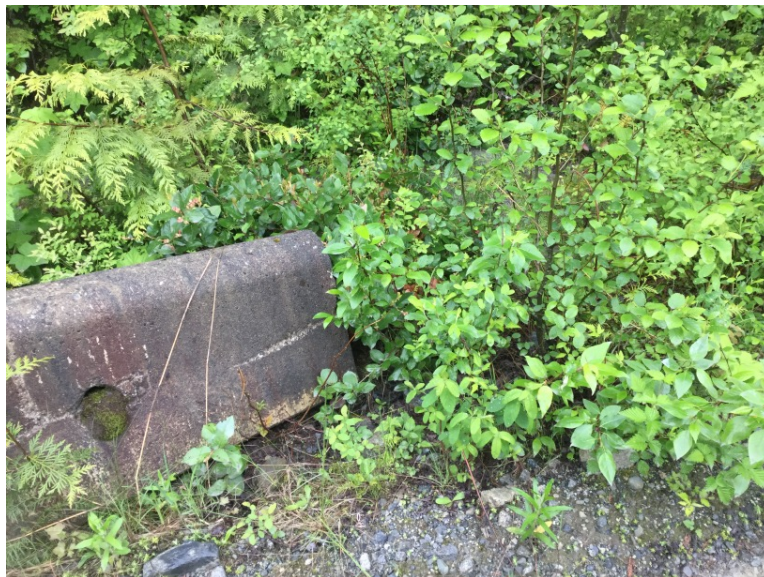
Missing bull nose at upstream left approach

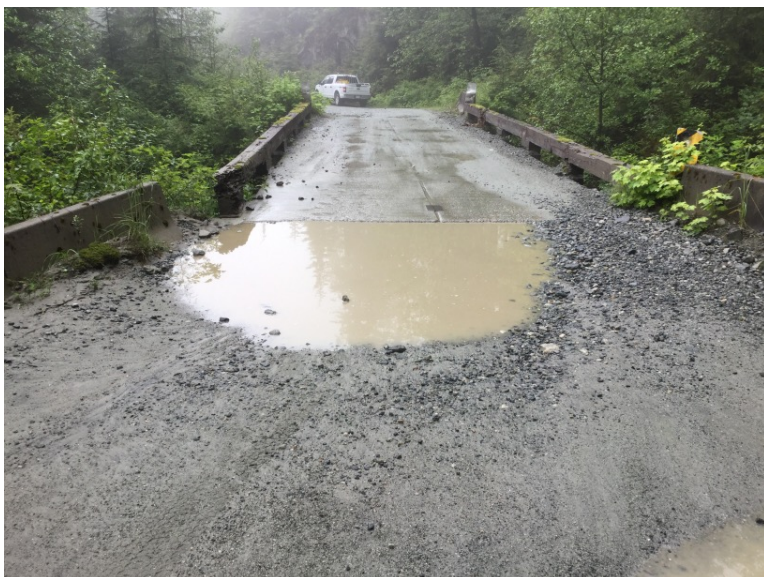
Road Surface Poor

Large pothole at left approach

| Repair Item | Repair Description | |
|---|---|---|
| 3 Approach. Approach surfacing grading. m.<br>Priority:Medium | Grade and grade approaches | |

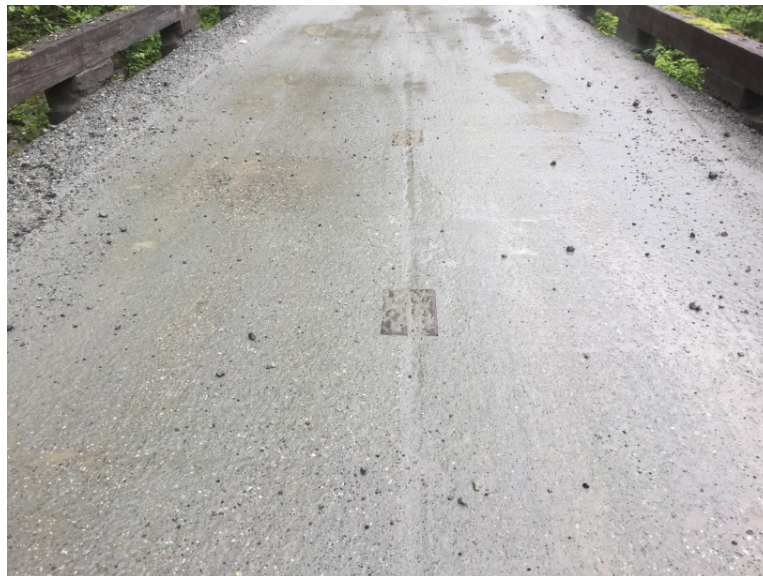
Shear connectors

Welded/grouted  
shear connectors **Good** **Welded**
