CK-2099  
CK-2099

FLORENCE LAKE 13.8km

2020 Inspection

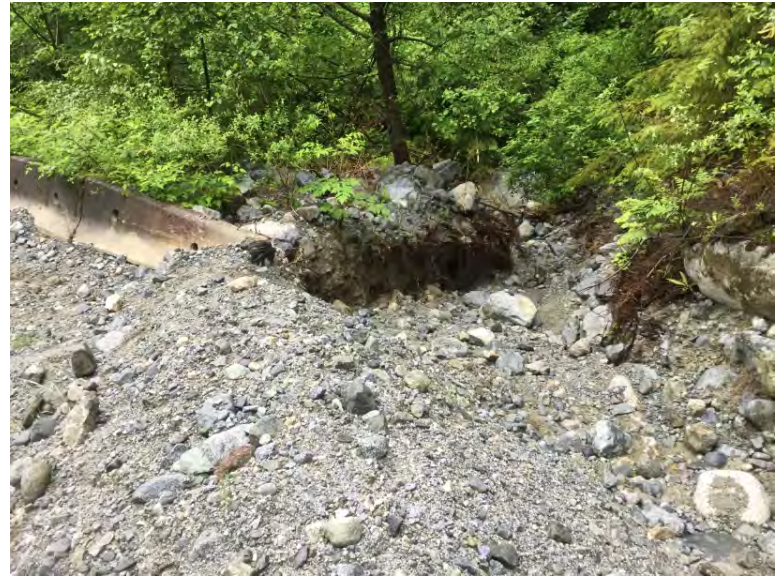
Comments Suspect that when CK-2100 plugged excess water came down road/ditch at left approach and added to heavy flows causing significant riprap erosion at both abutments

Upstream left approach ditch scour

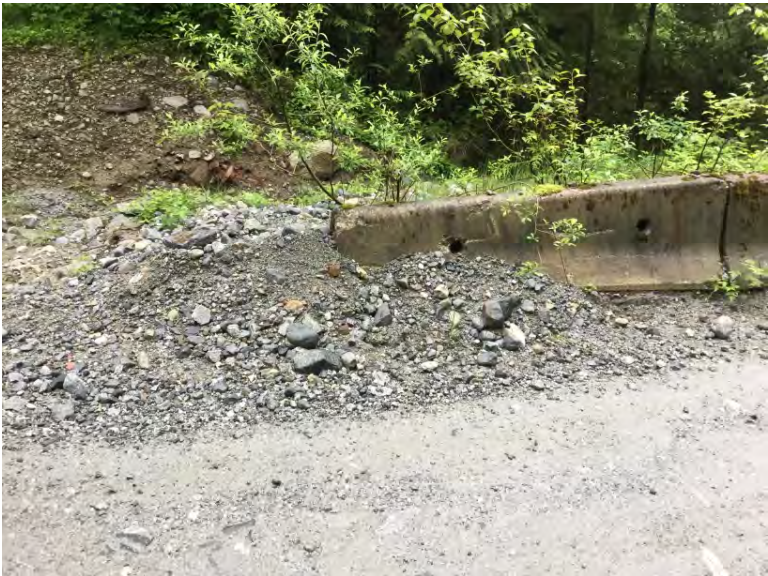
Missing bullnoses at left approach

Missing both bull noses at left approach

| Repair Item | Repair Description |
|---|---|
| 4 Approach. Approach fenders (install). # of units. Priority:Low | Replace missing bullnoses at left approach |

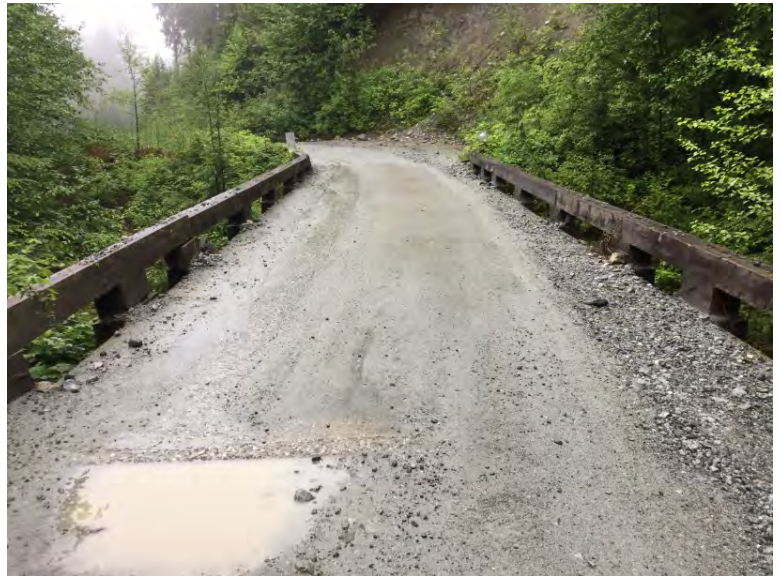
Deck Joints      Fair      Evidence that water is getting through

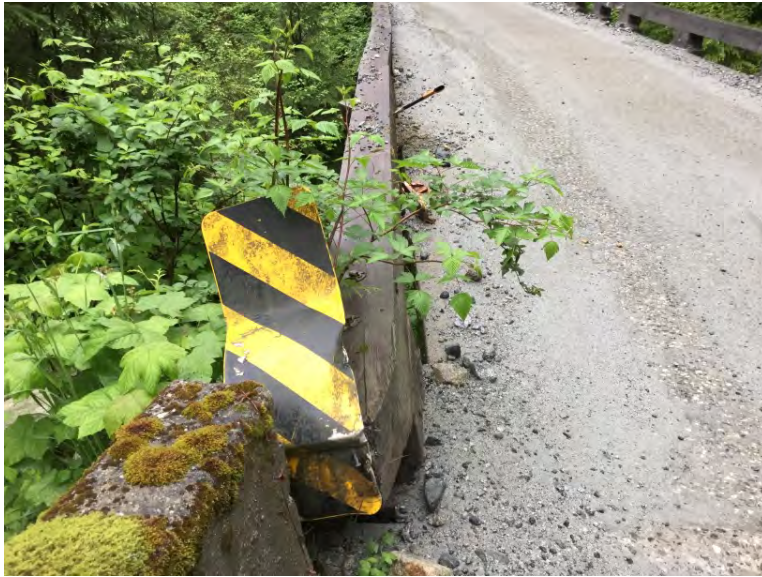
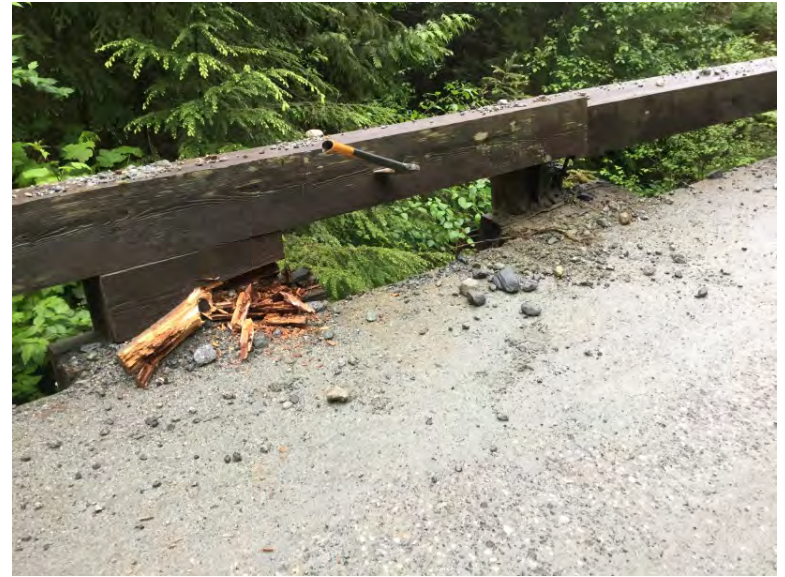
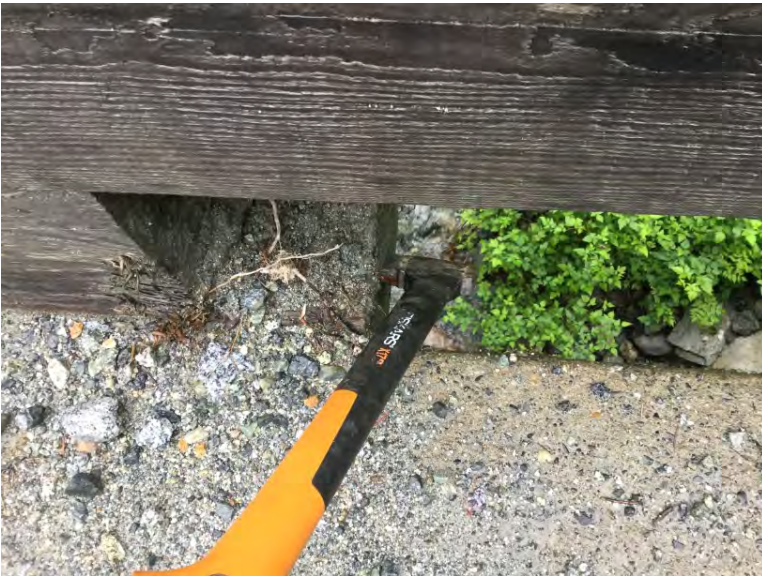
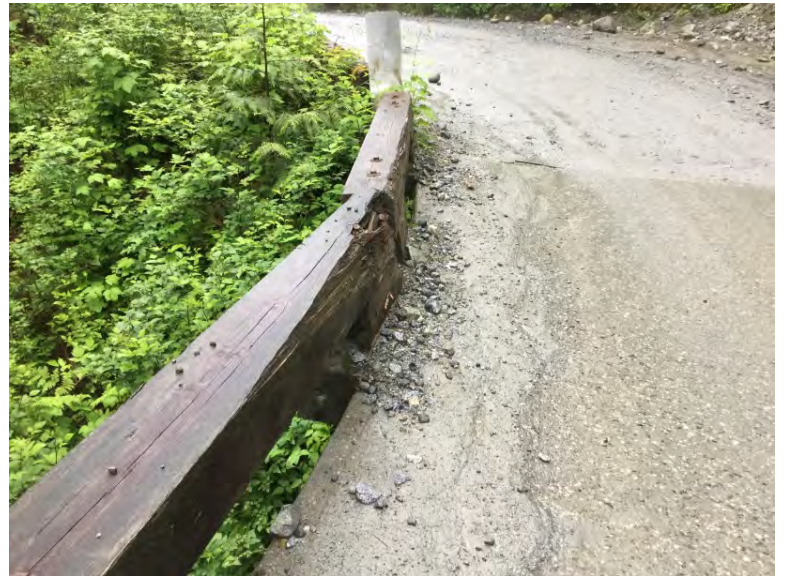
Guard Rail

Curb Rail/Blocks/Posts      Poor      Approximately 50% of risers and blocks damaged and/or rotten

Hardware      Poor      Loose rail bolts

Overall Deck Condition      Poor      Due to rail condition

| Repair Item | Repair Description |
|---|---|
| 2 Structure. Full Curb Replacement. . Priority:Medium | Replace guardrail, risers and blocks |

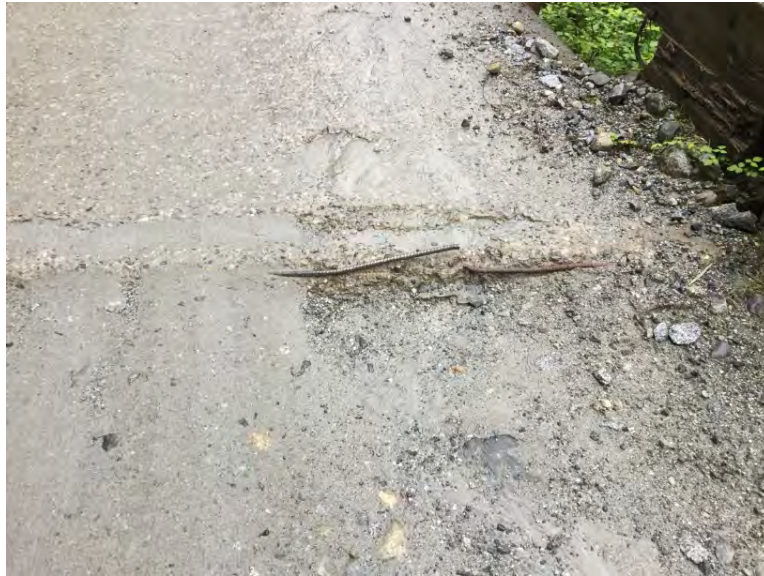
Ballast Wall Poor

Rebar exposed and broke at right bank

Downstream right bank ballast wall condition

| Repair Item | Repair Description |
|---|---|
| 1 Substructure. Ballast wall/retaining wall maintenance. m. Priority:High | Repair damage to right bank ballast wall |

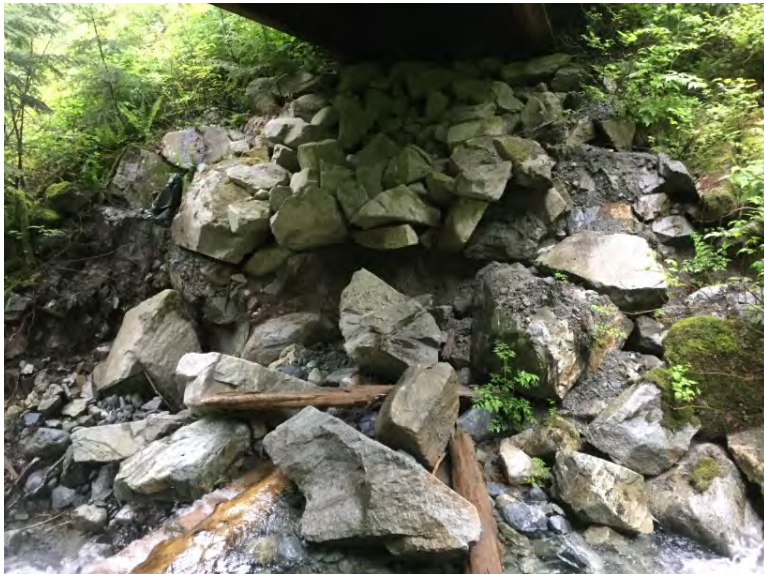
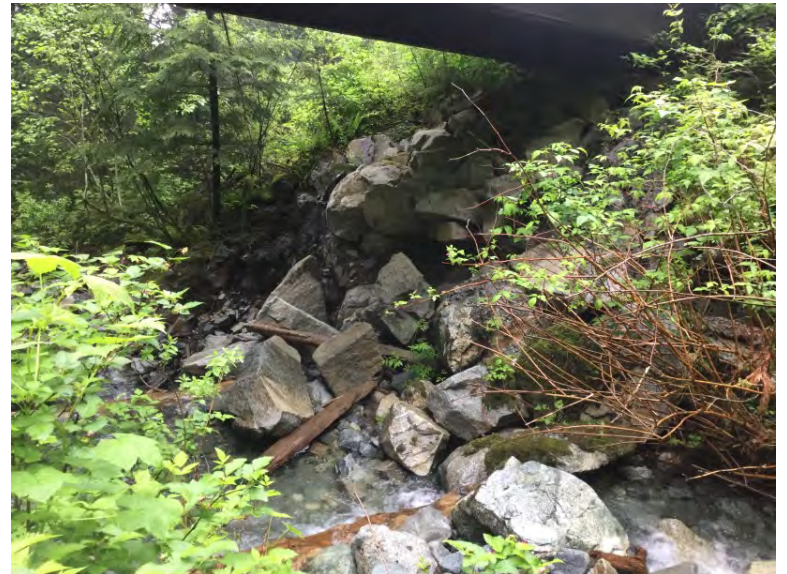
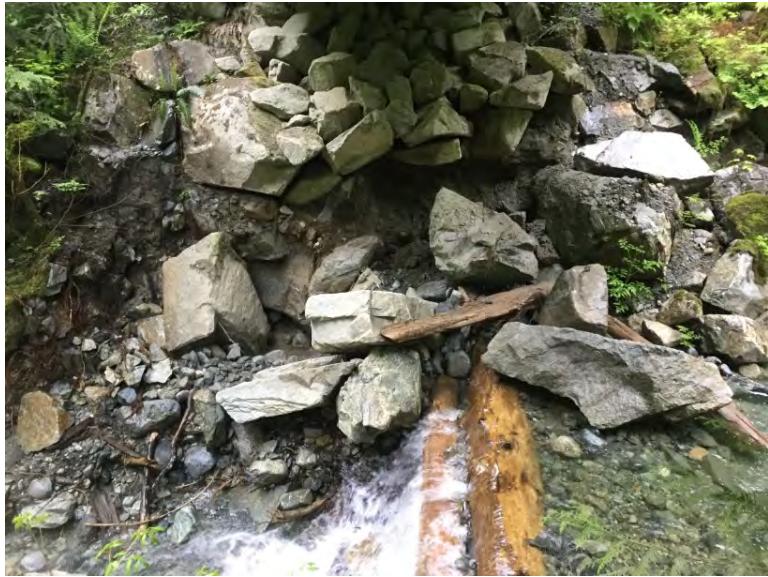
Right Bank Abutment when facing downstream

Riprap Poor

Heavily scoured at right bank and starting to scour at left bank

| Repair Item | Repair Description |
|---|---|
| 5 Miscellaneous. Other (specify in comments). # of items. Priority:High | Repair both banks riprap |

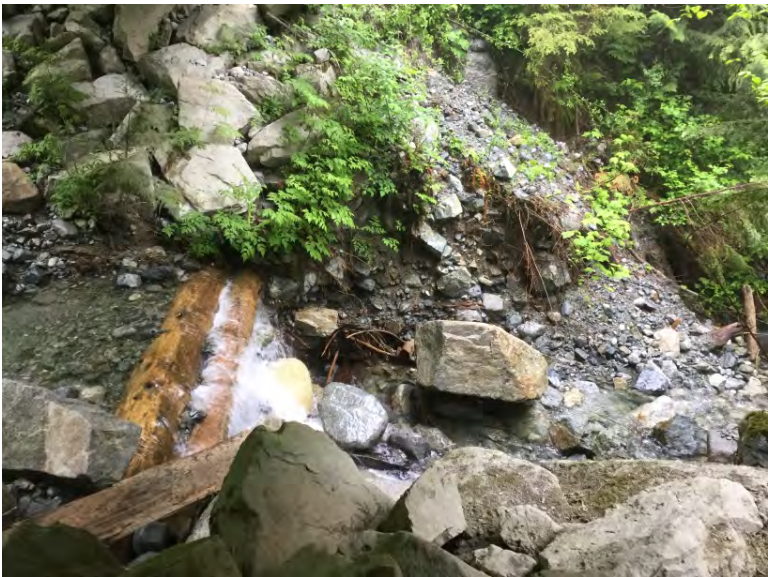
Downstream left bank scour

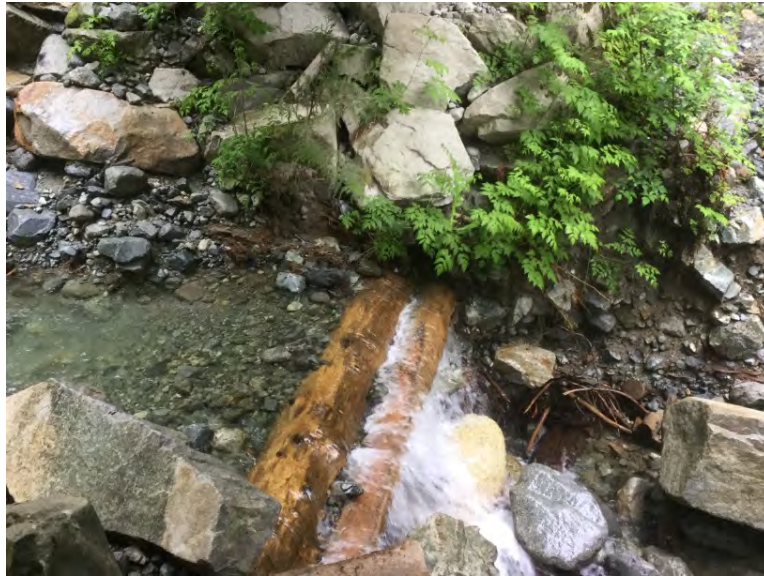
Riprap at both banks founded on organics

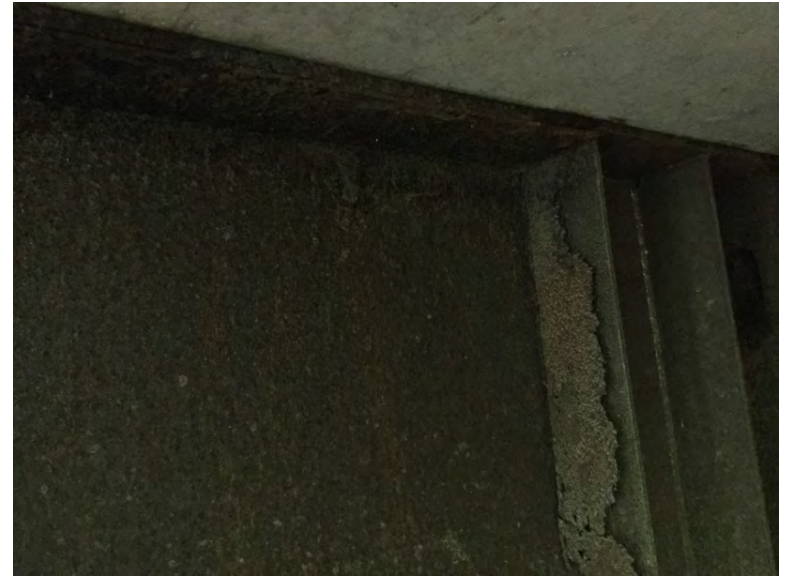
Minor corrosion noted on flanges and web at right bank and at deck joints

Corrosion noted at right bank

| Item | Monitor Description | Frequency |
|---|---|---|
| 2 | Corrosion of steel components | Routine Inspection |

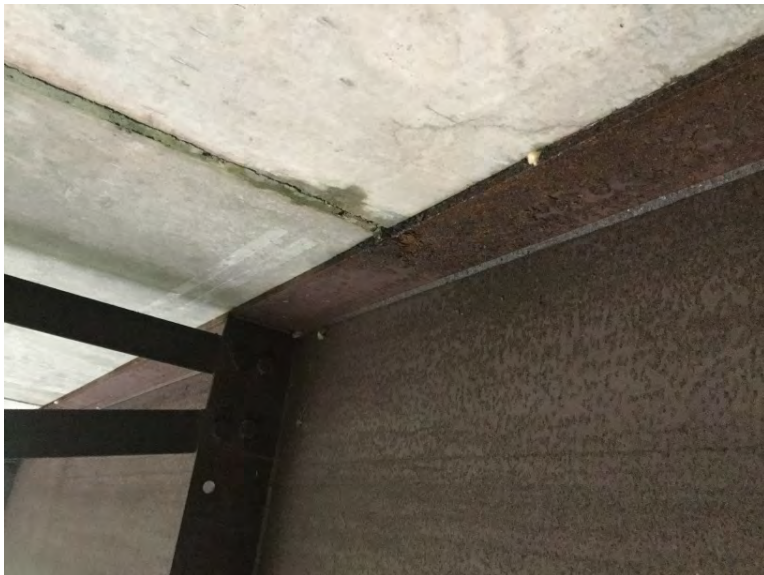
Corrosion noted at deck joints
