CK-2100  
CK-2100

## FLORENCE LAKE 14km

2020 Inspection

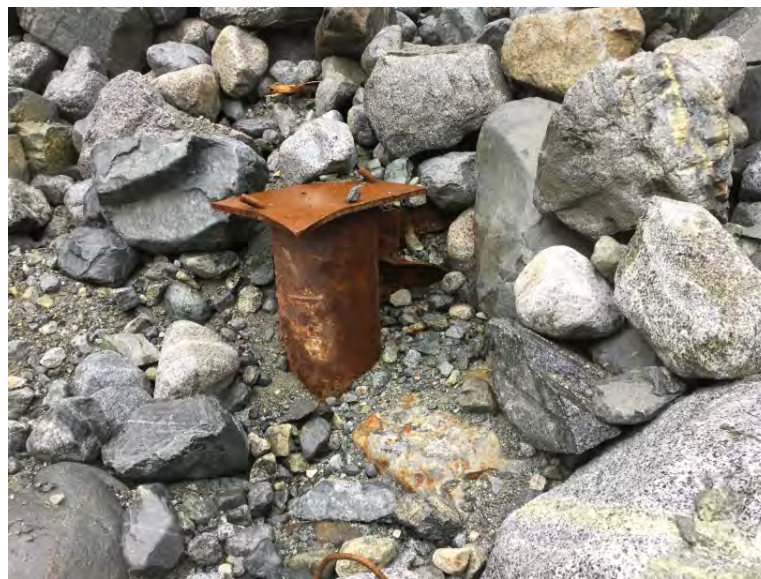
Old pipe columns still buried in approach material
