CK-2104  
CK-2104

HARRISON EAST 6.8km

2020 Inspection

Crossing Name Slollicum Creek

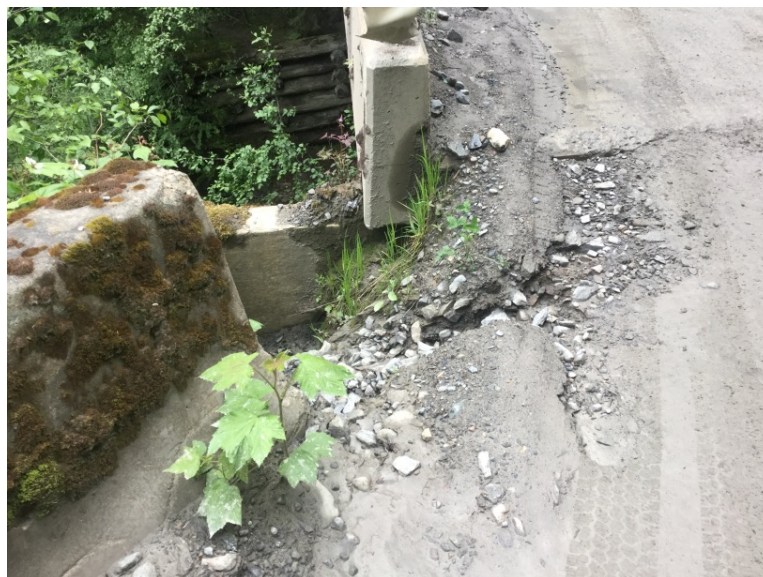
Fill Fair Old log cribs are retaining fill at both abutments, and the downstream left bank is eroding from a lack of surface drainage

Fill erosion down stream left bank

| Repair Item | Repair Description |
|---|---|
| 4 Approach. Approach fill repair. m <sup>3</sup> . Priority:Medium | Repair fill at down stream left approach |

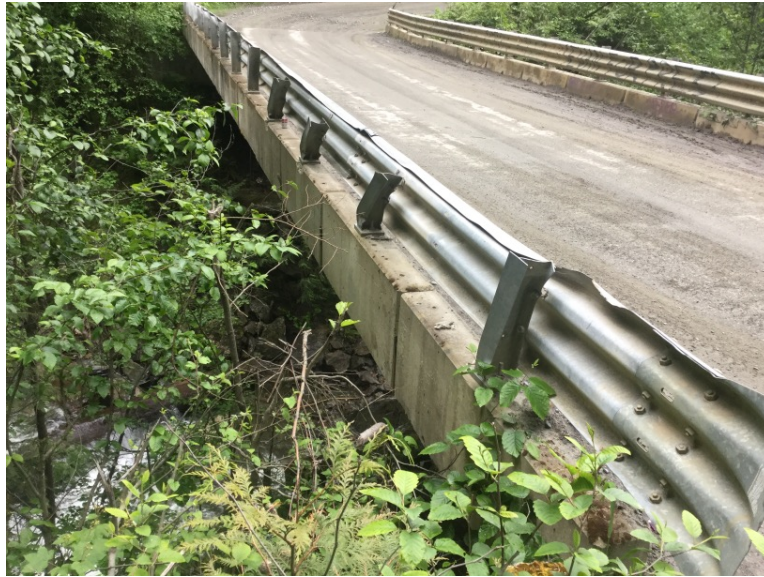
Curb Rail/Blocks/Posts      Poor      All 14 upstream risers damaged, but rail still functional

Hardware      Poor      Rail bolts connecting Wbeam to risers not functioning at all locations

Damaged guardrail and risers entire upstream

| Repair Item | Repair Description |
|---|---|
| 2 Structure. Curb Maintenance. # sites. Priority:High | Replace all 14 risers at upstream end |

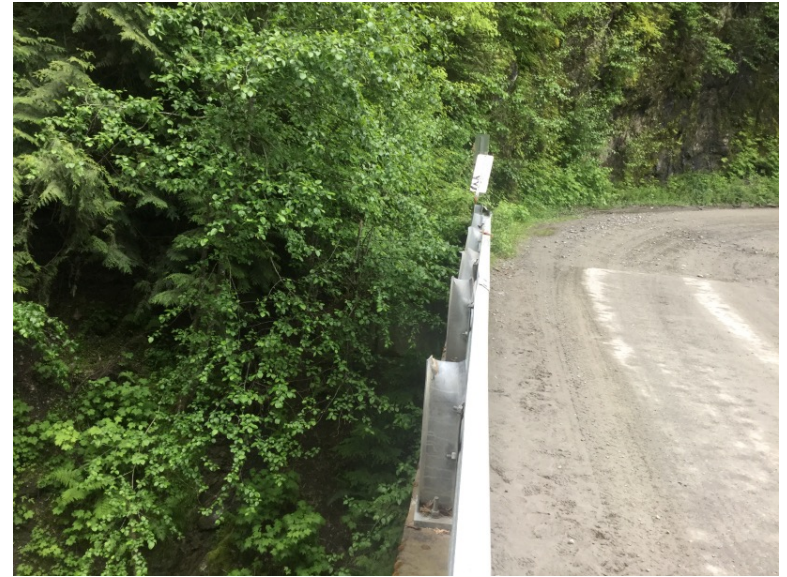
Upstream guardrail damage

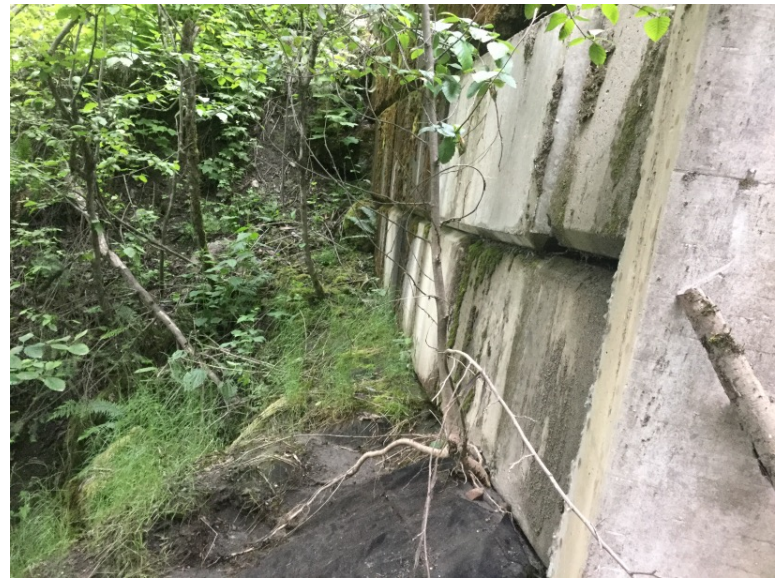
Wing Wall Good Lock blocks downstream right bank - 2nd and 3rd rows are slightly out of alignment and could have been like this since installation - monitor

Lock blocks retaining fill at downstream right bank

| Item | Monitor Description | Frequency |
|---|---|---|
| 1 | lockblocks retaining fill at the downstream right abnk | Routine Inspection |

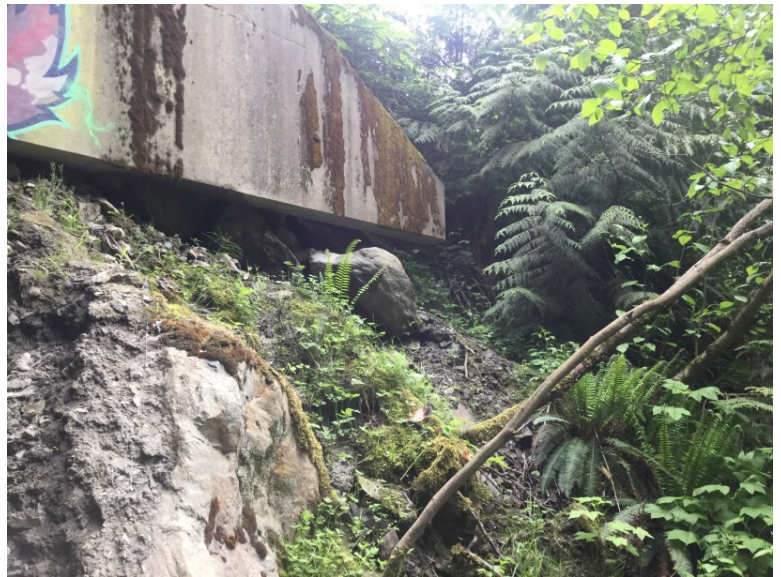
Downstream left bank
