CK-2108  
CK-2108

HARRISON EAST 30.7km

2020 Inspection

CBR iPad Offline Ver 0.33

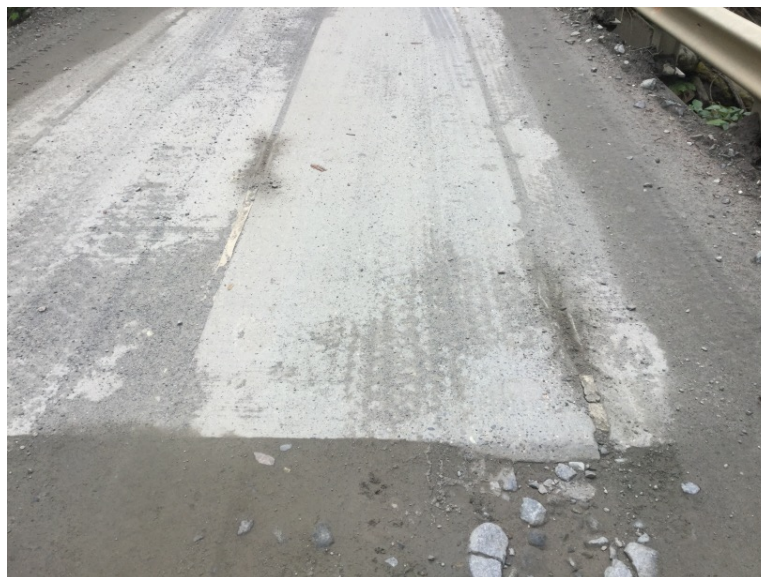
Paraseal joints have failed

| Repair Item | Repair Description |
|---|---|
| 2 Structure. Joint replacement. m <sup>2</sup> . Priority:Low | Replace paraseal |

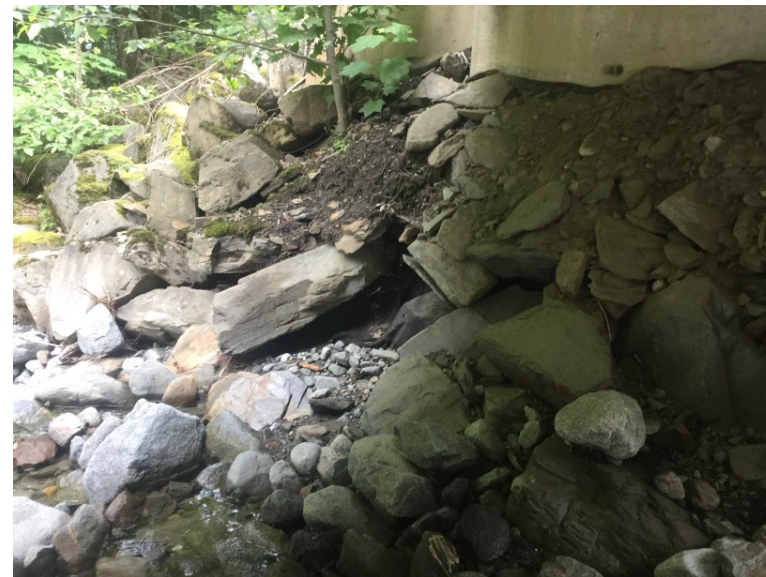
Riprap Fairr Both banks have now scoured and require repair and monitoring

Right bank riprap scour

| Repair Item | Repair Description |
|---|---|
| 3 Channel. Add Riprap (placed). m <sup>3</sup> . Priority:High | Repair scoured riprap at both abutments |

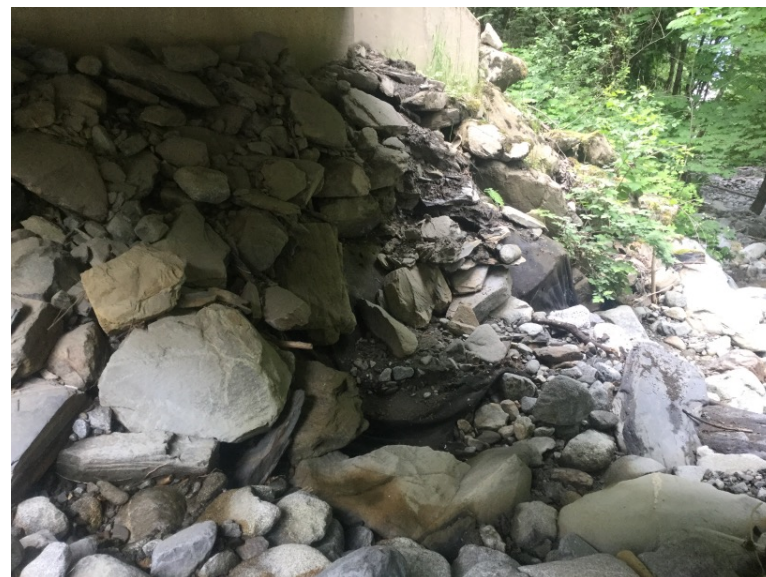
Left bank riprap scour

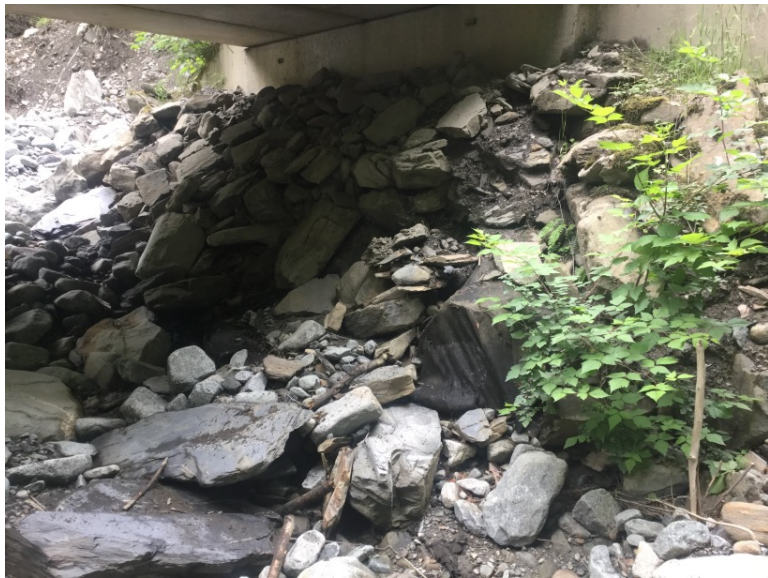
Downstream left bank scour

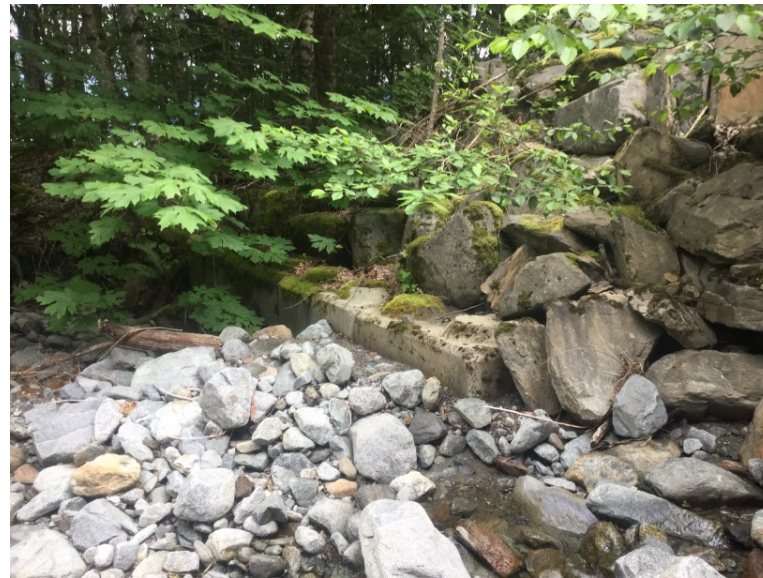
Wing Wall Good Lockblocks at downstream right bank

Lock blocks downstream right bank support riprap and fill

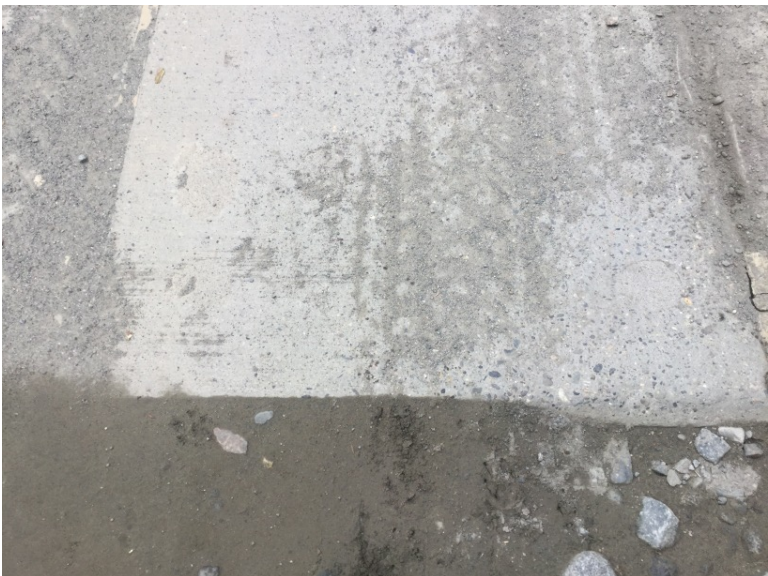
Each slab connected to cap in 2 locations at each abutment
