CK-2111  
CK-2111

HARRISON EAST 47.2km

2020 Inspection

Crossing Name Big Silver River

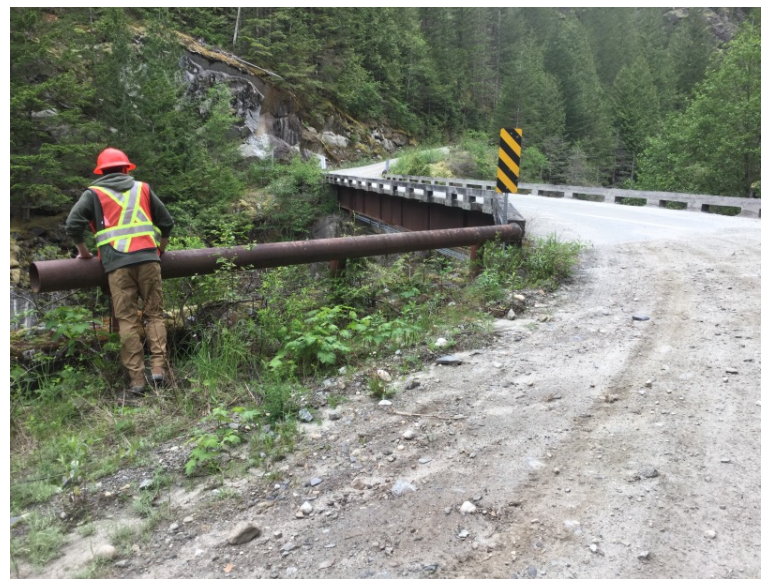
Approach Barrier downstream left approach

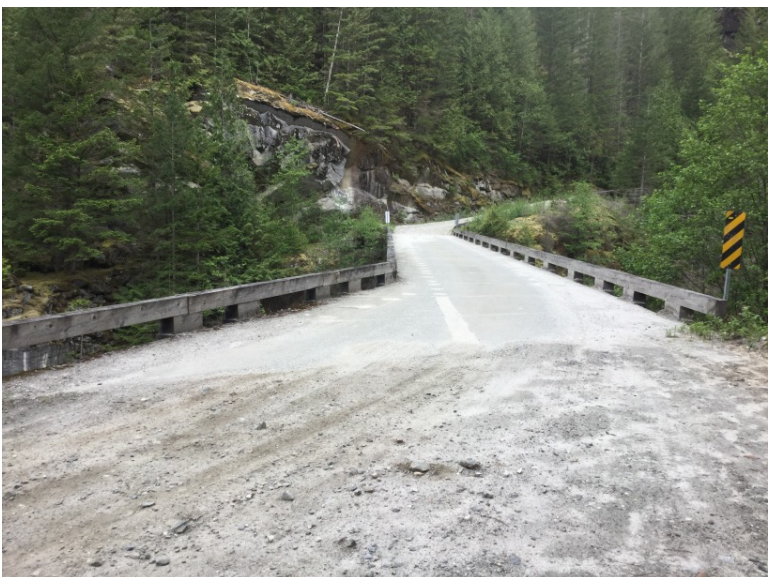
Concrete Deck      Good      wearing on wheel path, with heavy wear on left bank deck panel 1

Deck

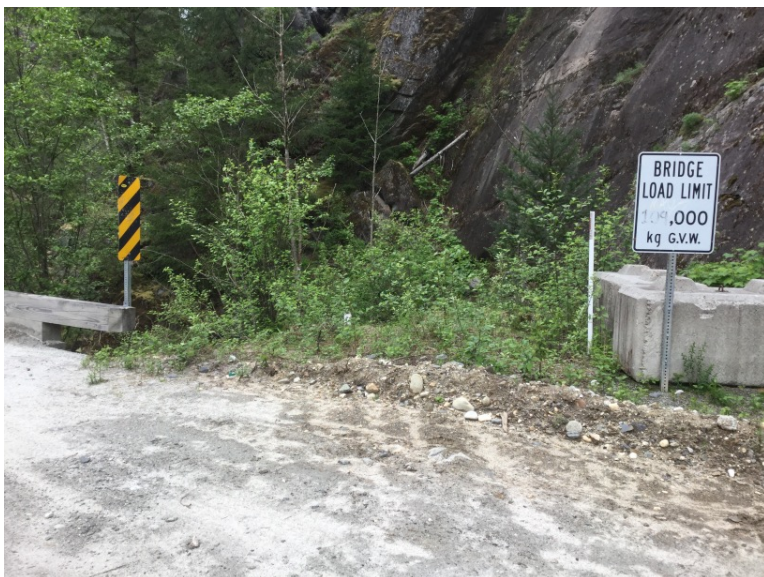
Fender Condition Fair Missing upstream left bank

Missing upstream left approach barrier

Add a minimum 6m long x 600mm log fender (or concrete no post barriers) to the upstream left bank approach. Repair the damage to the right bank ballast wall consistent with the Concrete Repair Guide for Concrete Bridge Components MoFLNRO (2017). Monitor the bearing bolt condition at the left bank and the condition of the right bank ballast wall. The current load rating of L120 or 109 tonnes to continue.

| Repair Item | Repair Description |
|---|---|
| 1 Approach. Approach fenders (install). Priority:high | Add upstream left bank approach barrier |

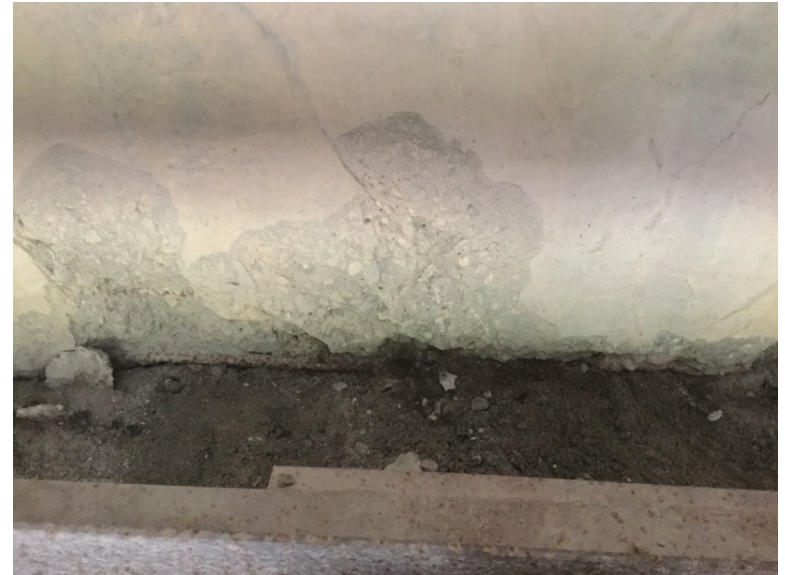
Ballast Wall Fair Damage/spall noted on stream side right bank

Right bank ballast wall damage

| Repair Item | Repair Description |
|---|---|
| 2 Substructure. Ballast wall/ retaining wall maintenance. Priority:Low | Repair damage noted to right bank wall |

| Item | Monitor Description | Frequency |
|---|---|---|
| 2 | right bank ballast wall condition | Routine Inspection |

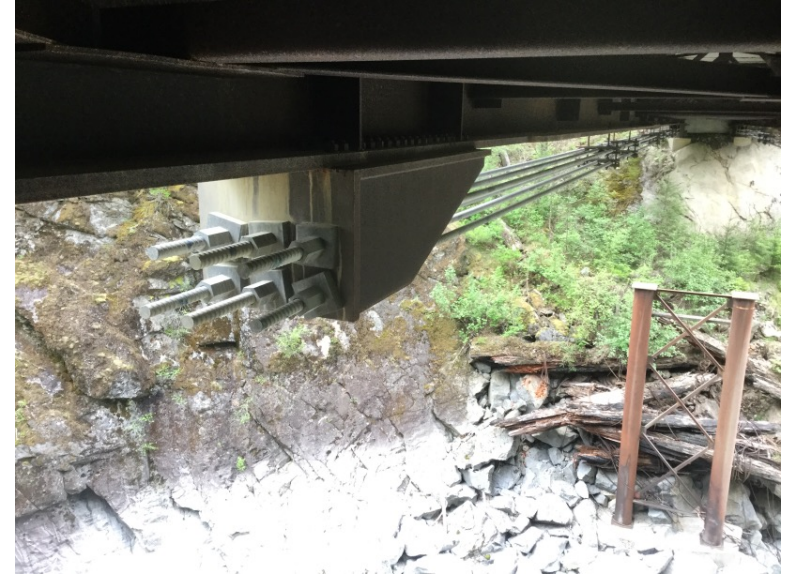
Under Trussing Good Dywidag post tensioning rods and hardware

Duwideg rods

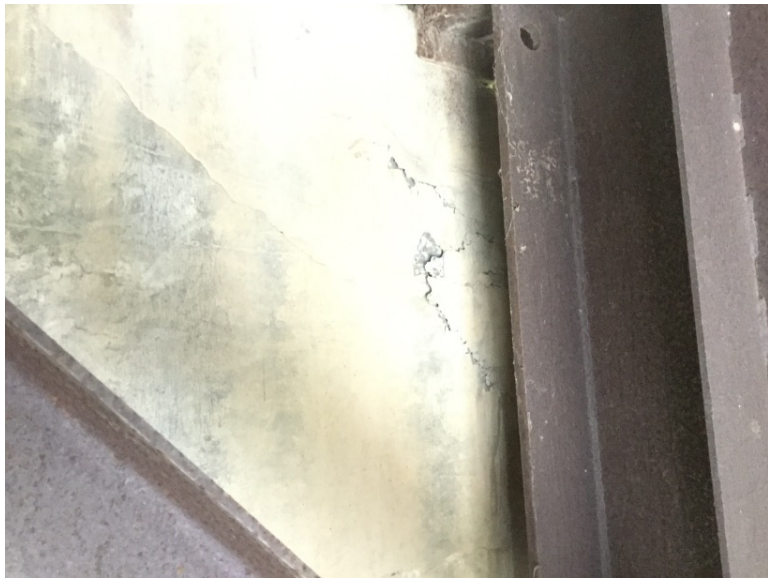
Right bank ballast wall damage

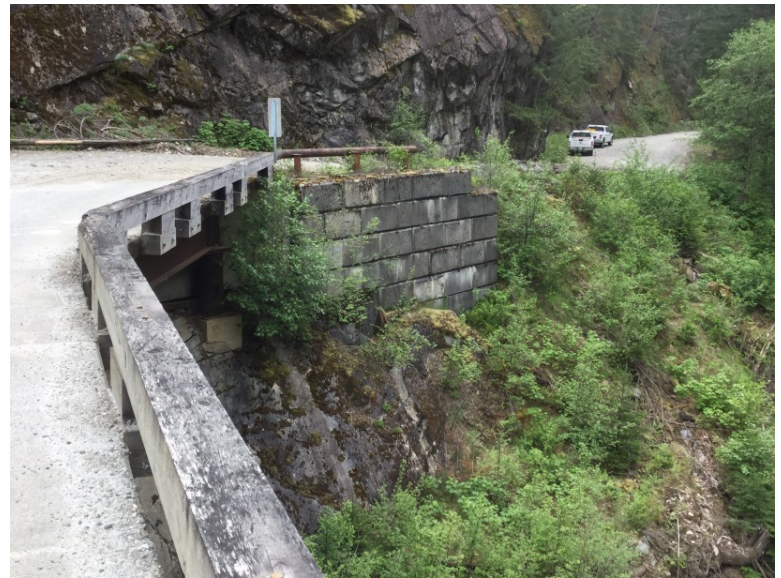
Wing Wall Fair Lock blocks downstream left bank - Good, downstream right bank have rotated slightly

Downstream left bank retaining wall

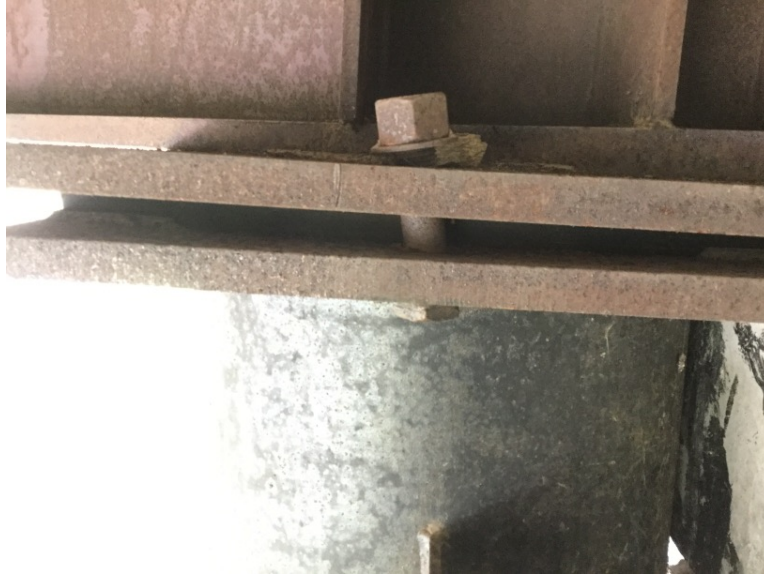
Bearings Fair Bearing bolts on bearings 1 and 2 are slightly bent towards stream side on left bank, bearing 3 on flare is in good condition left bank; right bank has steel keepers and in good condition

Upstream left bank bearing bolt

| Item | Monitor Description | Frequency |
|---|---|---|
| 1 | bearing bolt condition at left bank | Routine Inspection |
