CK-2112  
CK-2112

HARRISON EAST 50.2km

2020 Inspection

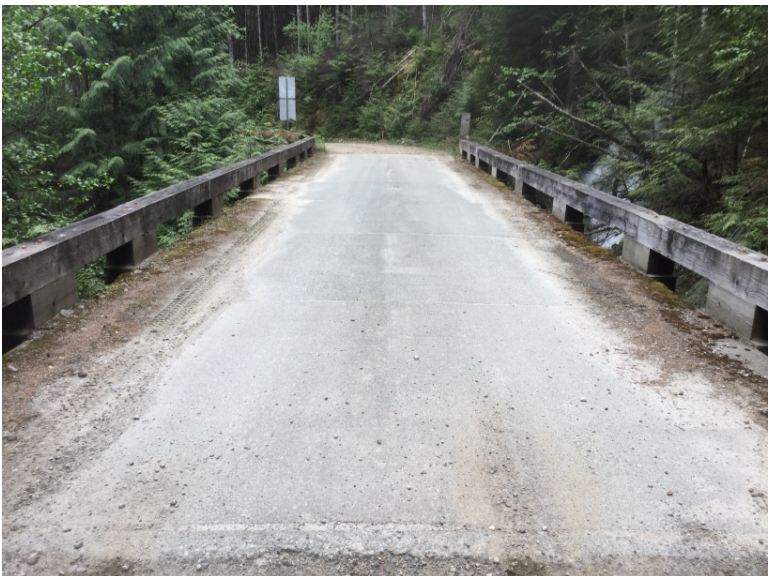
Concrete Deck      **Good**      Minor wear on wheel path

Grout Pockets      **Fair**      Evidence of water getting through

Deck Joints      **Fair**      Evidence of water getting through

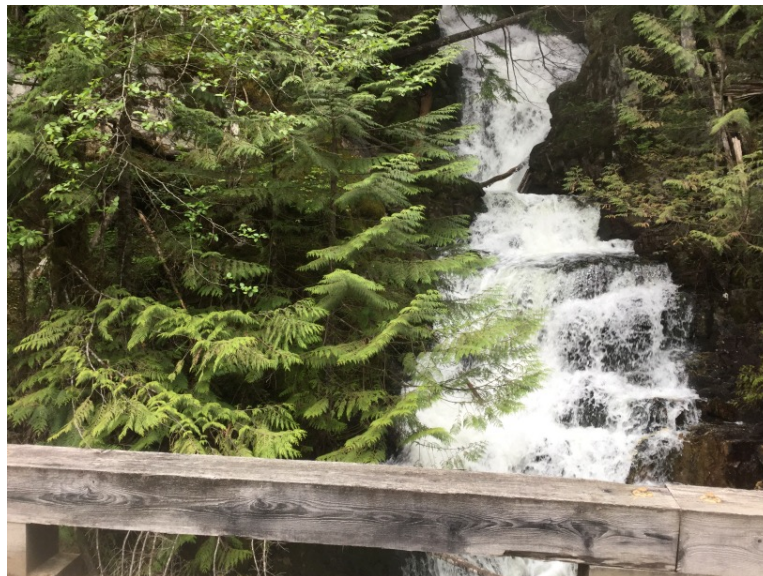
Upstream from Crossing

Missing upstream fenders

| Repair Item | Repair Description |
|---|---|
| 1 Approach. Approach fenders (install). # of units. Priority:Low | Install fenders at both upstream banks |

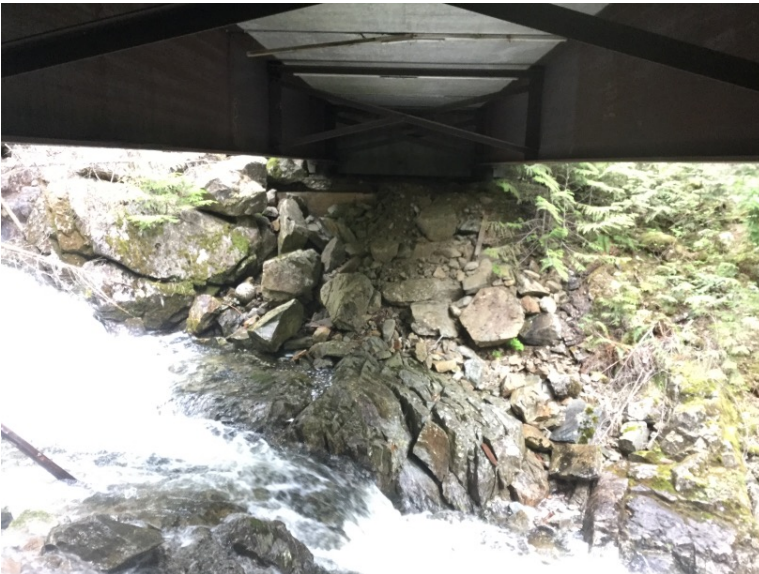
Left Bank Abutment when facing downstream

Upstream left bank has previously been scoured and stabilized

Comments Upstream left footing has previously been formed and stabilized with concrete

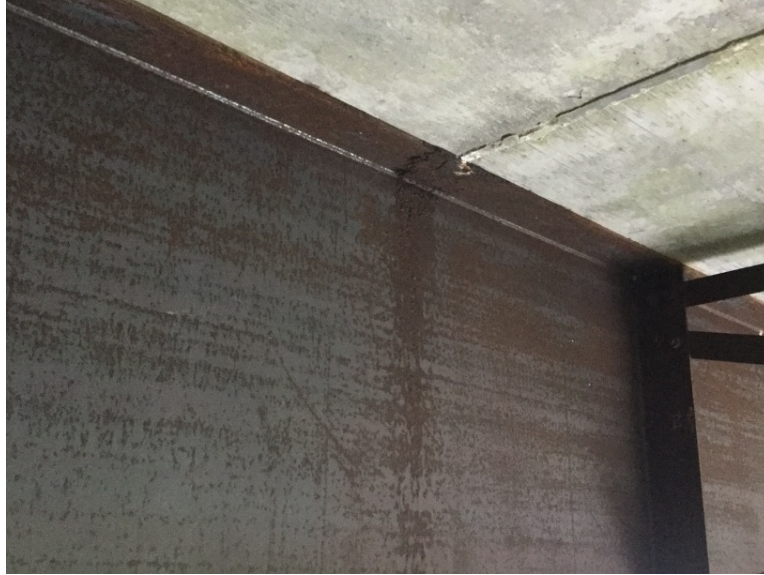
Minor corrosion noted at deck joints

Install 6m long x 600mm diameter log fenders at both upstream banks. Monitor the corrosion noted on the top flanges. The current load rating of L150 or 136 tonnes to continue.

| Item | Monitor Description | Frequency |
|---|---|---|
| 1 | corrosion on top flanges | Every routine inspection |
