CK-2114  
CK-2114

HARRISON EAST 54.8km

2020 Inspection

Crossing Name Gold Creek

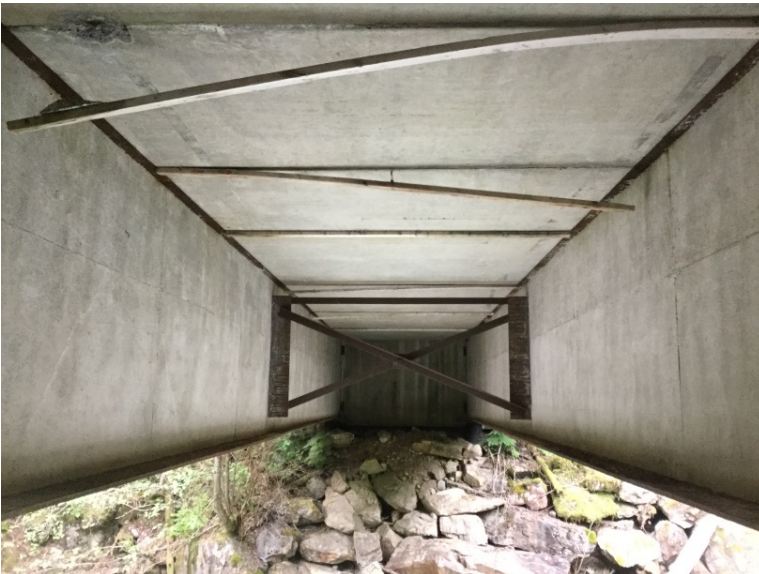
Superstructure

Composite girders with hairline cracks and minor steel delamination on top flange

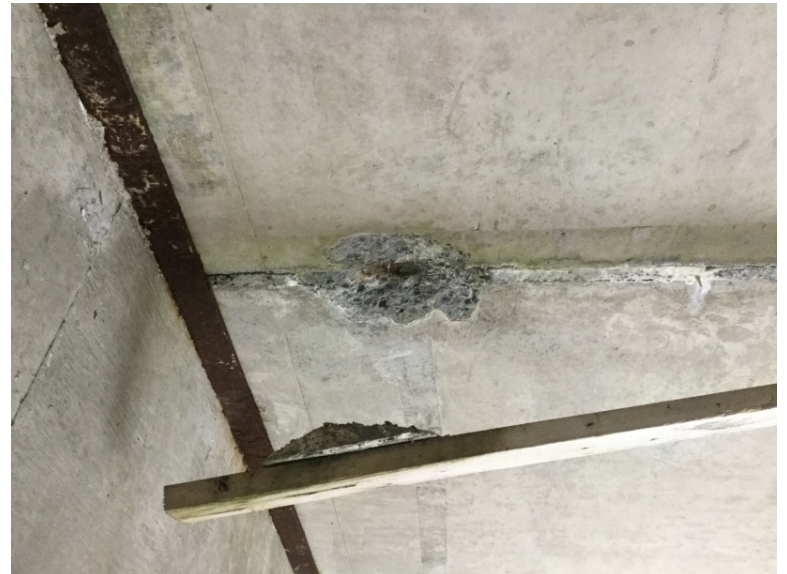
Minor spall

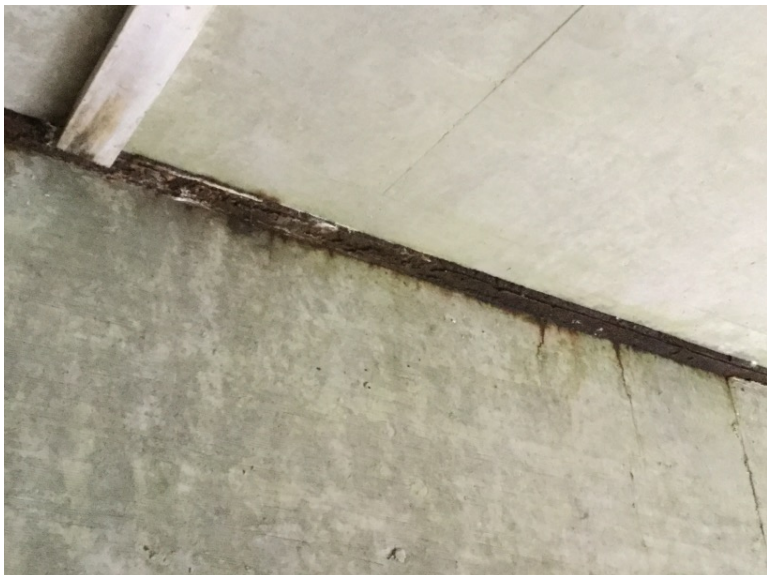
Minor corrosion on top flange
