CK-2121  
CK-2121A

Bear Creek FSR 7.4km

2020 Inspection

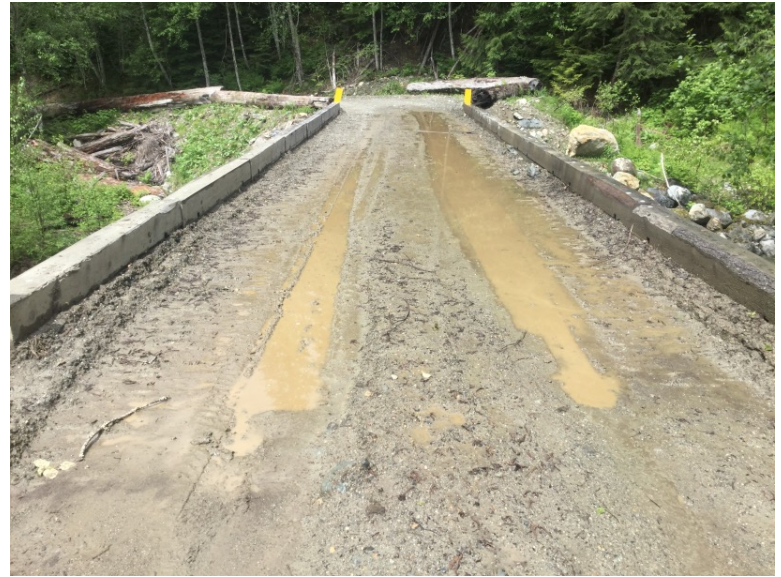
Overall Deck Condition Fair

Remove sediment from deck. The current load rating of L100 or 91 tonnes to continue.

| Repair Item | Repair Description |
|---|---|
| 1 Structure. Clean Deck. # of delineators. Priority:High | Clean sediment off deck |

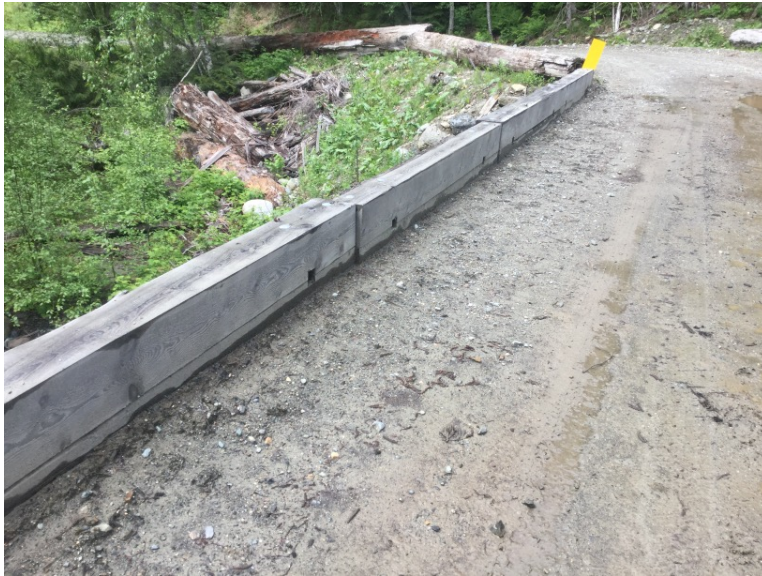
Full riser with drain holes

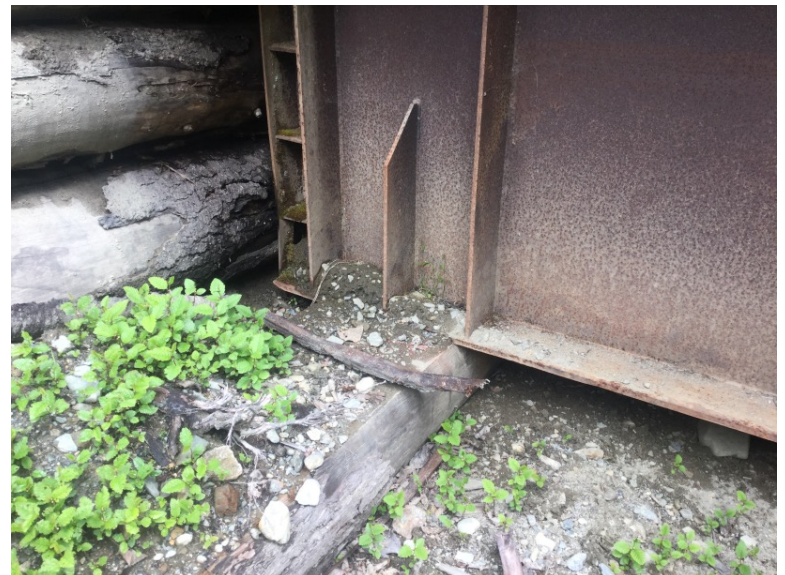
Bearing

Bearings Good

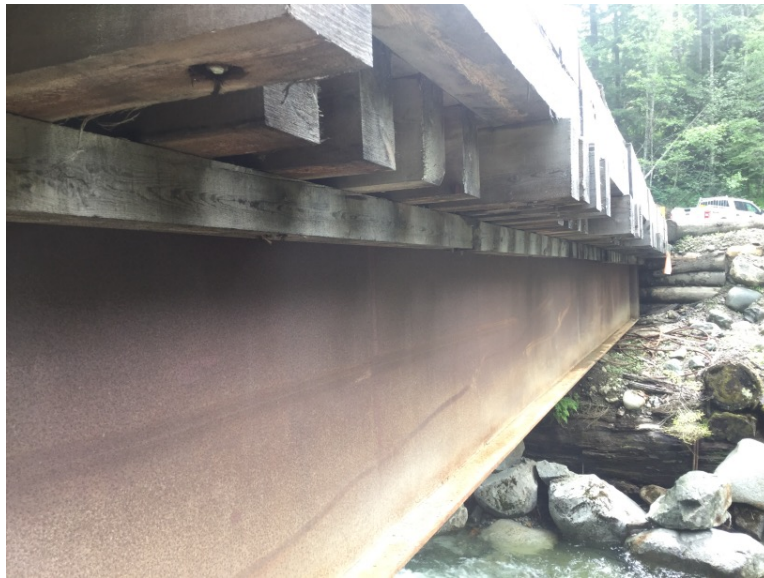
Deck to Girder Bolts Fair Modular panels

Modular panels

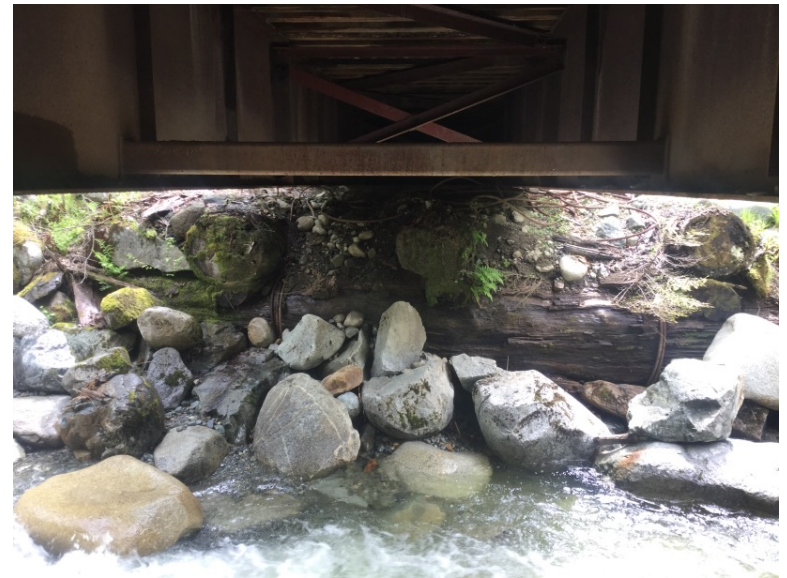
Left Bank Abutment when facing downstream

Large round boulders not keyed in and old log crib
