CK-2129

STS'AILES (WEST) 12.5km

2020 Inspection

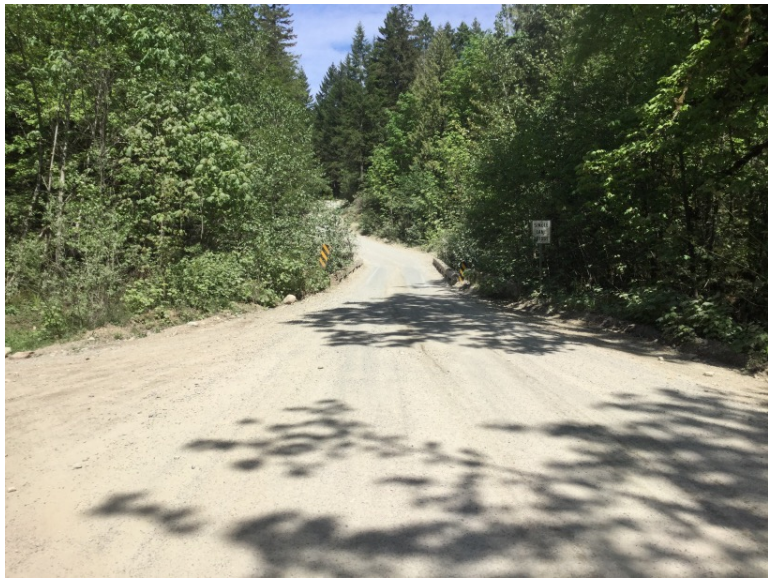
Approach from Right Bank when facing downstream

| Curb Rail/Blocks/Posts | Fair | Damage noted at right approach |

| 2 | Medium | Replace the first 3m of guardrail on the upstream and downstream of the right bank |

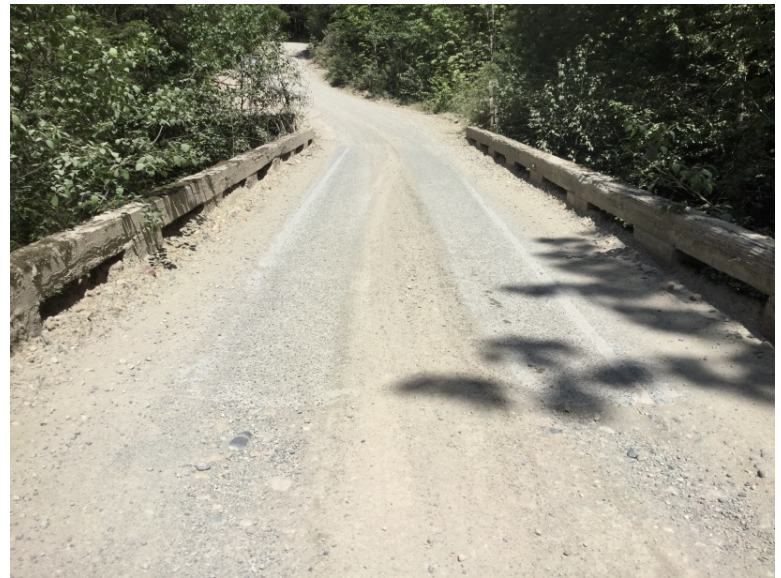
| Concrete Deck | Fair | Minor wear noted |

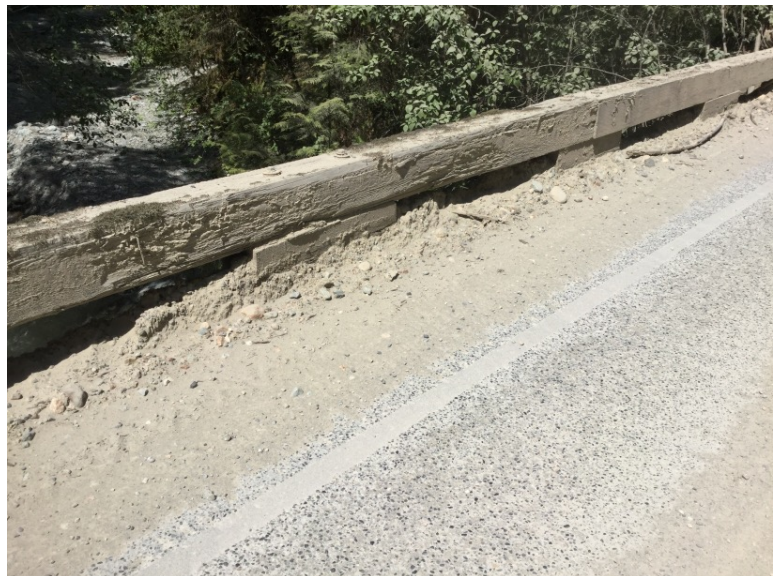
| Running Surface | Fair | Sediment collecting on deck |

Sediment on deck

| Item | Priority | Repair Description |
|---|---|---|
| 1 | Medium | Brush approaches and remove sediment from deck |

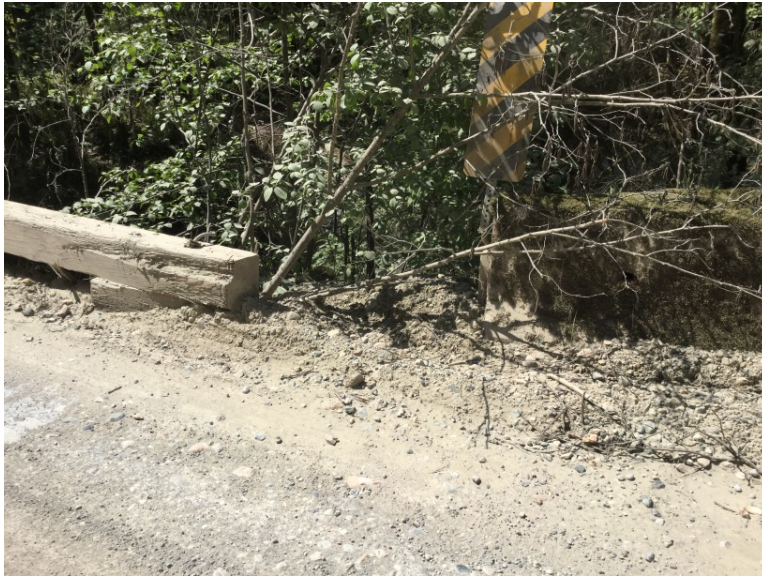
Upstream left bank barrier alignment

| Hardware | Fair | Missing a single bolt and hardware at the upstream left bank |

| 3 | Medium | Replace 1 rail bolt at upstream left approach |

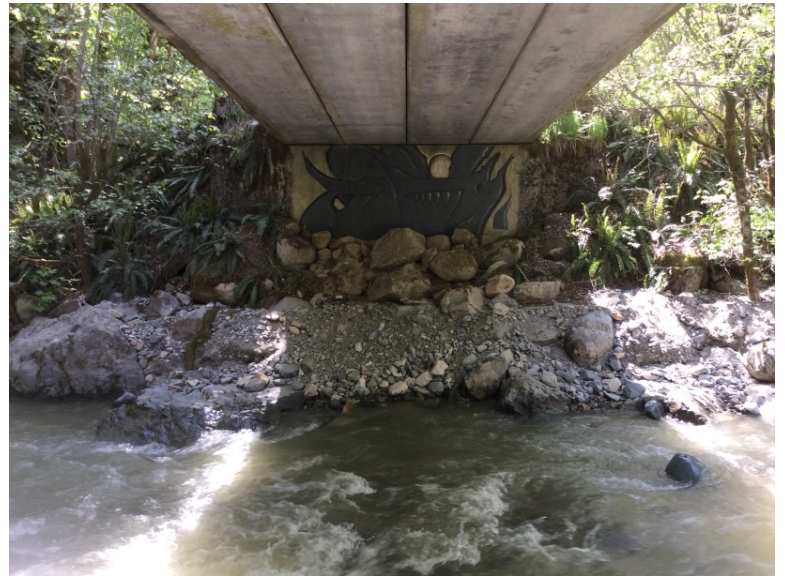
Right Bank Abutment when facing downstream

Concrete Good CIP

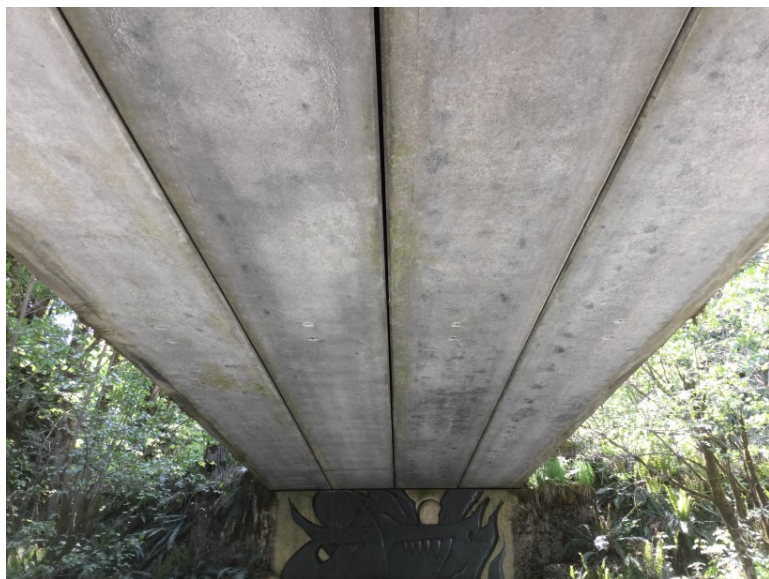
Superstructure

Girders Good 4 concrete slabs
