CK-2130  
CK-2130-2

STS'AILES (WEST) 12.8km

2020 Inspection

| Crossing Name | Wells Creek |

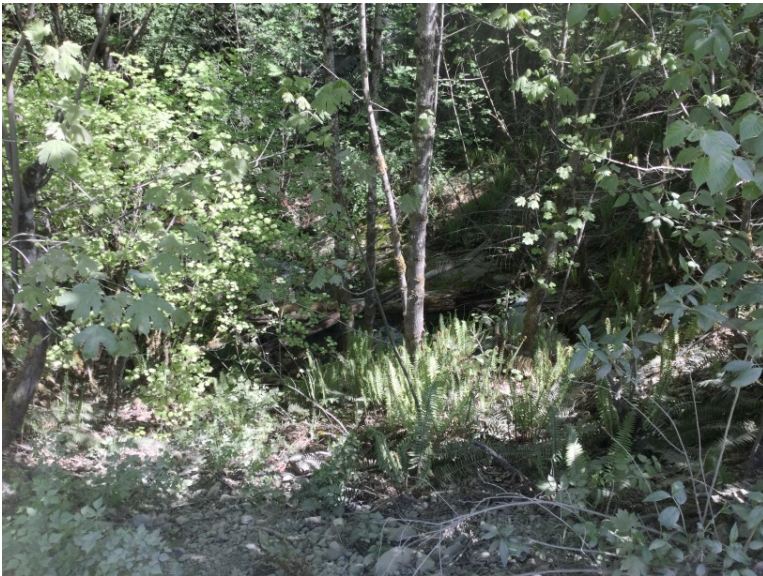
Downstream from Crossing

| Comments | Bedrock noted downstream | | | | |

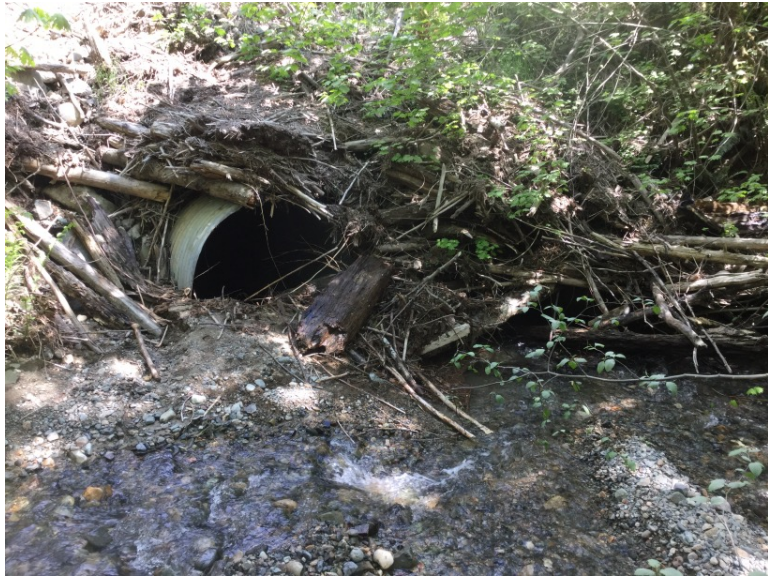
Inlet      Poor      Debris accumulations blocking entire downchain culvert and 50% of upchain, also aggrading

| Repair Item | Repair Description |
|---|---|
| 1 Channel. Debris removal.<br># of sites/items.<br>Priority:High | Remove debris accumulations at inlet |

| Item | Monitor Description | Frequency |
|---|---|---|
| 2 | debris accumulations at the inlet | Annual |

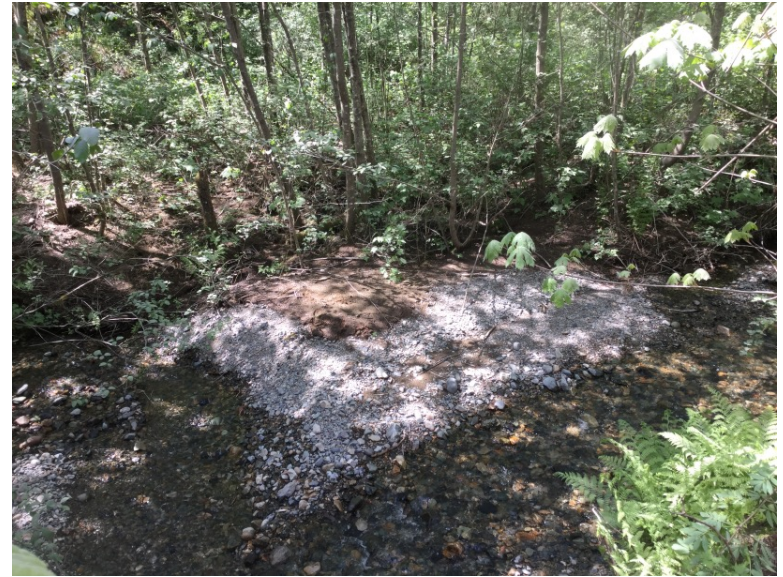
Island of vegetation upstream from crossing

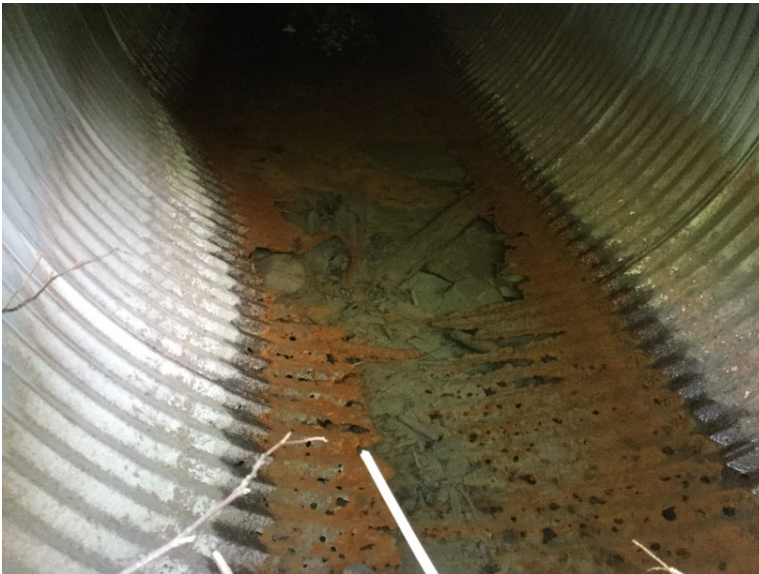
Coating      Fair      Fair on downchain culvert and poor on upchain

Floor      Fair      Fair on downchain culvert and poor on upchain

Upchain culvert corroded without a floor at inlet

| Item | Monitor Description | Frequency |
|---|---|---|
| 1 | upchain culvert floor condition | Annual |

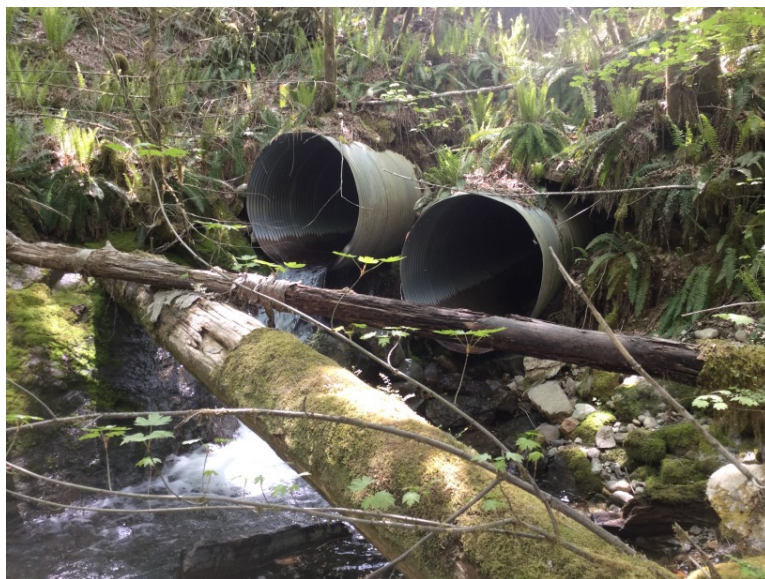
Outlet      Fair      1.5m drop in elevation to stream thalweg
